# Enamel alterations

Author\_Dr Prof Giuseppe Iaria, Italy

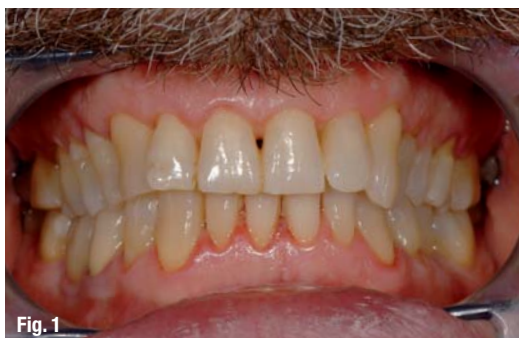
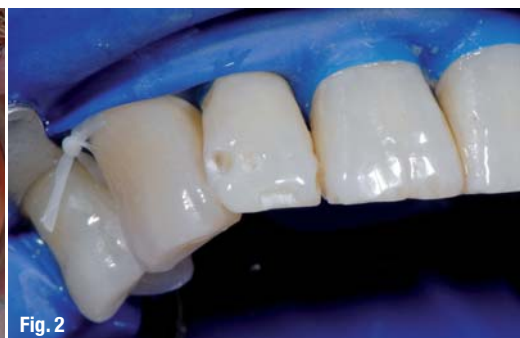
A healthy 56-year-old male patient presented with enamel alteration of tooth #7. The oral examination showed a healthy periodontium and temporomandibular joint, and the teeth were in a Class I occlusion (Figs. 1–4). The radiographic examination showed no other radicular lesions. The soft-tissue status indicated good periodontal health. For the hard-tissue test, percussion was normal, and there was no mobility or tenderness to touch or air spray. The tooth tested vital with the electric pulp tester and cold testing.

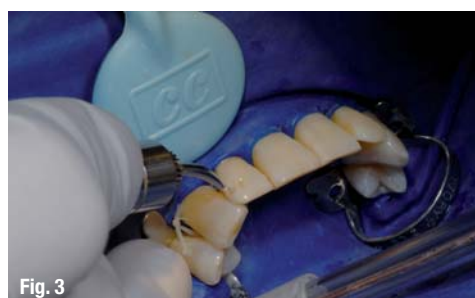
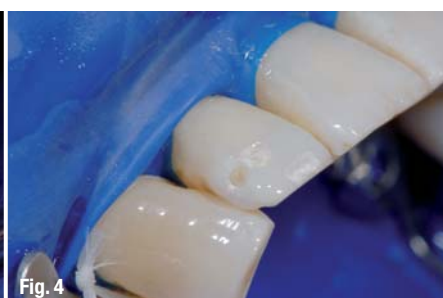
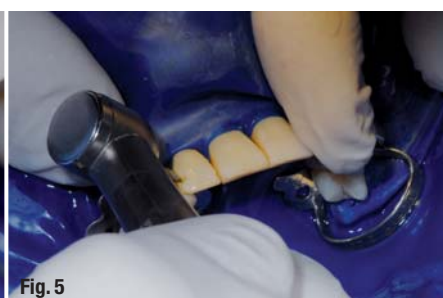
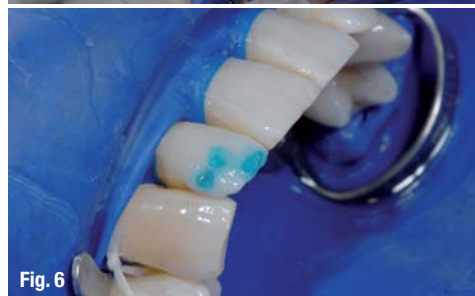
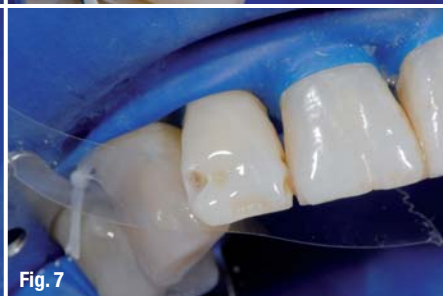
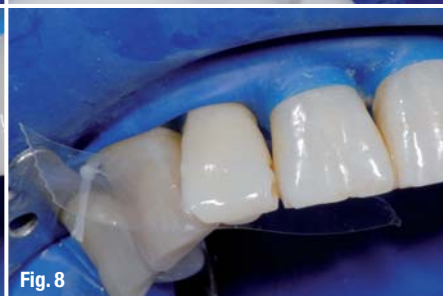
Adequate water spray must be maintained as the procedure is performed. Good visibility and low power are necessary for careful preparation in order to avoid both thermal damage and excessive removal of tooth structure.

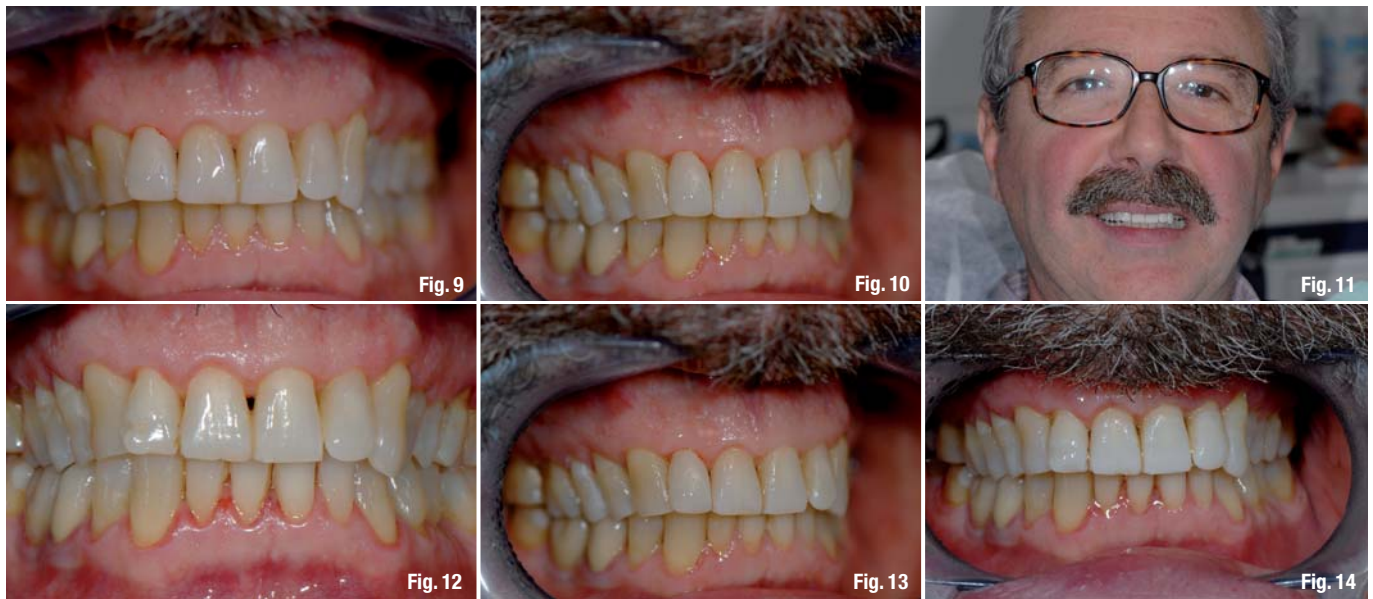
### Treatment alternatives
