Diagnosis and management of a longitudinal fracture necrosis associated with an extensive periodontal defect

Author_ Dr Antonis Chaniotis, Greece

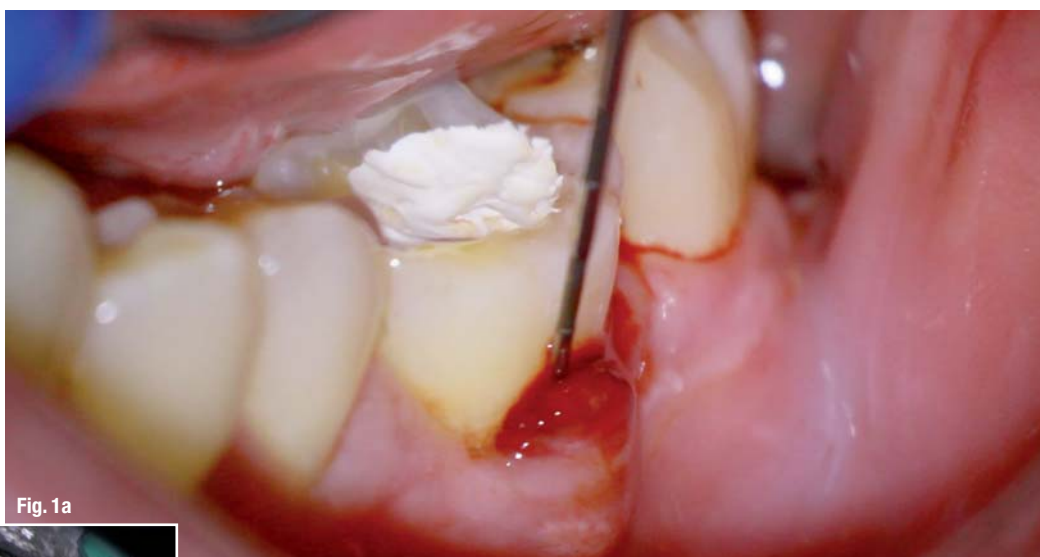
Fig. 1a

A 30-year-old male patient was referred to our endodontics practice for the evaluation and possible treatment of his mandibular left first molar. The referral note mentioned a possible diagnosis of VRF and suggested the extraction of the tooth, followed by grafting and implant placement. The patient's medical history was non-contributory. There was no history of trauma and no para-functional habits were identified. There was a buccal swelling in the furcation area and the tooth was percussion sensitive. The referring dentist had removed the amalgam restoration and placed a temporary filling material. Cold and electric vitality tests were negative. There was a deep buccal periodontal probing defect. The clinical view of the mandibular left first molar can be seen in Figure 1a. The radiographic examination revealed an extensive periapical lesion extending through the furcation area (Fig. 2a).
