# Diagnosis and management of a longitudinal fracture necrosis associated with an extensive periodontal defect

Author\_ Dr Antonis Chaniotis, Greece

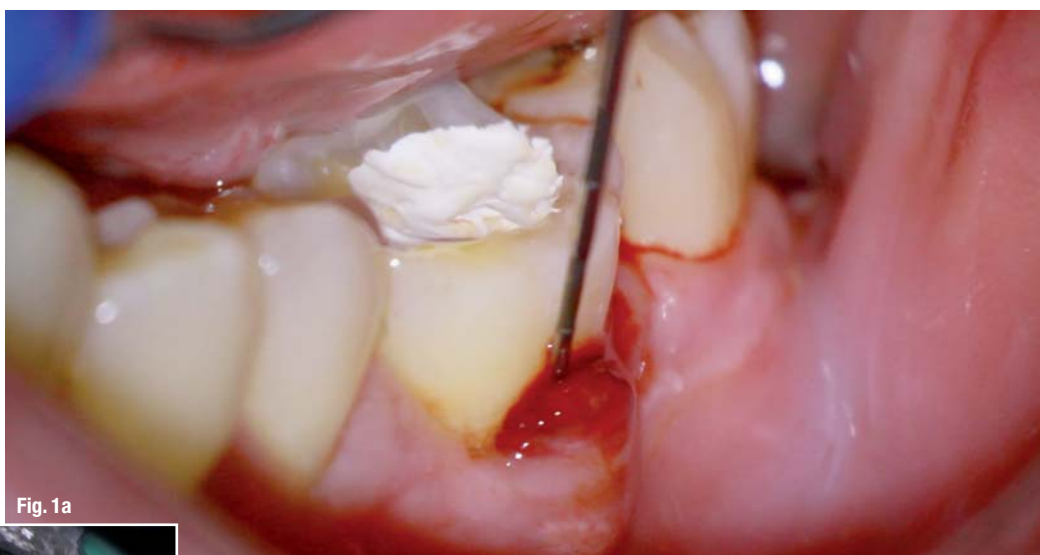
Fig. 1a

A 30-year-old male patient was referred to our endodontics practice for the evaluation and possible treatment of his mandibular left first molar. The referral note mentioned a possible diagnosis of VRF and suggested the extraction of the tooth, followed by grafting and implant placement. The patient's medical history was non-contributory. There was no history of trauma and no para-functional habits were identified. There was a buccal swelling in the furcation area and the tooth was percussion sensitive. The referring dentist had removed the amalgam restoration and placed a temporary filling material. Cold and electric vitality tests were negative. There was a deep buccal periodontal probing defect. The clinical view of the mandibular left first molar can be seen in Figure 1a. The radiographic examination revealed an extensive periapical lesion extending through the furcation area (Fig. 2a).

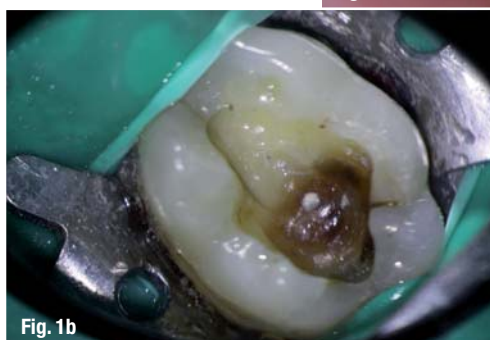
Fig. 1b

After administering infiltration anaesthetic, a rubber dam was placed. The temporary filling material was removed and the underlying dentine was stained with methylene blue dye (Figs. 1b & c). A fracture line was detected, extending from the mesial marginal ridge across the dentinal structure to the distal marginal ridge (Figs. 1c & d). The pulp chamber was accessed in order to determine the extent of the fracture line. Upon accessing the pulp chamber, the pulp floor calcifications were removed with ultrasonics under the microscope (Fig. 1e). The pulp floor and the axial dentinal walls were stained again with methylene blue dye and inspected under the microscope (Fig. 1f). No fracture lines or cracks were detected across the pulp floor, while the mesial and the distal fracture line appeared to end before entering the mesiobuccal and the distal root-canal orifices.

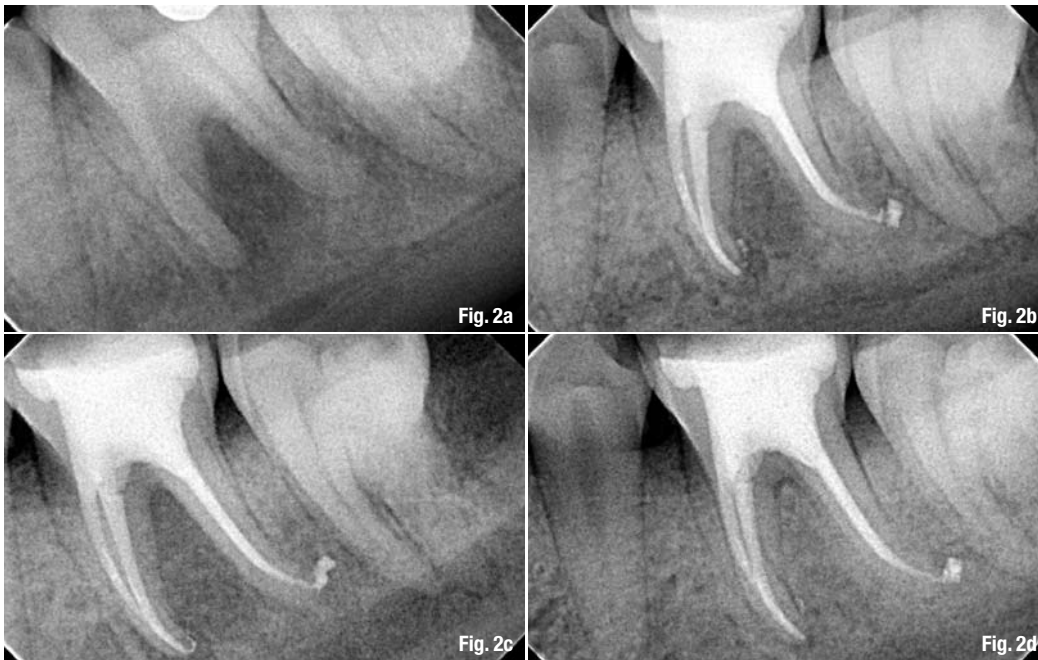
The pulp floor chamber was cleaned through sodium bicarbonate sand-blasting (Fig. 1g) and the orifices were covered with flowable dual-cured composite resin under the microscope. The build-up was accomplished using dual-cured composite resin and the occlusion was adjusted. The radiographic image of the tooth after the completion of the root-canal treatment and the build-up can be seen in Figures 2b and c.

The tooth was monitored for one year. The one-year follow-up radiograph revealed uneventful healing (Fig. 2d). The periodontal probing was within normal limits all around the tooth and the clinical view was favourable (Figs. 1h & i).
