Diagnosis and management of a longitudinal fracture necrosis associated with an extensive periodontal defect

Author_ Dr Antonis Chaniotis, Greece

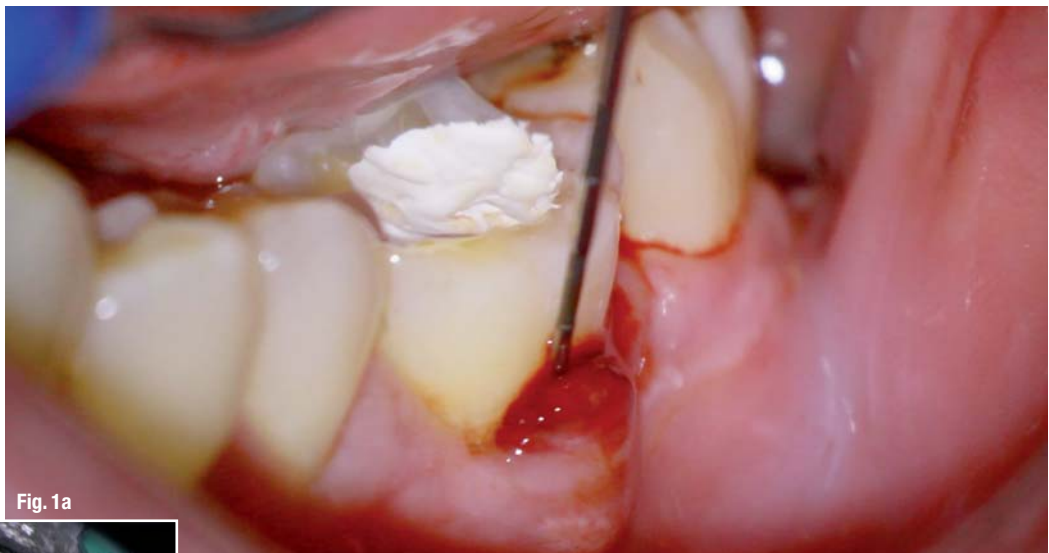
Fig. 1a

A 30-year-old male patient was referred to our endodontics practice for the evaluation and possible treatment of his mandibular left first molar. The referral note mentioned a possible diagnosis of VRF and suggested the extraction of the tooth, followed by grafting and implant placement. The patient's medical history was non-contributory. There was no history of trauma and no para-functional habits were identified. There was a buccal swelling in the furcation area and the tooth was percussion sensitive. The referring dentist had removed the amalgam restoration and placed a temporary filling material. Cold and electric vitality tests were negative. There was a deep buccal periodontal probing defect. The clinical view of the mandibular left first molar can be seen in Figure 1a. The radiographic examination revealed an extensive periapical lesion extending through the furcation area (Fig. 2a).

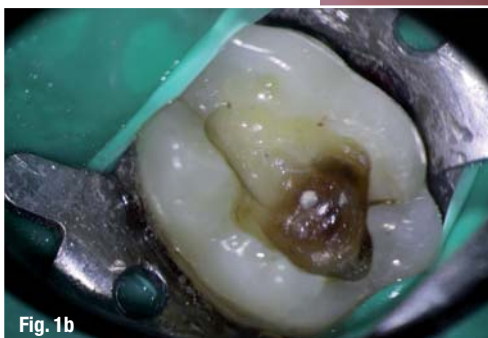
Fig. 1b

After administering infiltration anaesthetic, a rubber dam was placed. The temporary filling material was removed and the underlying dentine was stained with methylene blue dye (Figs. 1b & c). A fracture line was detected, extending from the mesial marginal ridge across the dentinal structure to the distal marginal ridge (Figs. 1c & d). The pulp chamber was accessed in order to determine the extent of the fracture line. Upon accessing the pulp chamber, the pulp floor calcifications were removed with ultrasonics under the microscope (Fig. 1e). The pulp floor and the axial dentinal walls were stained again with methylene blue dye and inspected under the microscope (Fig. 1f). No fracture lines or cracks were detected across the pulp floor, while the mesial and the distal fracture line appeared to end before entering the mesiobuccal and the distal root-canal orifices.
