Rehabilitation of a complex case with zirconium dental implants

Authors_Dr Andrea Enrico Borgonovo, Dr Marcello Dolci, Dr Rachele Censi, Dr Oscar Arnaboldi, Dr Virna Vavassori & Prof Carlo Maiorana, Italy

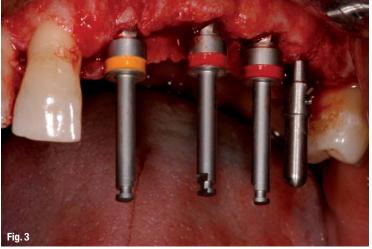
Fig. 1_Pre-op clinical view.
Fig. 2_Pre-op radiograph.
Fig. 3_Preparation of implant site.

A 55-year-old male patient presented with partial edentulism in the left maxilla in regions 21 to 26 at the Department of Oral Surgery at the Dental Clinic at the University of Milan. The patient was in general good health and a non-smoker. However, lately he had had financial difficulties that had led to him taking inadequate care of his oral health and consequently losing teeth. After professional hygiene and oral hygiene instructions, the patient was re-evaluated for an implant-prosthetic rehabilitation. His edentulism was complex owing to the lack of numerous teeth and because the alveolar process had undergone moderate resorption. Yet, it was sufficient to insert four dental implants. There was no need for an augmentation procedure and the predictable level within the gingival marginal profile was not considered a problem because of the patient's low smile line (Figs. 1 & 2).

After a diagnostic wax-up, the surgical guide was created. A mucoperiosteal flap was raised with a vertical releasing incision distal to tooth 1.2. Four one-piece yttria-stabilised ZrO₂ (YSZ) implants (whiteSKY, bredent) were inserted. Two 4 x 12 mm implants were

positioned in regions 2.1 and 2.3, and two 4.5 x 12 mm implants in regions 2.5 and 2.6 (Fig. 3). After the implant sites had been prepared, implant insertion was performed using a surgical contra-angle handpiece and then a dynamometric key, at a maximum torque of 40 N. The fixtures were screwed in until the sanded surface reached the bone crest level, leaving the polished part untreated at transgingival level. A heterologous bone graft (Bio-Oss, Geistlich Pharma), together with a double layer resorbable membrane (Bio-Gide, Geistlich Pharma), was positioned on the implant placed in region 2.1 because of the thin cortical wall and to reduce bone resorption. A sinus lift was performed using Summers' osteotome technique to insert the implant with an adequate length (12 mm) in region 2.6 (Figs. 4–7). The flaps were sutured with non-absorbable 4.0 monofilament (Premilene, B. Braun). The removable partial denture was adapted in order to avoid any contacts with the implants.

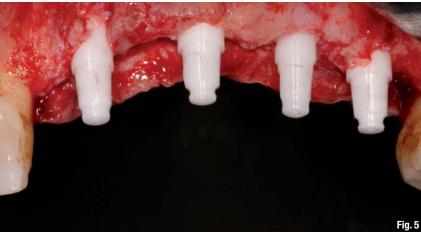
Fig. 4_Sinus lift using Summers' osteotome technique in region 2.6. **Fig. 5**_The four implants are positioned.

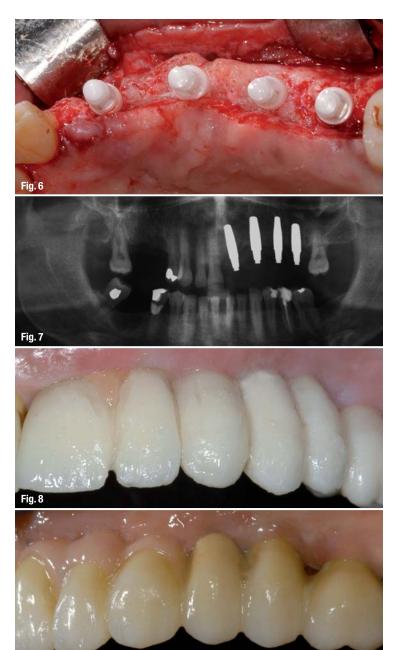
Fig. 6_Occlusal view of the implants.

Fig. 7_Post-op radiograph.

Fig. 8_The acrylic resin temporary

bridge is placed.

Fig. 9_Clinical view of the

all-ceramic ZrO₂ bridge five years

after surgery.

the implants were loaded. Six months after surgery, the YSZ implants were definitively restored with a ZrO_2 bridge. A light-pink ceramic layer was applied to the marginal areas of regions 2.1 to 2.3 to better support the upper lip and limit the width of the interdental space (Fig. 9).
