Endodontic retreatment: Achieving success the second time around

Author_ Dr Brett E. Gilbert, USA

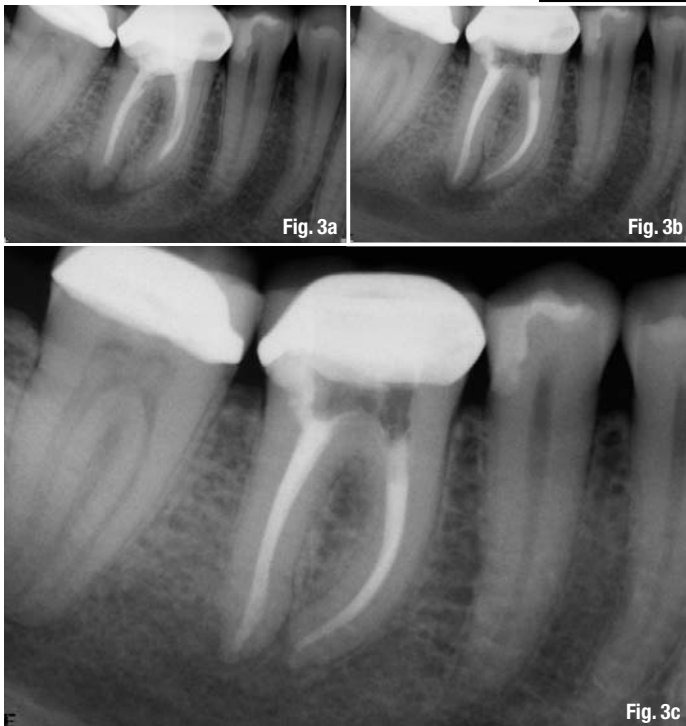
Fig. 3a Pre-operative image.
Fig. 3b Post-operative image.
Fig. 3c 13-month follow-up image. (Case by Dr. Brett Gilbert)

Full-strength 6% sodium hypochlorite been shown to be highly antimicrobial and able to dissolve tissue and disrupt bacterial biofilm.^{20,21} These qualities in an irrigant are ideal for the debridement of residual bacteria and tissue debris. The use of a rubber dam to isolate the treatment field is the standard of care for endodontic treatment. Failure to use a rubber dam may be a fundamental contributor to post-treatment disease. The following case illustrates the ability to overcome prior incomplete treatment to achieve successful healing (Figs. 3a-c).

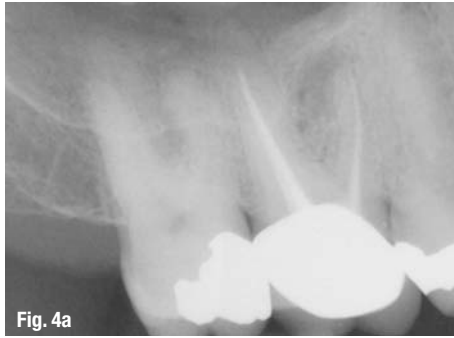
Fig. 4a

Fig. 4a_Tooth #3 with a radiolucent periapical lesion on the MB root apex.

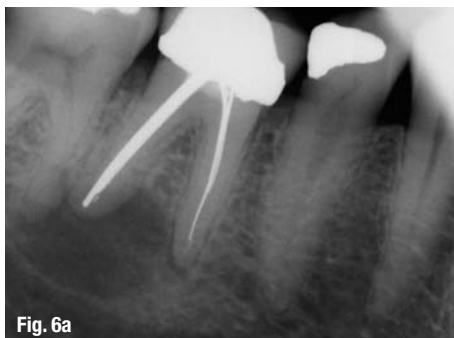
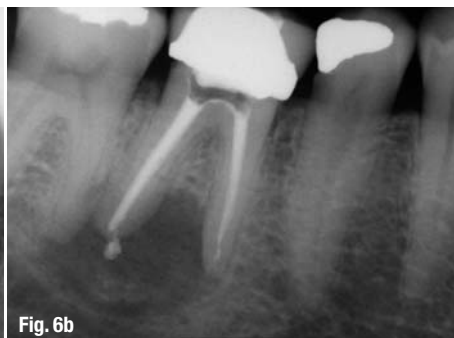
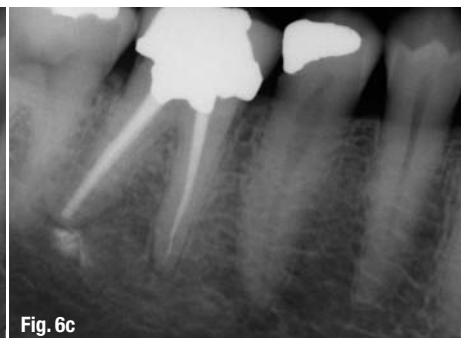
Fig. 6a_Pre-operative image.

Fig. 6b_Post-operative image.

Fig. 6c_13-month follow up image.

silver-point fillings, as demonstrated in Figure 5. These instruments allow clinicians to conserve root dentine by providing excellent visibility under a dental operating microscope, thereby greatly improving the ability to retreat canals (Figs. 6a–c). A heat source such as a System B tip (Axis, SybronEndo) is efficient for the removal of gutta-percha and resin materials from the coronal third. Hand and rotary files can remove root fillings and shape canals to appropriate working lengths. Current NiTi rotary files are highly flexible and resistant to separation and allow us to mechanically enlarge the apical third of root canals safely and efficiently without alteration of the natural canal morphology, which allows effective irrigation to reach the complex apical root-canal anatomy where bacteria are able to hide and resist debridement.
