Endodontic retreatment: Achieving success the second time around

Author_ Dr Brett E. Gilbert, USA

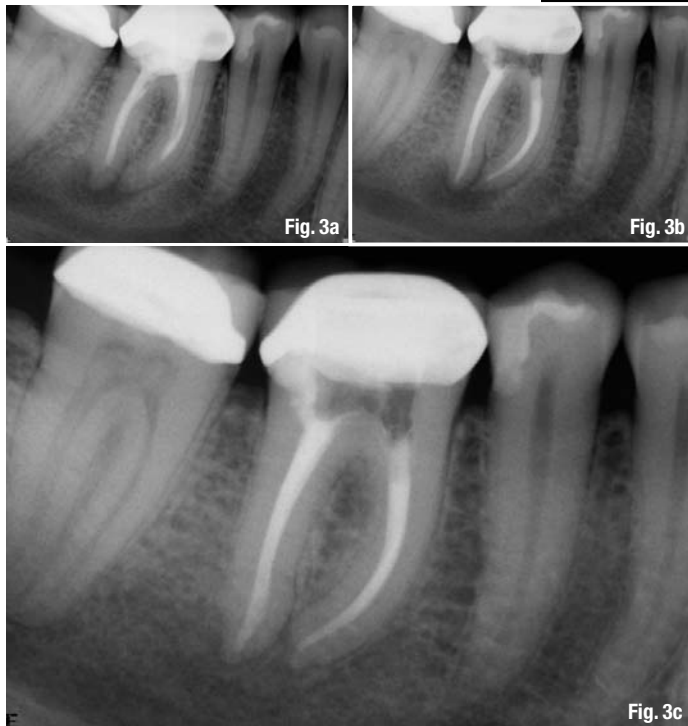
Fig. 3a Pre-operative image.
Fig. 3b Post-operative image.
Fig. 3c 13-month follow-up image. (Case by Dr. Brett Gilbert)

Full-strength 6% sodium hypochlorite been shown to be highly antimicrobial and able to dissolve tissue and disrupt bacterial biofilm.^{20,21} These qualities in an irrigant are ideal for the debridement of residual bacteria and tissue debris. The use of a rubber dam to isolate the treatment field is the standard of care for endodontic treatment. Failure to use a rubber dam may be a fundamental contributor to post-treatment disease. The following case illustrates the ability to overcome prior incomplete treatment to achieve successful healing (Figs. 3a-c).

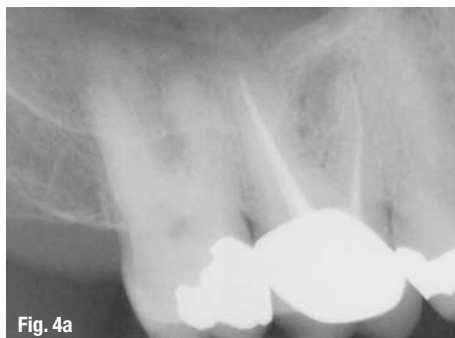
Fig. 4a

Fig. 4a_Tooth #3 with a radiolucent periapical lesion on the MB root apex.

With the bacterial challenges clinicians have to face, retreatment techniques must be capable of effective elimination of bacteria and their substrates. The use of a dental operating microscope and ultrasonic instruments allows clinicians to uncover all existing canal anatomy properly to ensure that they are able to cleanse the root-canal system completely. The following clinical case (Figs. 4a & b) illustrates the extent of the canal space left untreated in the initial root-canal therapy by not opening the mesiobuccal canal adequately and not locating and cleansing the hidden second mesiobuccal canal.

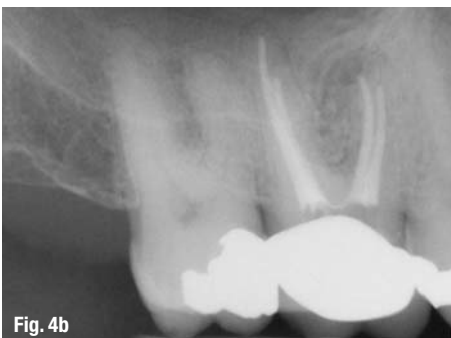
Fig. 4b

Fig. 4b_Post-operative image showing treatment of MB2 and appropriate lengths on retreatment of DB and P canals. (Case by Dr. Brett Gilbert)

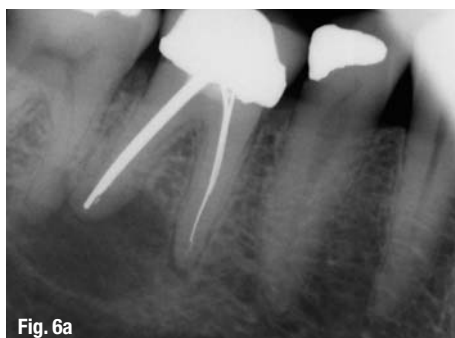
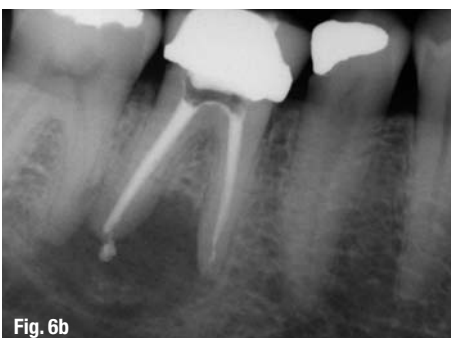
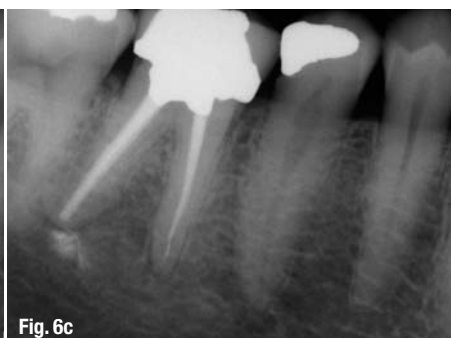
Fig. 6a_Pre-operative image.
Fig. 6b_Post-operative image.
Fig. 6c_13-month follow up image.

silver-point fillings, as demonstrated in Figure 5. These instruments allow clinicians to conserve root dentine by providing excellent visibility under a dental operating microscope, thereby greatly improving the ability to retreat canals (Figs. 6a–c). A heat source such as a System B tip (Axis, SybronEndo) is efficient for the removal of gutta-percha and resin materials from the coronal third. Hand and rotary files can remove root fillings and shape canals to appropriate working lengths. Current NiTi rotary files are highly flexible and resistant to separation and allow us to mechanically enlarge the apical third of root canals safely and efficiently without alteration of the natural canal morphology, which allows effective irrigation to reach the complex apical root-canal anatomy where bacteria are able to hide and resist debridement.
