Replacement of a single anterior tooth

Surgical procedure and three-year results

Author_Dr Peter Randelzhofer, Germany

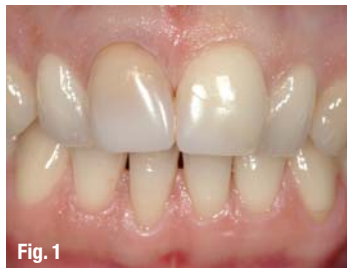
Fig. 1 The patient had a high smile line, and tooth #11 was discoloured and had a poor prognosis. The gingiva was thick and the interdental papillae had a high-scalloped appearance.

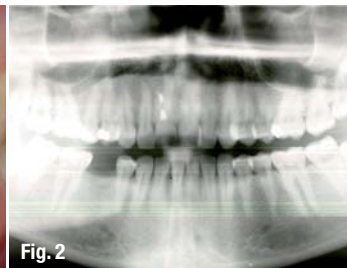
Fig. 2 Radiograph showing endodontic infection of tooth #11.

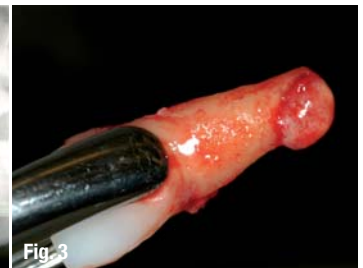
Fig. 3 Careful extraction of tooth #11.

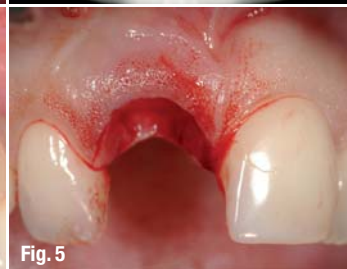
Fig. 5 Intact coronal buccal bone plate: Note the thin interdental papillae. The remaining scar tissue of the former apex resection is clearly visible.

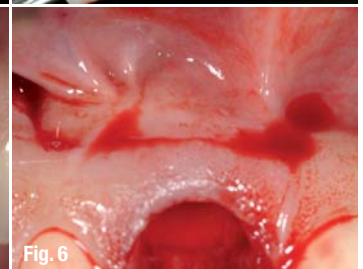
Fig. 6 After a vestibular half-circle incision in the apical part of the keratinised gingiva, a flap was reflected downwards.

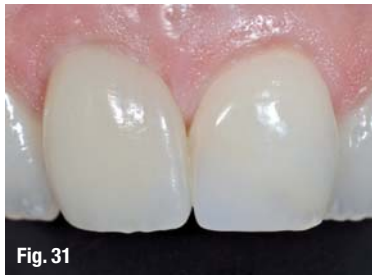
Fig. 31

Fig. 31_Stable soft tissue showing no resorption at the implant-crown interface or gingival sulcus.

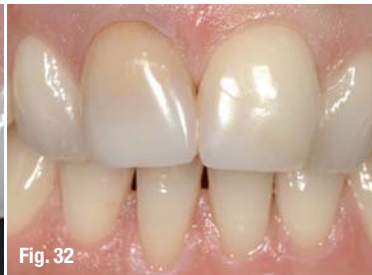
Fig. 32

Fig. 32_Initial situation before extraction.
