Replacement of a single anterior tooth

Surgical procedure and three-year results

Author_Dr Peter Randelzhofer, Germany

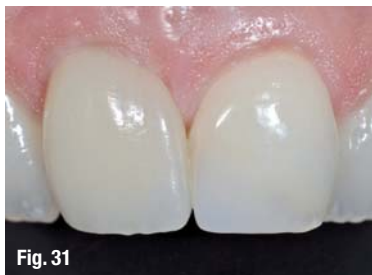
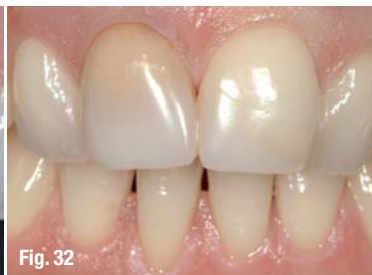
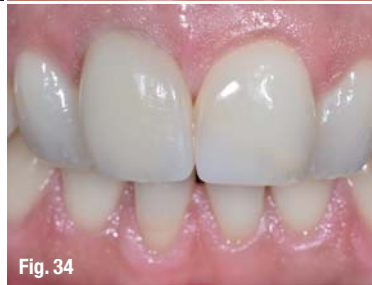
Fig. 32_Initial situation before extraction.

Fig. 33_Initial situation with non-preservable tooth #11.

Fig. 34_Clinical situation three years after implantation.

Fig. 35_Final X-ray after one and three years.
