Irrigation for the root canal and nothing but the root canal

Author_ Dr Philippe Sleiman, Lebanon

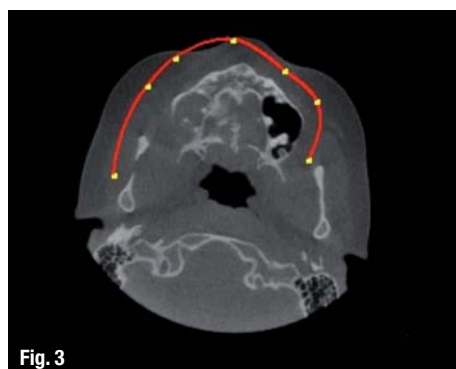
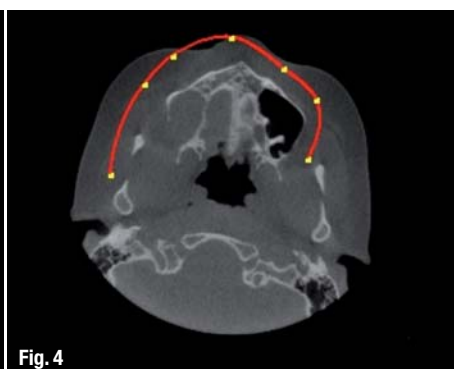
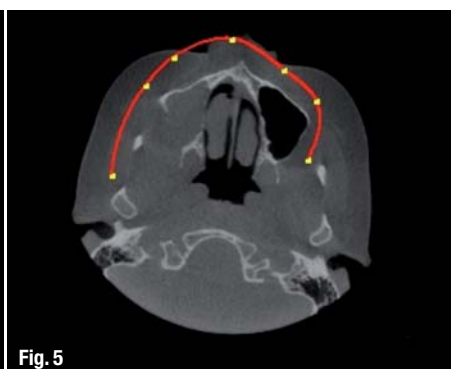
A couple of hours later, the patient returned to my office and I took the time to examine the images. In the panoramic view, it was clear that half of the sinus was filled with inflammatory tissue (Fig. 2); in the sectional views, I noticed that the posterior wall of the sinus was non-existent in some places (Figs. 3–5). Potentially, it could be the position of the patient during the root-canal procedure that made NaOCl stagnate on the posterior wall and aggravate the damage.

The patient was informed of my opinion and recommended to see her otorhinolaryngologist, who took over the case, since it was already beyond the specialty of the dental profession and so she did.
