Irrigation for the root canal and nothing but the root canal

Author_ Dr Philippe Sleiman, Lebanon

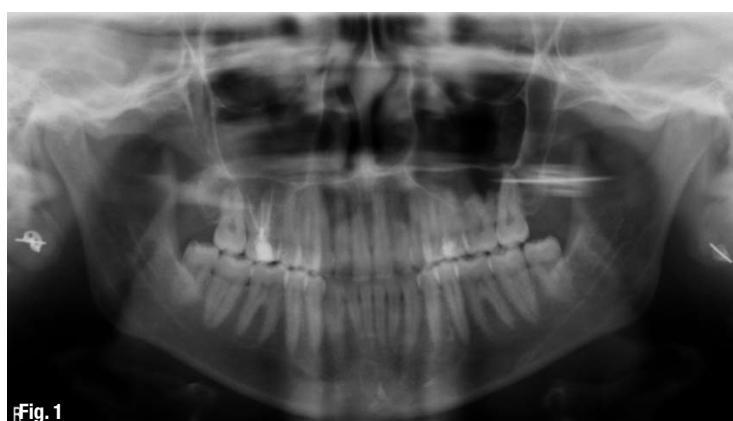
Fig. 1

The patient was referred to my office for a complaint regarding the maxillary molar. After examining the patient and looking at her preoperative X-ray, I saw nothing wrong with the existing root-canal treatment, at least concerning the roots, but found a vague image in the sinus that I thought could be related to the maxillary molar and could be the cause of the problem. I asked my assistant to take a panoramic X-ray, which demonstrated a much larger problem inside the sinus but at that point I did not realise the scale of the issue.
