Resorption mechanism of an injectable calcium phosphate bone regeneration cement—Radiographic and histological monitoring

author_Sérgio Alexandre Gehrke, Brazil

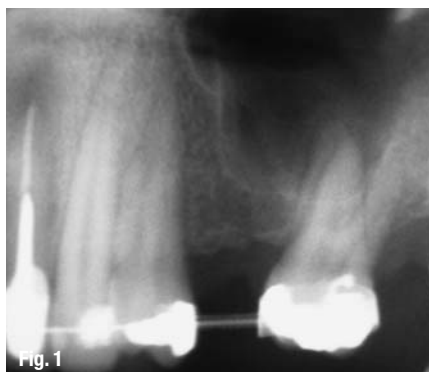
Fig. 1 Pre-operative radiograph (case I).

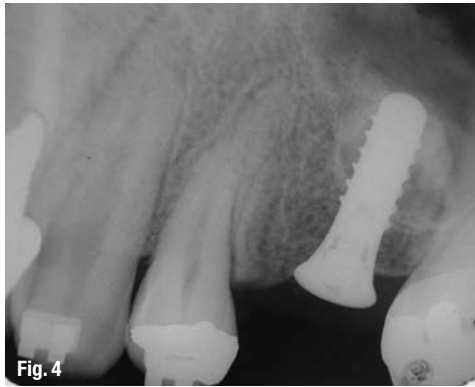
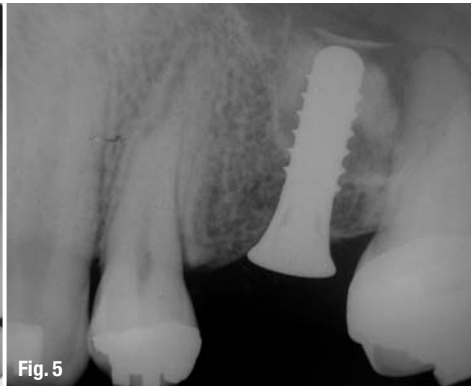
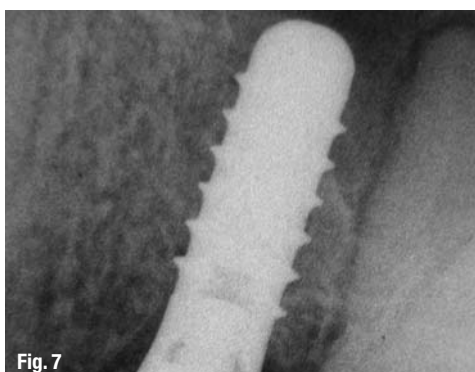
Fig. 4–7— Radiographs of case I at 30, 60, 120 and 180 days after surgery.

Thanks to the adequate radiopacity of the cement, it is easy to perform a radiographic follow-up and analysis of the resorption and new bone growth. Radiographs were therefore taken at 30, 60, 120 and 180 days after implant installation (Figs. 4–7), as well as 12 months (Fig. 8) after installation of the

VitalOs cement. This process progresses towards the center of the cement mass. In the sinus lift case, the progress also takes place from the coronal towards the apical region around the implant (yellow arrows on Figure 4). Across the different times of analysis it is possible to see that the material is gradually being replaced and the osseous tissue is being formed, apparently without incorporation of cement particles. At the end of the neoformation process, the newly formed bone displays radiographic characteristics which are similar to those of the native surrounding bone. This is also confirmed after 12 months of loading, where the bone around the implant has not resorbed, indicating a good preservation of the new osseous volume around the implant.

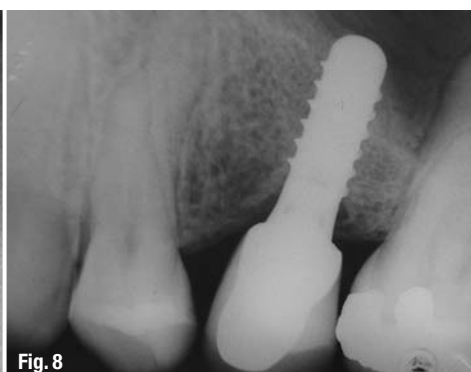
Fig. 8— Radiograph of case I taken 12 months after loading.

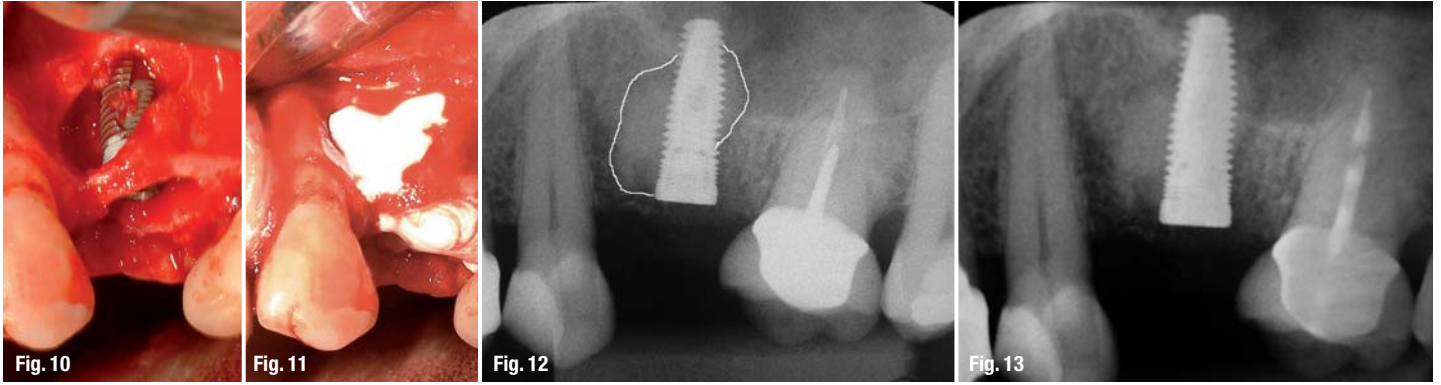
Fig. 10, 11_ Implant installation and filling with PD VitalOs Cement.

Fig. 12–15_ Radiographs of case II at 30, 60, 120 and 180 days after surgery.

The control performed followed the same schedule described for the case I, i.e. radiographs were taken at 30, 60, 120 and 180 days after implant installation (Figs. 12–15), as well as 12 months (Fig. 16) after installation of the restoration.

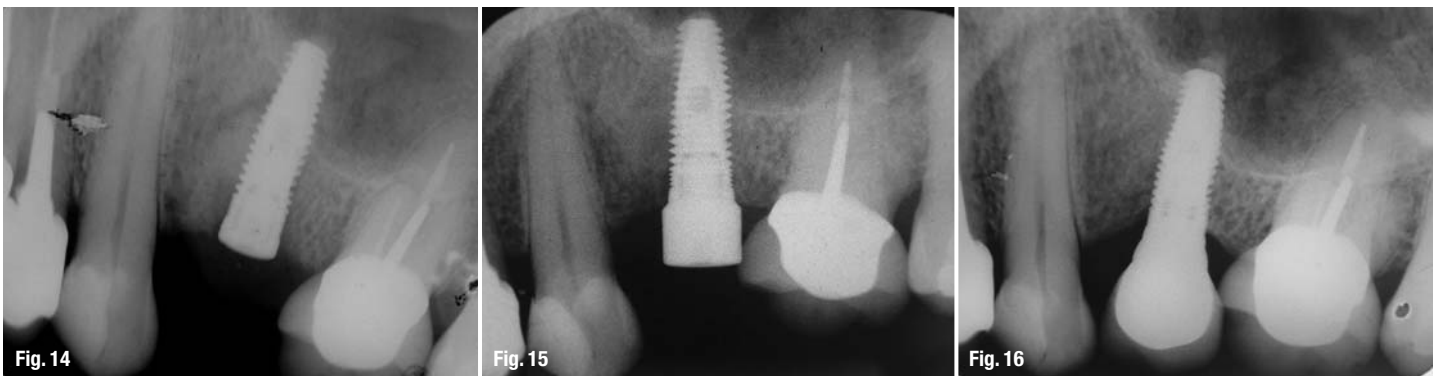
Fig. 16_ Radiograph of case II taken 12 months after loading.

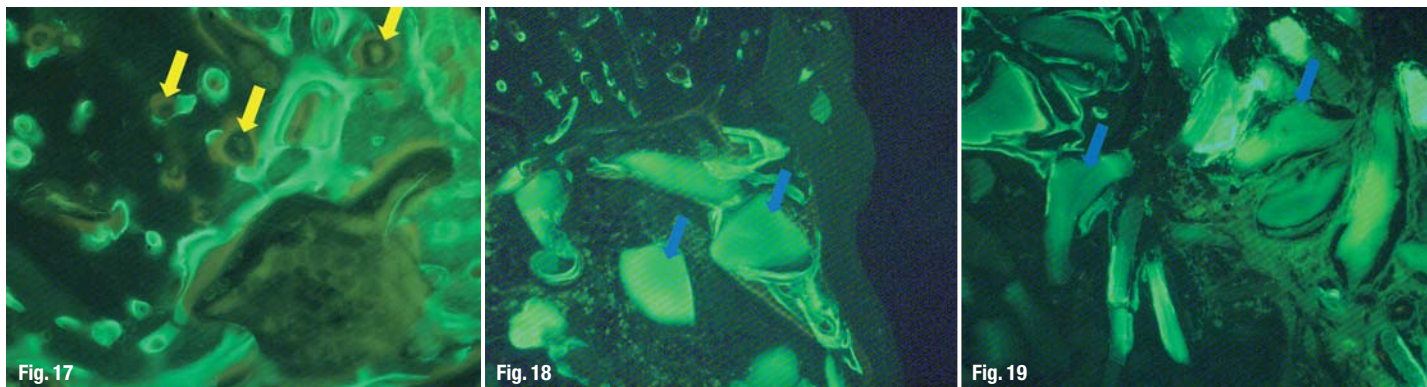
Fig. 17–19 Fluorescence histologies of sites filled with VitalOs, Bio-Oss and Bone Ceramic respectively.

The results of the histological study show that the injectable brushite cement resorbs much more uniformly and rapidly than the granular materials (Figs. 17–19). It is also possible to state that the ossification process in the defects filled with VitalOs starts in the first weeks after augmentation: intensive brick-red areas due to alizarin indicate bone deposition between the second and the fourth week, and green areas due to calcein reveal the osteogenesis activity after 4–6 weeks. The coloration of the osteogenesis areas is more intense at every follow-up stage in the defects filled with the cement than in those filled with granular materials. This shows the maturity of the bone in the sites grafted with the brushite cement. Moreover, the organization of this newly formed bone tissue presents a structure which is more suitable for subsequent implant installation, i.e. a more organized and lamellar bone, with presence of osteons (yellow arrows, Fig. 17).

New bone formation is also seen in the defects grafted with granules. However, the bone deposition is stronger in the calcein phase (green fluorescence, see Figs. 18–19) than in the alizarin one (red), which indicates a delayed bone formation, starting four weeks after surgery. The fluorescence of the new bone tissue is weaker than in the sites filled with PD VitalOs Cement, which is a sign for lower maturity of the new bone tissue.

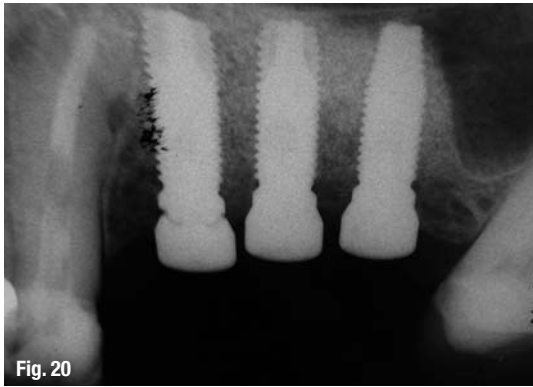
Fig. 20

Fig. 20, 21_Radiographs of a case augmented with Bone Ceramic: 180 days after surgery and one year after crown installation, respectively.

The radiographic monitoring is more difficult to achieve with granular materials because their appearance on radiographs is closer to that of bone and the grafted area becomes eventually a mix of granules and bony tissue. To emphasize this, Figures 20 and 21 show radiographs of sites augmented with granular materials (Bone Ceramic), 180 days after augmentation and one year after crown installation, respectively. It can be seen that the newly formed bone is not as well defined as in the cases filled with the brushite cement (Fig. 15). The resorption mechanism of granular materials is also accompanied by new bone formation, but this takes place between the granules, most of them remaining eventually embedded in the new bone structure.
