Resorption mechanism of an injectable calcium phosphate bone regeneration cement—Radiographic and histological monitoring

author_Sérgio Alexandre Gehrke, Brazil

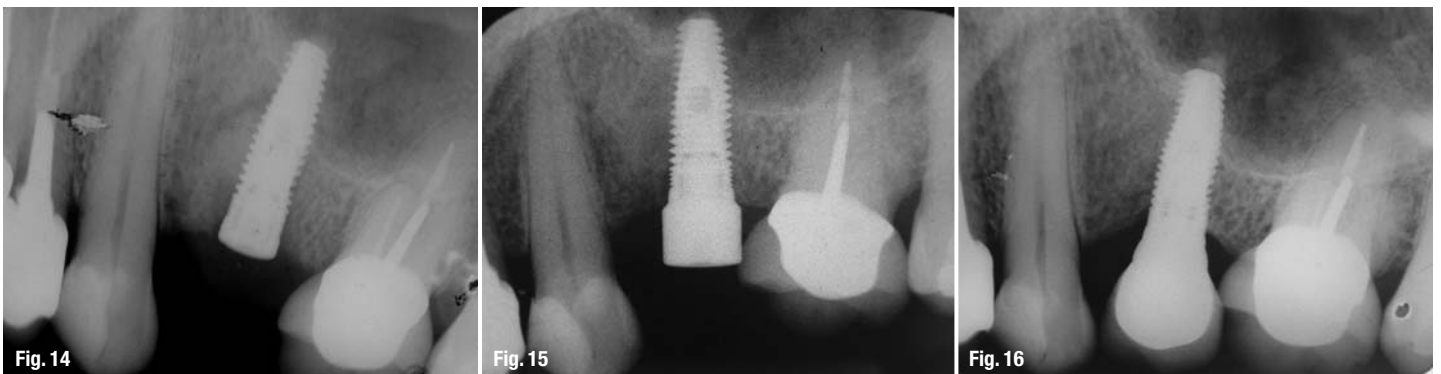
Fig. 12–15_ Radiographs of case II at 30, 60, 120 and 180 days after surgery.

The control performed followed the same schedule described for the case I, i.e. radiographs were taken at 30, 60, 120 and 180 days after implant installation (Figs. 12–15), as well as 12 months (Fig. 16) after installation of the restoration.
