Resorption mechanism of an injectable calcium phosphate bone regeneration cement—Radiographic and histological monitoring

author_Sérgio Alexandre Gehrke, Brazil

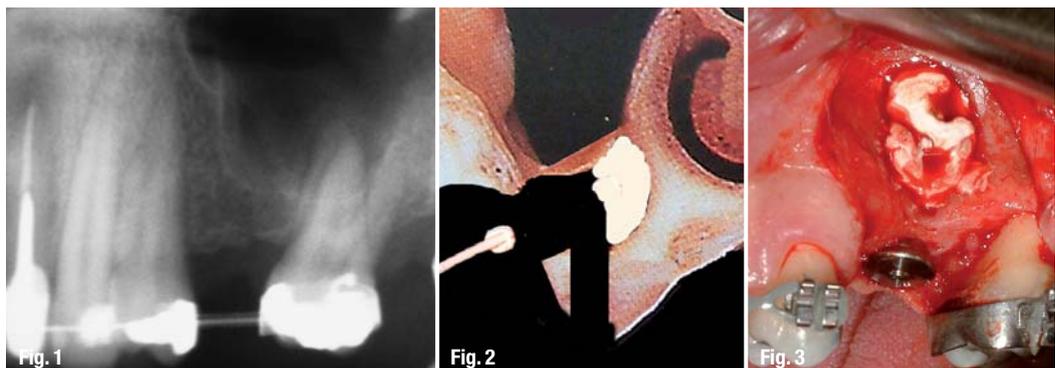
Fig. 1 _ Pre-operative radiograph (case I).

Fig. 2 _ Illustration of the installation of the first cement portion, against the inner wall of the sinus cavity.

Fig. 3 _ Sinus cavity completely filled with VitalOs, after installation of the implant.

After administration of a local anesthetic, a lateral access to the sinus cavity was performed through a lateral window. Then, the sinus membrane was carefully lifted up to the desired height. The drilling of the site was performed according to the recommendations of the manufacturer. During this phase, particular attention was paid to avoid perforating the membrane with the drills. A gaze humidified with a vasoconstrictor solution was placed into the sinus cavity for five minutes to control the bleeding as efficiently as possible. Indeed, blood flow must be avoided during injection of the PD VitalOs cement in order to allow contact between Cement and bone and anchoring of VitalOs onto the sinus wall. Then, the cement was injected into the sinus to fill the space between the inner (nasal) wall of the cavity and the space prepared for the installation of the implant (Fig. 2). Once the cement was hard, the implant was installed as planned. Finally, the rest of the cavity was filled up with VitalOs up to the edges of the lateral window, without using a membrane. Indeed, the use of a membrane is not necessary with VitalOs, since the product acts itself also as a barrier.

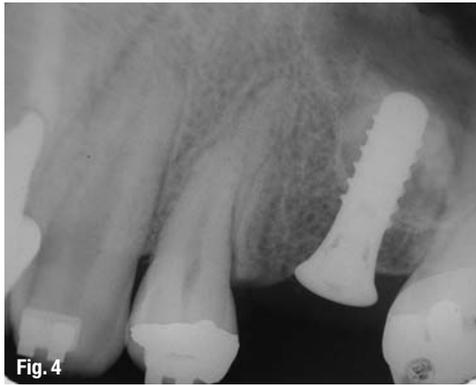
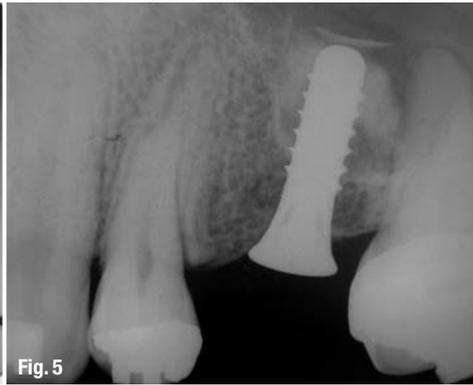
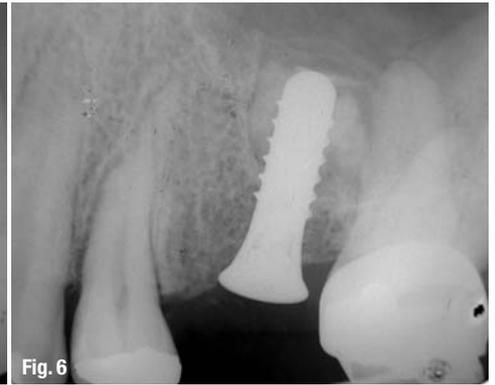
Fig. 4–7— Radiographs of case I at 30, 60, 120 and 180 days after surgery.

Fig. 8— Radiograph of case I taken 12 months after loading.

Fig. 9— Pre-operative radiograph (case II).

Thanks to the adequate radiopacity of the cement, it is easy to perform a radiographic follow-up and analysis of the resorption and new bone growth. Radiographs were therefore taken at 30, 60, 120 and 180 days after implant installation (Figs. 4–7), as well as 12 months (Fig. 8) after installation of the

VitalOs cement. This process progresses towards the center of the cement mass. In the sinus lift case, the progress also takes place from the coronal towards the apical region around the implant (yellow arrows on Figure 4). Across the different times of analysis it is possible to see that the material is gradually being replaced and the osseous tissue is being formed, apparently without incorporation of cement particles. At the end of the neoformation process, the newly formed bone displays radiographic characteristics which are similar to those of the native surrounding bone. This is also confirmed after 12 months of loading, where the bone around the implant has not resorbed, indicating a good preservation of the new osseous volume around the implant.

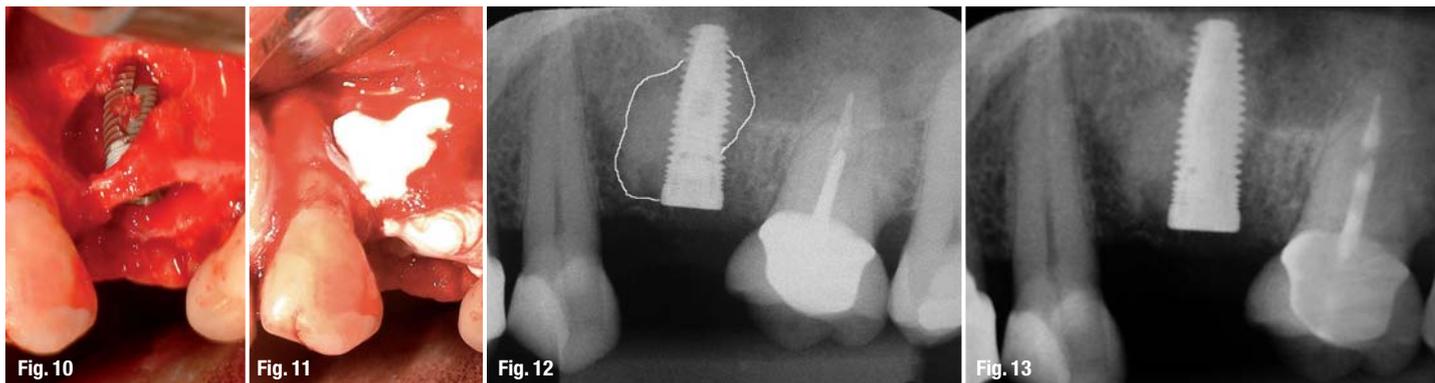
Fig. 10, 11 Implant installation and filling with PD VitalOs Cement.

Fig. 12–15 Radiographs of case II at 30, 60, 120 and 180 days after surgery.

Fig. 16 Radiograph of case II taken 12 months after loading.

The control performed followed the same schedule described for the case I, i.e. radiographs were taken at 30, 60, 120 and 180 days after implant installation (Figs. 12–15), as well as 12 months (Fig. 16) after installation of the restoration.

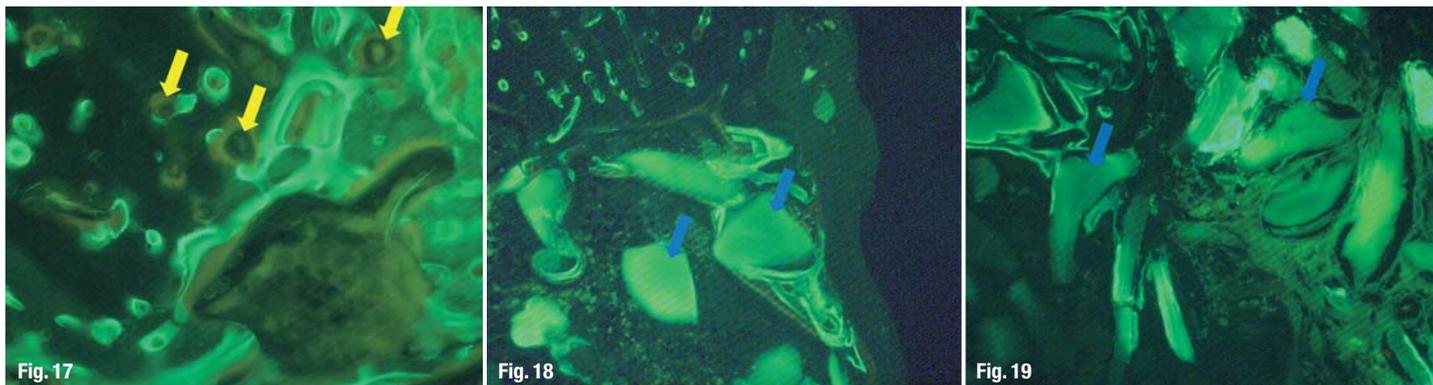
Fig. 17–19 Fluorescence histologies of sites filled with VitalOs, Bio-Oss and Bone Ceramic respectively.

The results of the histological study show that the injectable brushite cement resorbs much more uniformly and rapidly than the granular materials (Figs. 17–19). It is also possible to state that the ossification process in the defects filled with VitalOs starts in the first weeks after augmentation: intensive brick-red areas due to alizarin indicate bone deposition between the second and the fourth week, and green areas due to calcein reveal the osteogenesis activity after 4–6 weeks. The coloration of the osteogenesis areas is more intense at every follow-up stage in the defects filled with the cement than in those filled with granular materials. This shows the maturity of the bone in the sites grafted with the brushite cement. Moreover, the organization of this newly formed bone tissue presents a structure which is more suitable for subsequent implant installation, i.e. a more organized and lamellar bone, with presence of osteons (yellow arrows, Fig. 17).

New bone formation is also seen in the defects grafted with granules. However, the bone deposition is stronger in the calcein phase (green fluorescence, see Figs. 18–19) than in the alizarin one (red), which indicates a delayed bone formation, starting four weeks after surgery. The fluorescence of the new bone tissue is weaker than in the sites filled with PD VitalOs Cement, which is a sign for lower maturity of the new bone tissue.

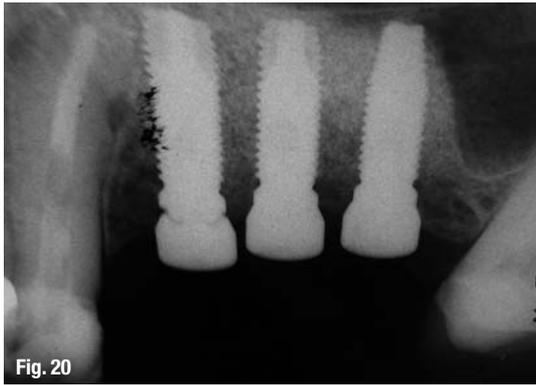
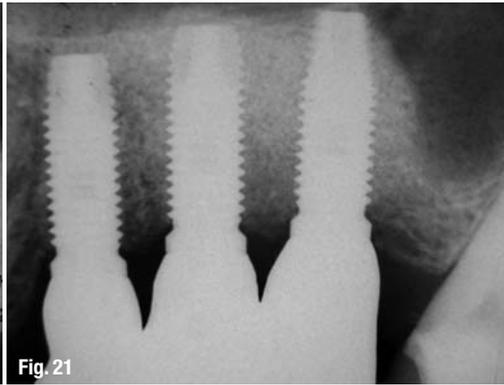
Fig. 20, 21 Radiographs of a case augmented with Bone Ceramic: 180 days after surgery and one year after crown installation, respectively.

The radiographic monitoring is more difficult to achieve with granular materials because their appearance on radiographs is closer to that of bone and the grafted area becomes eventually a mix of granules and bony tissue. To emphasize this, Figures 20 and 21 show radiographs of sites augmented with granular materials (Bone Ceramic), 180 days after augmentation and one year after crown installation, respectively. It can be seen that the newly formed bone is not as well defined as in the cases filled with the brushite cement (Fig. 15). The resorption mechanism of granular materials is also accompanied by new bone formation, but this takes place between the granules, most of them remaining eventually embedded in the new bone structure.
