Resorption mechanism of an injectable calcium phosphate bone regeneration cement—Radiographic and histological monitoring

author_Sérgio Alexandre Gehrke, Brazil

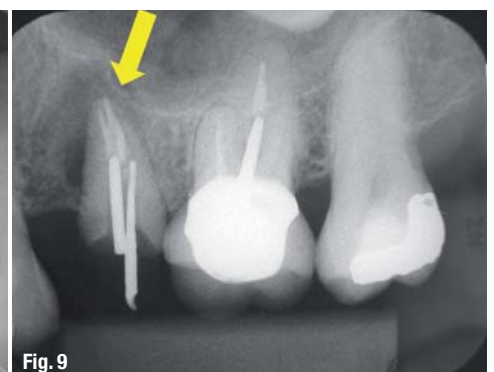
Fig. 8— Radiograph of case I taken 12 months after loading.

Fig. 9— Pre-operative radiograph (case II).

Fig. 10, 11 Implant installation and filling with PD VitalOs Cement.

The second case is a 40-year-old female patient in good health condition, non-smoking, presenting with a fracture of tooth 14 and presence of a large radicular cyst (Fig. 9) requiring removal of the root. The site presented a very large loss of bony structure, with fenestration of the buccal side of the socket wall. Therefore, the implant could only be stabilized in the inferior wall of the sinus cavity with the use of Summers' osteotomes.
