# Surgical management of peri-implantitis with laser

## A Case Report with eight years follow up

**Authors** Prof. Dr Aslan Yağar Gokbuget, Emin Selim Pamuk, Res. Asst. Dt. Necla Asli Kocak, Turkey

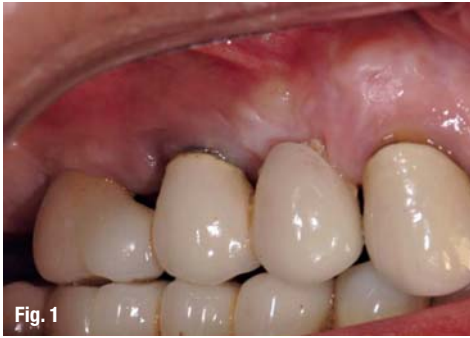
Fig. 1

**Fig. 1**\_First examination.  
**Fig. 2**\_After removal of the dental prosthesis.  
**Fig. 3**\_Probing depth around implants.

A 60-year-old female patient presented at our private clinic PGG for treatment of the implants at the right maxillary molar site. The implant has been placed seven years ago and the implant supported simulated porcelain fused to metal fixed partial denture was made (Fig. 1). Upon review of her medical history she was otherwise healthy. She previously had been treated for chronic periodontitis with non-surgical approach. Then radiographic examination was made and revealed a combined marginal and vertical radiolucency. The implant crown was removed (Fig. 2) and on clinical examination deep probing depths were isolated (Fig. 3). No clinically detectable mobility of the fixture was present. The patient was referred for an extra implant on the right first premolar site while doing a surgical entry for the peri-implantitis around the two implant at the right maxillary molar site. One hour prior to surgery, the patient was given 2 g of Amoxicillin and following surgery placed on a regimen of Amoxicillin 1,000 mg tid for 5 days post-op. A crestal incision is scalloped around the implant neck to eliminate the internal epithelium and granulation tissue from the pocket. A mucoperiosteal flap is raised to expose the implants (Fig. 4), and bone tissue and granulation tissue is eliminated from the bone defect with Er:YAG laser with power settings of VSP 120 mJ, 10 Hz with water and air flushing and Nd:Yag laser with 300 µm tip, VSP, 2Hz, 20 W power setting is used for implant surface detoxification. An additional 3.3 x 13 mm TSW implant was placed to first premolar site, then Xenogenous bone grafts (Bio-Oss®) compacted into the defect. A non-resorbable Gore-Tex® barrier was placed over the defect and was extended buccally and lingually. The buccal and lingual flaps were released and tension-free primary closure was achieved with 4-0 teflon sutures. She was instructed to continue the antibiotics as prescribed and to rinse with the 0.12% Chlorhexidine gluconate bid for one minute, twice a day. Finally, a strict maintenance and oral hygiene protocol were established.
