# Jawbone cavitation and its implication in implant dentistry

**Author** Prof. Dr Mauro Marincola, Italy

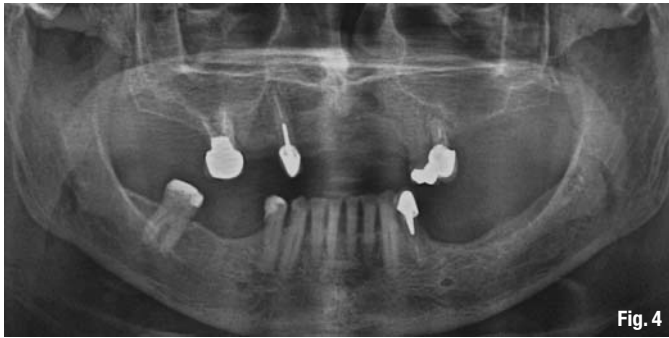
Fig. 4

**Fig. 4** A trained eye is needed to recognise the circular bone cavitation mesial to the lower right molar. Observe the capsulation, the thin crestal cortical and the lack of trabecular geometry.

The treatment plan was to insert four short implants to replace the second premolars and first molars of the mandible. The dental panoramic tomogram showed a circular formation of 5–6 mm in diameter mesial to the second molar root on the right side of the mandible

(Fig. 4). My experience with bone cavitations suggested a surgical approach that would entail performing an osteotomy and afterwards cleaning, disinfecting and filling the cavitation before placing the implant. Bone cavitations are not visible at crest level (Fig. 5) because the bony defect is located inside the bone marrow.

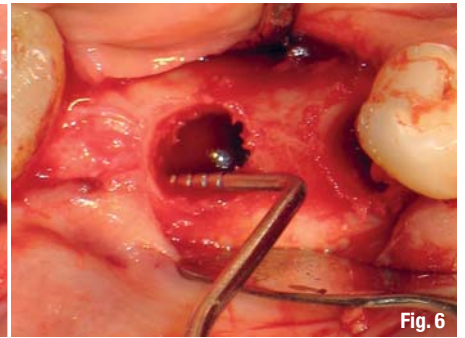
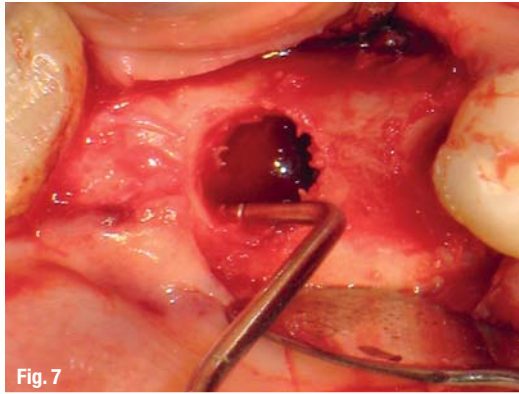
Fig. 6

**Figs. 6 & 7** Depth gauge demonstrating the absence of trabecular bone. The distal extension of the hole is approx. 10 mm.

Once the diameter of the planned implant size (5 mm) had been achieved, the walls and floor of the osteotomy were controlled with a depth gauge. All walls except the lingual plate were missing and no floor limited the 8 mm length of the osteotomy. The depth gauge established a distal hole of 10 mm. The mesial and buccal defects extended for only a few millimetres (Figs. 6 & 7).

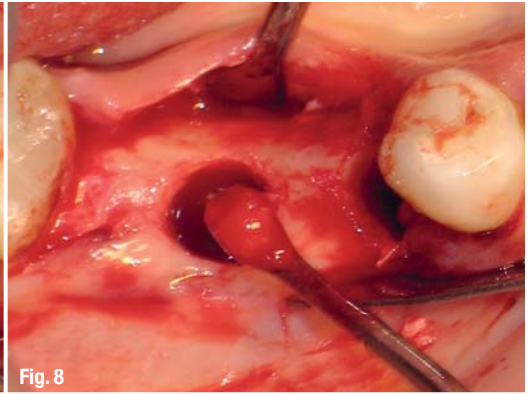
Fig. 8

**Fig. 8**\_Solid, healthy bone must be reached to allow the normal regeneration of bone. When infection or necrosis remain throughout the socket and adjacent bone, with or without condensing osteitis, healing will rarely ever be completed.

The fibrous tissue was removed from the cavity with a Lucas curette (Fig. 8). Multiple applications of a diode laser combined with local antibiotics were performed before proceeding to fill the cavity.

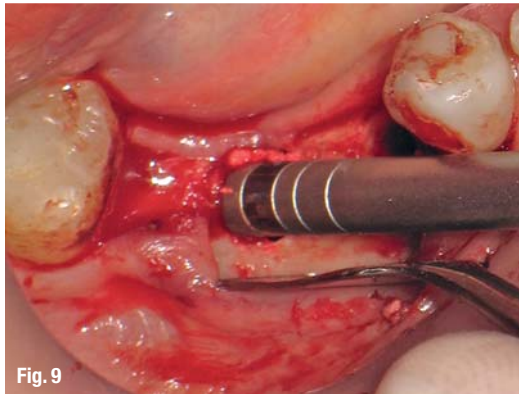
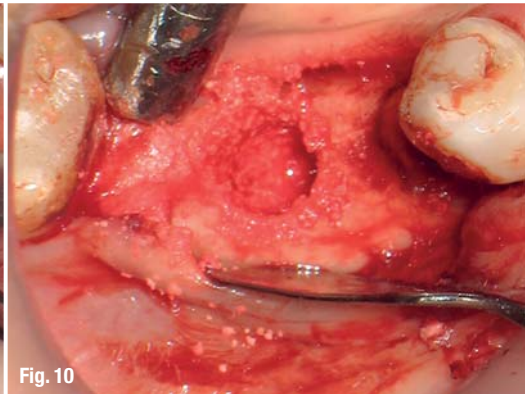
Fig. 9

**Figs. 9 & 10**\_The hole is filled with a synthetic graft material (Synthograft) after elimination of fibrous marrow and disinfection of the cavity.

The graft material should be 100 per cent synthetic in order to avoid cross infection, as may be the case with xenografts. The beta-tricalcium phosphate ( $\beta$ -TCP; SynthoGraft, Bicon) was mixed with the patient's blood and injected into the cavity (Figs. 9 & 10). Once the cavity had almost been filled, two Short Implants ( $\varnothing$  5 mm, length 6 mm) were placed into the graft (Fig. 11). Finally, the implants were completely buried under the crestal bone (Fig. 12), in accordance with the characteristics of the implant design (plateau press fitted root form implant).
