# Jawbone cavitation and its implication in implant dentistry

Author\_Prof. Dr Mauro Marincola, Italy

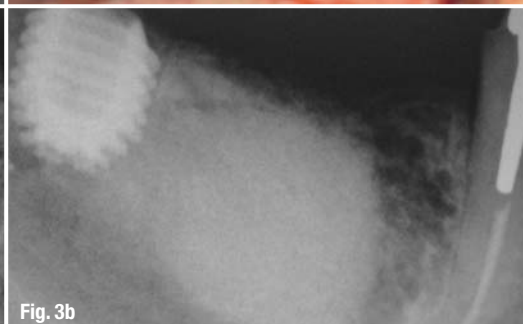
**Figs. 3a & b** 15 mm mesio-distal and 10 mm vertical bone cavitation filled with  $\beta$ -TCP graft. The distal hole was a third of dimension and a Short Implant (Bicon) could be placed immediately.

The next treatment step is a bone grafting procedure to fill the cleaned and disinfected cavity. If the cavitation is limited to 5–6 mm in diameter, a plateau press fitted root form implant can be placed into the grafting material immediately. Otherwise, the implant will be placed in a larger grafted area after three months of healing (Figs. 3a & b).
