Immediate implantation and full-ceramic restoration in the maxillary anterior region

Authors_Dr Arndt Happe & Andreas Nolte, Germany

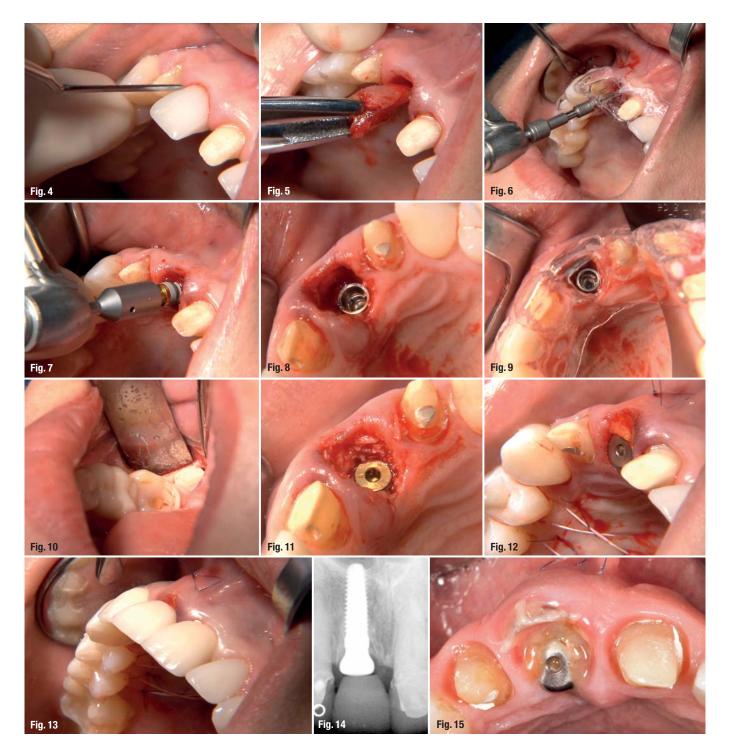
Fig. 4_ After removing the temporary crowns on teeth 12 and 21, the supra-alveolar periodontal attachment of tooth 11 was severed with a periotome.

- Fig. 5_The root was extracted after atraumatic removal of the crown. The buccal bone lamella connected to the root surface was lost during the process.
- Fig. 6_The palatal margin of the alveolus was marked with the pilot drill through a deep-drawn guide prepared in the laboratory.
- Fig. 7_When inserting the implant, the surgeon oriented himself along the palatal bone wall.
- $\textbf{Fig. 8}_{\textbf{The implant was palatally displaced in the correct position; the buccal bone}$ lamella no longer existed.
- Fig. 9_The position of the implant in the dental arch was checked with the aid of the guide.

Fig. 10_ A retromolar bone cylinder was harvested with a trephine drill to obtain autologous bone for augmentation of the buccal lamella.

- Fig. 11_The space between the implant and buccal soft tissue was filled with a mixture of autologous bone and bovine bone replacement material.
- Fig. 12_ In order to obtain optimal buccal contours, a connective-tissue graft harvested from the palate was drawn under the soft tissue and sutured.
- Fig. 13_The temporary bridge was cemented with the healing cap without contact with the pontic.
- Fig. 14_The sub-crestal bone position and good cervical join of the temporary bridge are shown on the post-operative X-ray.
- Fig. 15_Good healing and successful integration of the connective-tissue graft are evident one week after immediate implantation. The white-yellow deposits are fibrin.

In order to extract tooth 11 with as little trauma as possible, the surgeon first severed the periodontal fibre system with a periotome (Fig. 4) and expanded the coronal alveolar gap with piezo-surgical instruments. First, the crown was luxated and extracted with extraction pliers, then the root,

again with piezo-surgery, a sharp lever and diamond pliers. This revealed that the thin buccal bone lamella was connected to the root (Fig. 5). The osseous margin of the alveolus was examined carefully with a periodontal probe (bone sounding).

Despite a lack of bone wall, an immediate implantation as planned was to be performed according to the protocol of the University Medical Center of the Johannes Gutenberg University of Mainz.⁸ With the aid of the guide prepared in the laboratory; the positions were marked prior to preparing the implant bed (Fig. 6). Pilot drilling and further drilling steps were performed by the surgeon without a guide and with drill extension for optimal cooling. Insertion of the implant (CONELOG, CAMLOG; 3.8 mm diameter, 13 mm length) was also performed without a guide (Fig. 7).

Correct 3-D orientation of the implant was checked with the final drill and using the drill guide. The buccal implant shoulder should be 3 mm apical of the marginal soft tissue and distinctly palatal to the dental arch (Figs. 8 &t 9). This ensures that the subsequent implant-supported crown can be screwed in palatally. The gap between the implant and buccal soft tissue was filled with bone material. This was a mixture of autologous bone gained during preparation. Granular autologous bone harvested from the retromolar area and bovine bone augmentation material were used to prevent resorption (Figs. 10 &t 11).

In order to obtain the best possible soft-tissue conditions in the sense of a thicker gingival type, the surgeon harvested a connective-tissue graft from the palate. Using the tunnel technique according to Azzi,⁹⁻¹¹ this was pulled between the bone granulate and the buccal soft tissue and fixed with a monofilament, non-absorbable suture material (Fig. 12). Then a CONELOG wide-body healing cap (4 mm height) was screwed in and the temporary bridge cemented (Fig. 13). This supported the soft tissue, but did not contact the healing cap, so that the lower section of the pontic could be cleaned with super floss. Figures 14 and 15 show the post-operative X-ray and the situation at the check-up one week after immediate implantation.

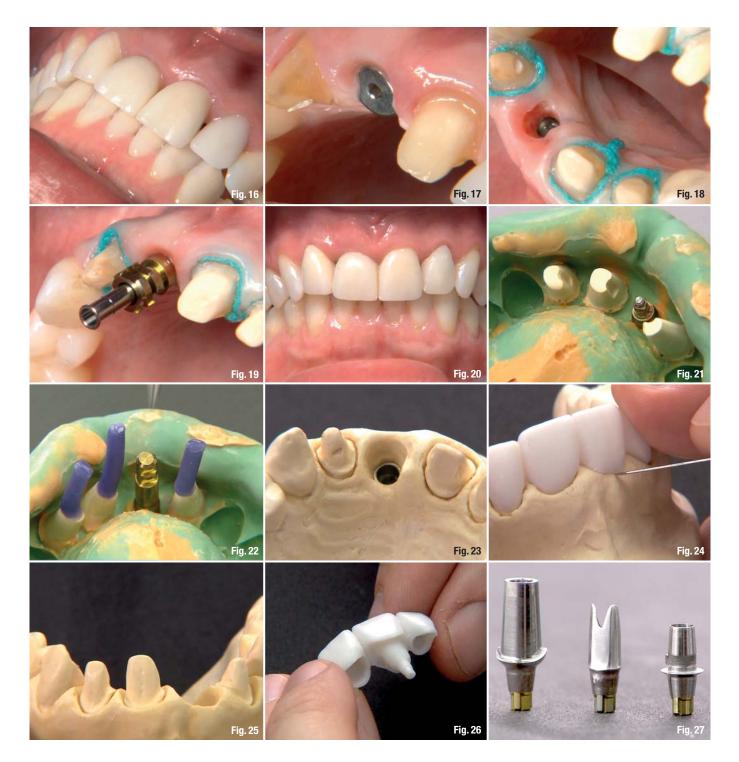
Fig. 16_After a three-month healing period, the implant was successfully osseointegrated and the soft tissue had stabilised for final impression taking.

- Fig. 17_The peri-implant soft tissue is well formed and largely irritation free under the temporary bridge.
- $\label{lem:fig.18} \textbf{Fig. 18}_ \textbf{Good perfusion of the peri-implant soft-tissue well can be observed.} \\ \textbf{Buccal tissue thickness exceeds 3 mm.} \\$
- Fig. 19_Impression taking of the prepared teeth and the implant.
- **Fig. 20**_Following reinsertion of the temporary bridge, excess soft tissue was observed in the area of the implant (position 11).
- **Fig. 21**_Individual stumps made of super-hard plaster with grooves to prevent rotation were fixed in the impression with instant adhesive.

Fig. 22_Preparation of the master model. The wax pins served as access to the stumps on the master model.

- **Fig. 23**_The precise periodontal and peri-implant soft-tissue situation was represented on the master model.
- $\label{lem:fig.24} \textbf{Fig. 24} \underline{\mbox{The marginal border of the planned implant crown was transferred to the plaster surface.}$
- **Fig. 25**_The peri-implant emergence profile was expanded and the papillae sharpened to provide a harmonious gingival profile.
- $\textbf{Fig. 26}_{0} ptimal\ hold\ of\ the\ wax-up\ during\ try-in\ through\ filled\ implant\ interface.$
- **Fig. 27_**Overview of abutment options (from left: CONELOG Esthomic abutment (1.5–2.5 mm gingiva height) prior to and after customising, the CONELOG Titanium base CAD/CAM.

After three months of implant healing, the periimplant and periodontal tissues were ready for final impression taking (Figs. 16 & 17). To this end, double 0 sutures soaked in glycerine were placed in the sulci and the preparation borders placed slightly subgingivally as part of final fine preparation. Then a thicker retraction cord, strength 0, soaked in epinephrine was placed (adrenaline; Fig. 18). The healing cap was unscrewed (Fig. 18) and a CONELOG impression post for open trays screwed in (Fig. 19). Impression taking was performed after drying and removal of the thick retraction cord (Fig. 19) in one step with an individual open tray and a two-phase polyvinyl siloxane (A-silicone). Following arbitrary transfer of the occlusal relations with a bite fork, facebow and bite registry, the healing caps and temporary bridge were reinserted. A tem-

Using super-hard plaster, the dental technician fabricated root-shaped (conical) stumps to prevent rotation. These were placed in the impression to fabricate the master model and extended with wax pins (Figs. 21–23). A new wax-up was prepared based on the updated aesthetic analysis and the outer cervical contour of the implant restoration was transferred to the model (Fig. 24). The anatomical shape of the emergence profile was then created with a fine milling machine. The implant crown was thus given a natural emergence contour. The papillae were slightly sharpened and smoothed to give an optimal gingival contour. The optimised shape of the papillae avoided concavities occurring later in the cervical, slightly subgingival ceramic areas, which are difficult to clean and can lead to irritation of the gingiva (Fig. 25). The wax-up was fitted with a pin at the implant position, which engaged with the implant interface for better fixation of the wax-up during try-in (Fig. 26).

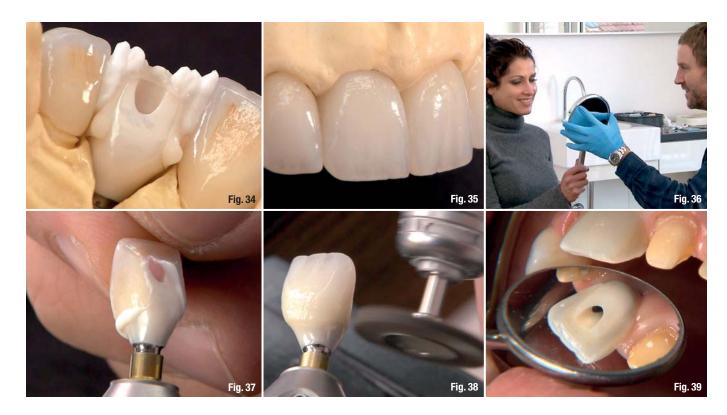
Fig. 34_Modelling of the mamelon for the implant-supported veneer from a palatal view.

Fig. 35_After glaze firing and polishing, the natural anatomy and surface characteristics of the restoration were checked.

Fig. 37_The pressed ceramic veneer was mounted on the previously bonded hybrid abutment by bonding with dual-curing composite.

Fig. 38_The transitions between the abutment and the veneer were smoothed and polished to a high gloss with a brush and polishing

Fig. 39_The implant restoration is screw-retained. For biomechanical reasons, the screw access channel was placed in the zirconium oxide section.

After a successful aesthetic try-in in the laboratory (Figs. 36 & 45), the individual parts were combined. First, the titanium base was sand-blasted and conditioned, then the secondary zirconium oxide abutment was conditioned. Both parts were bonded with special composite. Then the inner side of the veneer and the sintered zirconium oxide veneer ceramic of the hybrid abutment were etched with hydrofluoric acid, conditioned and bonded with dual-curing composite (Fig. 37). Then, the transition areas were smoothed and polished (Fig. 38).

The crowns were mounted by bonding and the implant-supported veneer crown was screw-retained (Figs. 39 &t 40). This was followed by a careful check of the approximal contacts and function. The final X-ray confirmed successful osseointegration of the implant and harmonious emergence of the implant-supported restoration from the bone (Fig. 41). Figures 42 to 45 show the aesthetically successful outcome and a very satisfied patient.
