# Complete prosthetic restoration in a patient with cleft palate

**Authors**\_Dr Michael Peetz & Dr Thomas Hitz

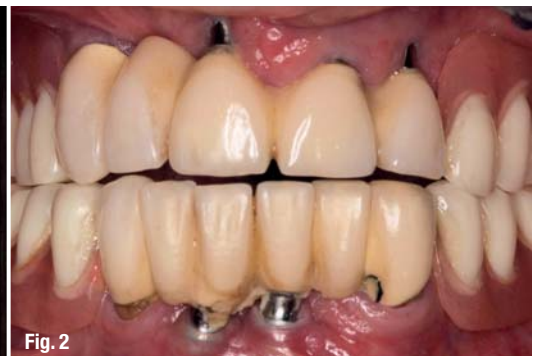
**Fig. 2** Initial clinical findings.

The patient, a healthy non-smoker, presents with anterior residual dentition (Figs. 1 & 2). He wishes to have improved oral health and increased stability of his prosthesis. At birth he had a cleft palate, which was treated in childhood. All teeth are missing except 13, 33 and 43, 13 and 43 have been endodontically treated. Four years earlier, in the context of a complete prosthetic restoration, implants were set in positions 11, 21, 22 and 41, 42. Upper and lower jaws have received combined fixed and removable solutions. The patient has an open bite in the anterior region, deficiently short incisors in the upper jaw and an unstable occlusion in the posterior region. Periodontitis is evident and found to be serious in the mandible and moderate to severe in the maxilla. Insufficient oral hygiene has led to plaque accumulation with resulting gingivitis. There are pronounced recessions around the implants with exposed machined and partially exposed rough surface areas. Radiologically, peri-implantitis at implants (Bauer screws) 11, 21, 22 is diagnosed (Fig. 3) with suspicion of a foreign body in region 26. Region 13 shows a failing edge of the crown. Mesial lesions in the crown are detected in region 31, 41.

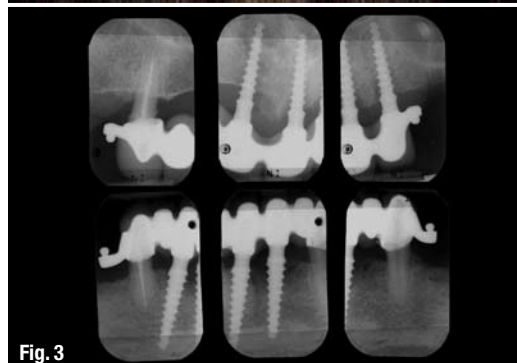
**Fig. 3** Intraoral radiographs at initial exam.

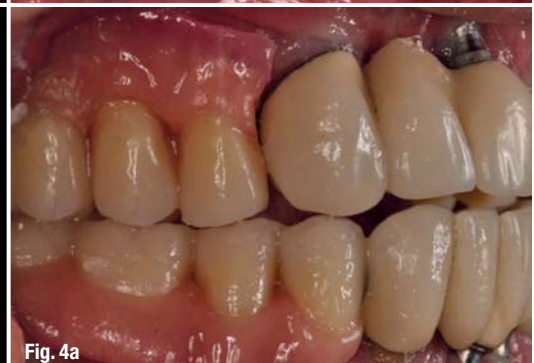
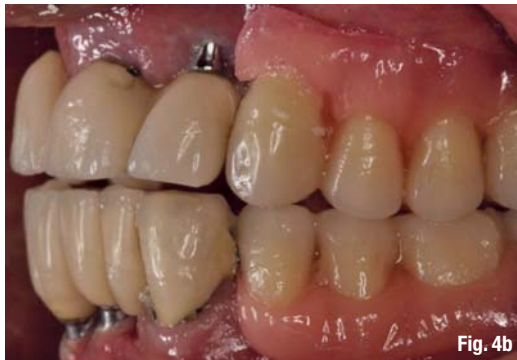
**Fig. 4a**

**Figs. 4a & b** Intraoral wax-up with corrected vertical dimension.

After taking the impressions, the vertical dimension in the wax-up is raised (Fig. 4). In the maxilla, the bridge is removed and implants are explanted, tooth 13 is extracted due to a major loss of substance (Fig. 5). Implant 31 is explanted while implant 41 is treated by implantoplasty whereby the coronal aspect is removed (Fig. 6). An explanation would endanger the preservation of tooth 43, due to its location. For this reason, the endosseous portion is left below the cortical bone level. The patient is immediately supplied with a temporary prosthesis. To select the optimal aesthetic tooth shape, two alternative setups for the maxilla are created.

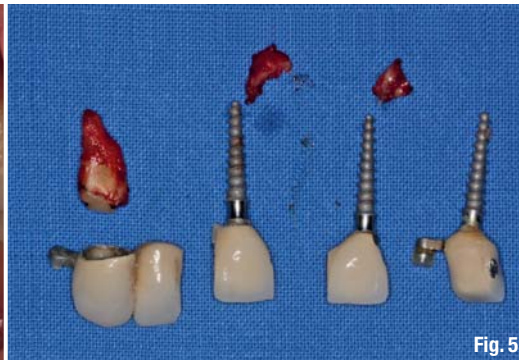
Fig. 5

**Fig. 5**\_Maxilla: Extracted canine and explanted implants.

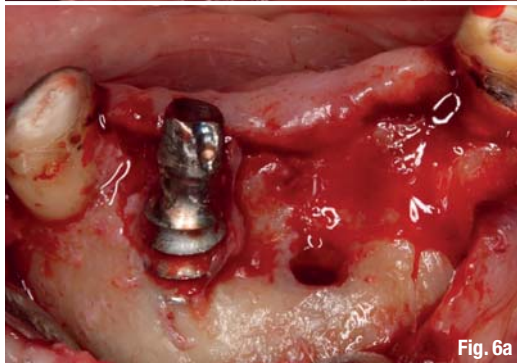
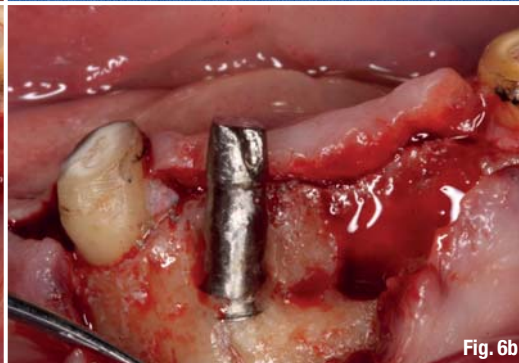
Fig. 6a

**Figs. 6a & b**\_Mandible: An implant is explanted, the remaining implant is cut and left *in situ*.

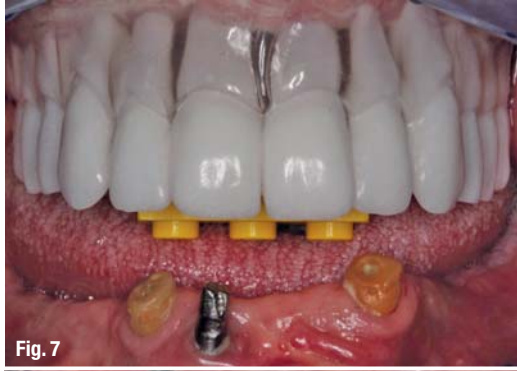
Fig. 7

**Fig. 7** The radiographic template is placed in the mouth for the CBCT scan: the Lego brick (yellow) is used as the reference mark.

Implant restorations in the maxilla are performed using computer-assisted navigation (Figs. 7-9). The lacking keratinised mucosa is reconstructed in the maxilla with a palatal graft and a ro-

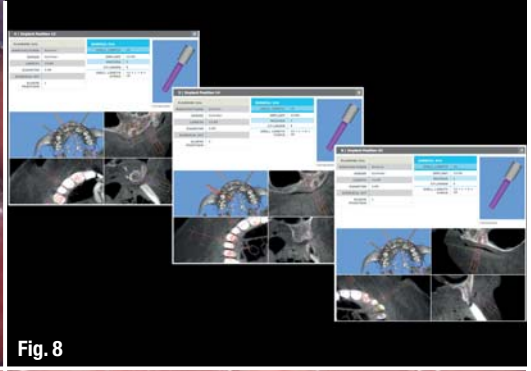
Fig. 8

**Fig. 8** Computer-aided planning of implant placement.

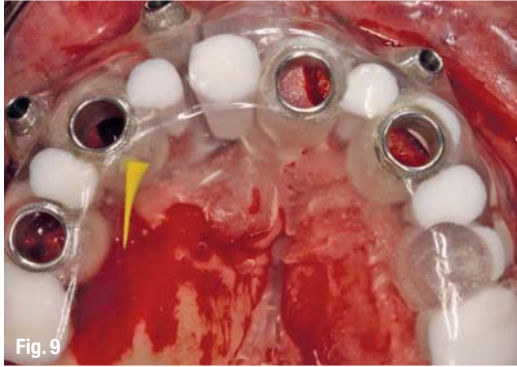
Fig. 9

**Fig. 9** Lifted flap with proper placement and fixation of the surgical template.

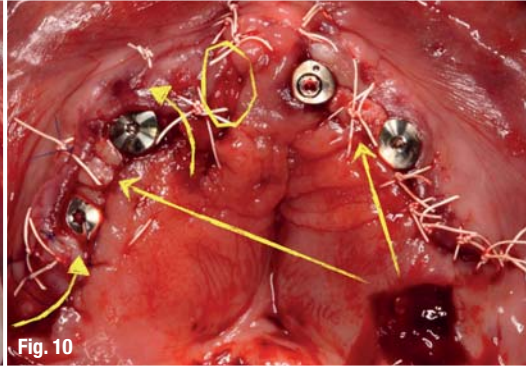
Fig. 10

**Fig. 10** Missing mucosa is reconstructed with palatal grafts and rotation flap.

tational flap (Fig. 10). After lifting the flap, the remaining mandibular implant reveals bone loss, due to an inadequately inserted implant (Fig. 11). The implant is cut and left *in situ* to avoid creating a large bone defect by explantation.

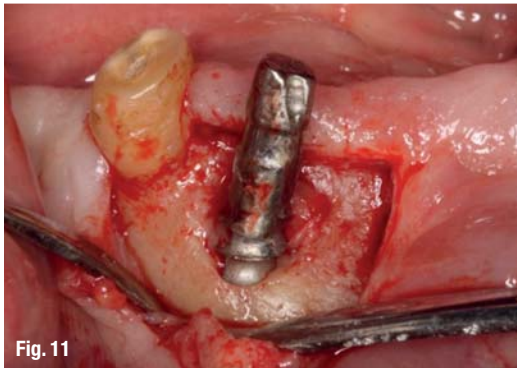
Fig. 11

**Fig. 11** The remaining implant in the lower jaw presents with a bone defect. It is cut and left *in situ*.

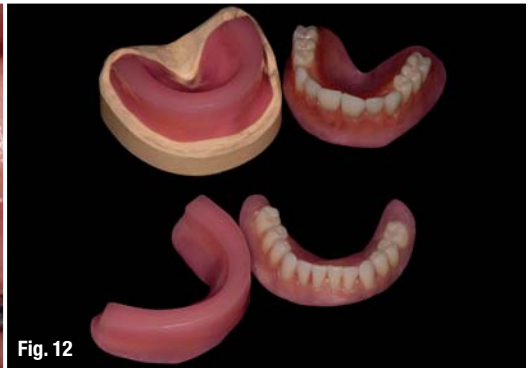
Fig. 12

**Fig. 12** The initial diagnostic set-up must be adapted to the altered mucosal contour.

The canines are supplied with root posts. The original diagnostic setup is adapted to the altered soft tissue structure. The prosthetic restoration is shown in part in Figures 12 to 14. You can follow the detailed procedure online, documented with numerous images.

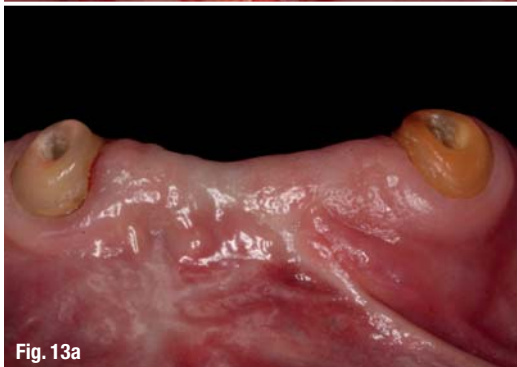
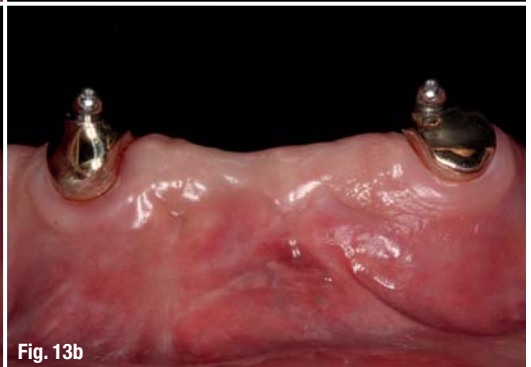
Fig. 13a

**Figs. 13a & b** Cementation of root caps.

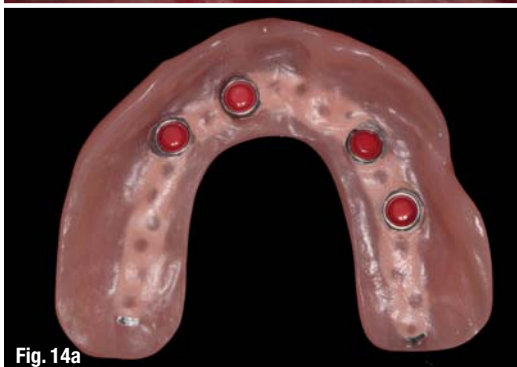
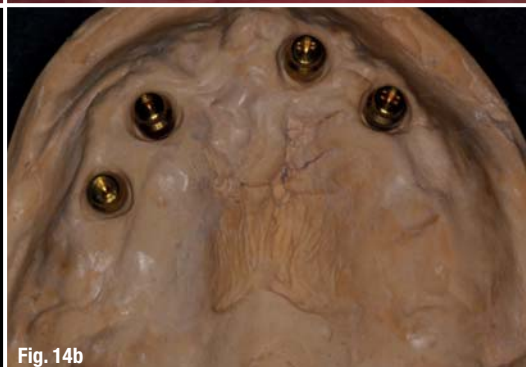
Fig. 14a

**Figs. 14a & b** Final maxillary prostheses.

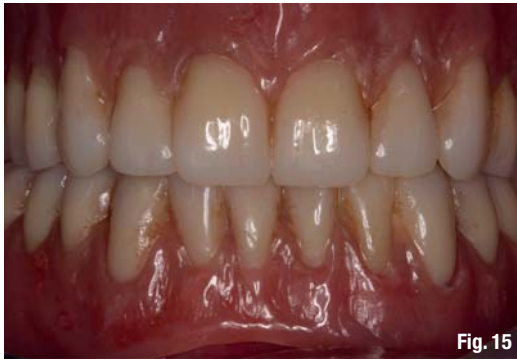
Fig. 15

**Fig. 15**\_Final clinical results.  
**Fig. 16**\_Final radiological findings.  
**Figs. 17a & b**\_Clinical situation before and after therapy: optimised tooth alignment and smile line.

The patient adapted well to the new prosthesis. He was pleased with the stability and aesthetic appearance (Figs. 15–17).
