Using a Soft Tissue Dental Laser to Remove a Venous Lake

author_Angie Mott, RDH, USA

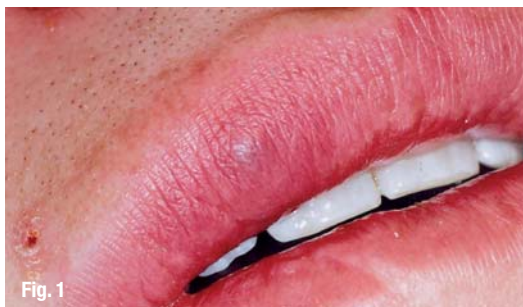
Fig. 1

Fig. 1_Initial view of Venous Lake.

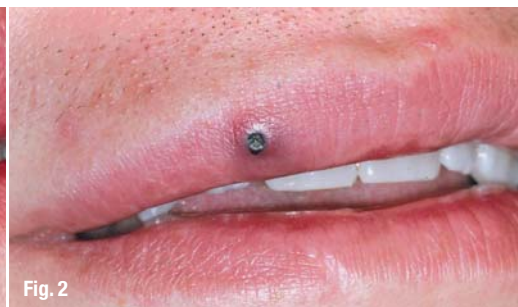
Fig. 2

Fig. 2_View four days after lasering area, lesion “popped” open a few days after lasing and bled for a short time. Body is now able to heal itself.

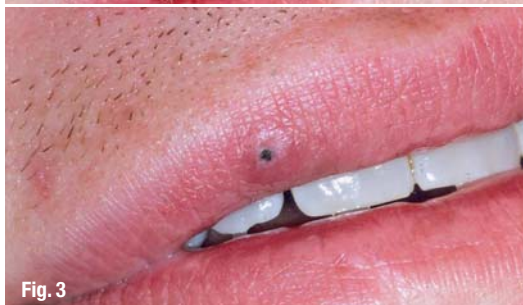
Fig. 3

Fig. 3_This view is four more days later, area continues to heal.

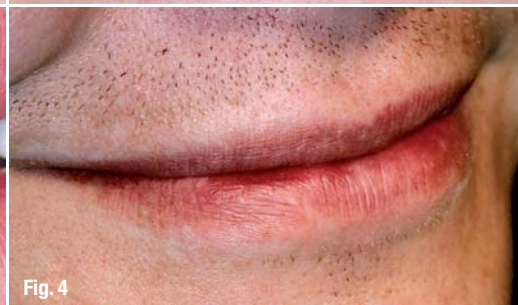
Fig. 4

Fig. 4_Final view, notice that the lip is completely healed without any evidence of scarring.
