Aadva implant in private practice

Author Dr Jean Pierre Brun, Dr Philippe Leclercq, Prof. Joe Merheb, Dr Willem Frederik Simons, Prof. Bart Van Meerbeek, Prof. Marc Quirynen, Belgium

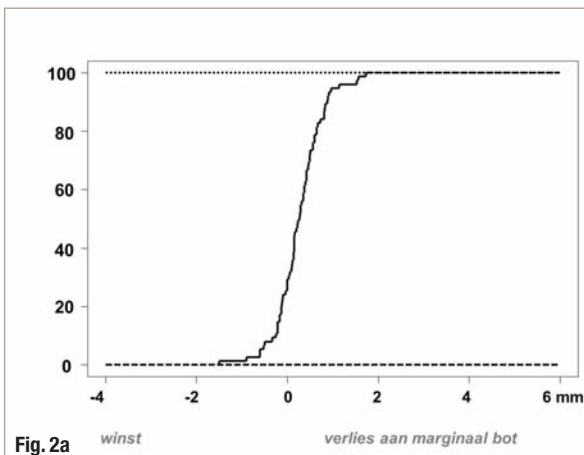
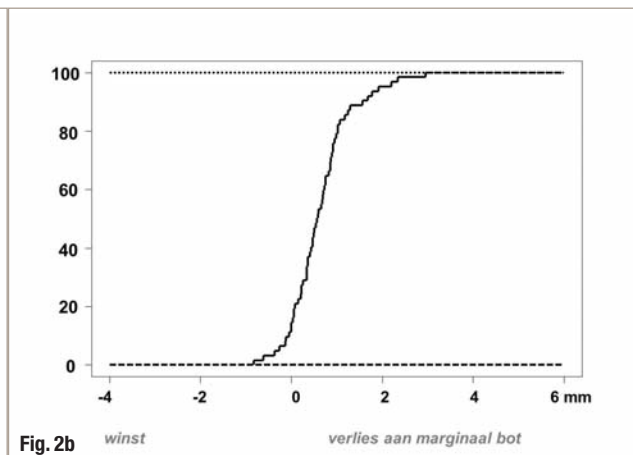
Figs. 2a & b Cumulative percentage of bone loss around the implants. Changes between the loading time and 1 (upper) or 2 (lower graph) years later respectively.

ways with the same implants at any given time) revealed a 0.2 mm bone loss between placement and loading, 0.2 and 0.4 mm during the first and second years, and no further loss afterwards. The longitudinal analyses (with the same implant observed at several points in time) showed a 0.3 mm relative bone loss during the first and second year of loading, with an unchanged situation afterwards (Fig. 2). The number of implants with more than 1 mm bone loss was 5.5% during the first year and 8.8% during the first two years.

The data of this study showed a 0.4 mm average bone loss during the healing period, which is similar to the best performing implants currently on the market. These observations contrast with studies on other implant designs that report much higher bone losses during this period.^{24,25} Bone level appears to subsequently remain relatively stable with an average loss of 0.3 mm during the first and second year. Afterwards it was found that this bone resorption could be further reduced. It should nevertheless be pointed out that this paper reports on a field study, far away from the academic environment but

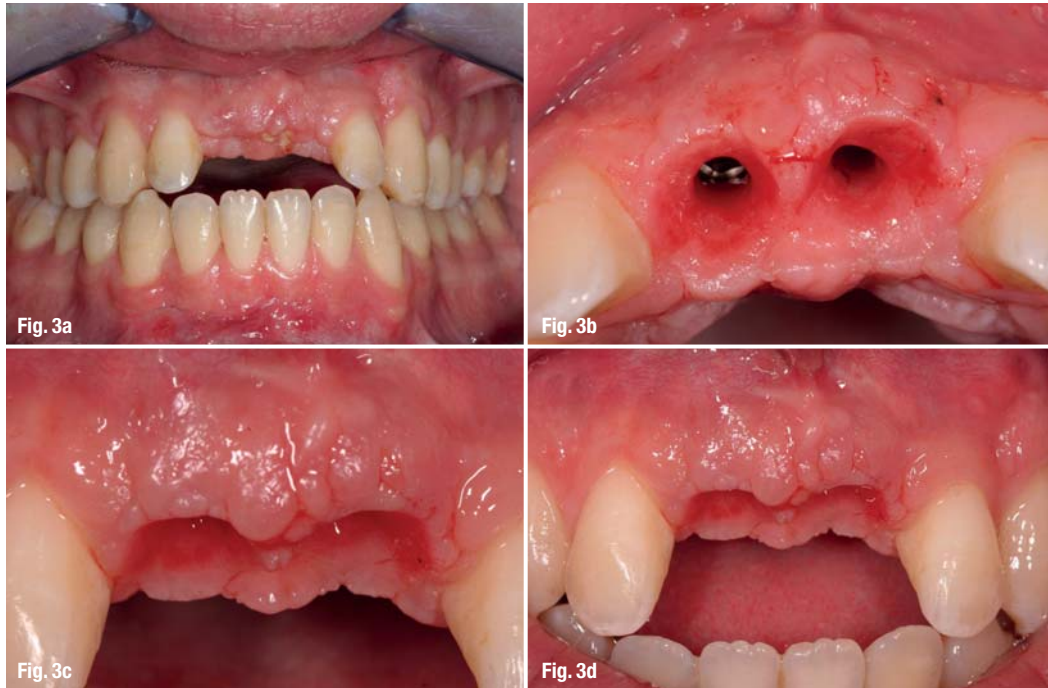
Fig. 3a_Teeth loss following trauma rendered hard and soft tissue reconstruction necessary.

Fig. 3b_The vertical positioning of the implant combined with a conical connection will guide the prosthetic emergence profile.

Figs. 3c & d_Stable soft tissues and nice biological width.

Clinical observations showed almost no soft tissue recession, as illustrated in a case (Fig. 3). It is assumed that this is due to the favourable crestal bone height and the internal connection (platform switching).

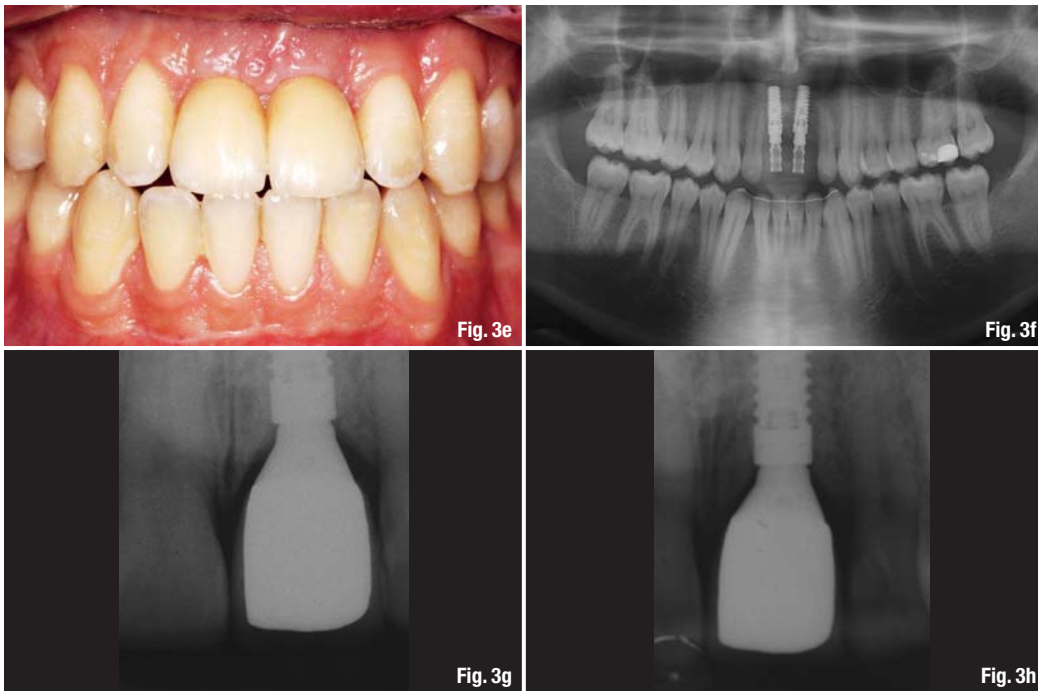
Fig. 3e The tissue contour is improved by the crestal design of the Aadvia implant.
Fig. 3f The radiographic control at the impression stage shows the importance of implant positioning.
Fig. 3g Missing central Incisor (21) treated with an Aadvia implant; 1 year follow-up.
Fig. 3h Same clinical case; 4 years follow up.

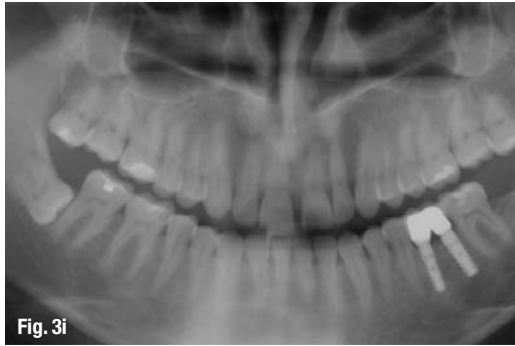
Fig. 3i

Fig. 3i_Contained tooth gap treated with 2 Aadva implants; 2 years follow-up.

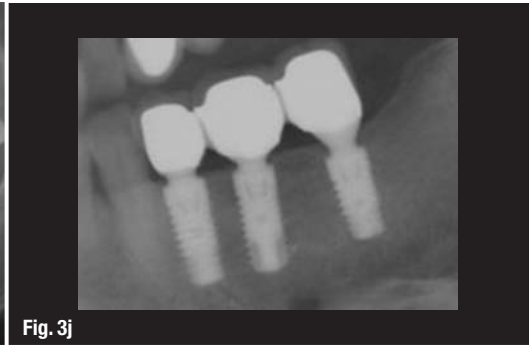
Fig. 3j

Fig. 3j_Posterior tooth gap treated with 3 Aadva implants; 3 years follow-up.

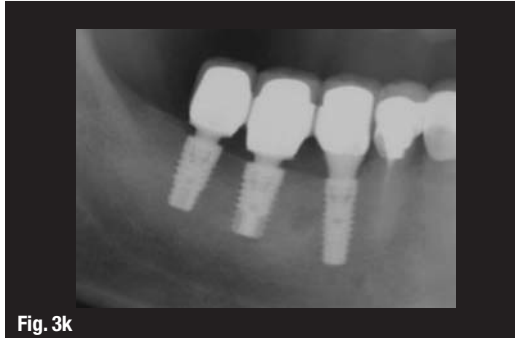
Fig. 3k

Fig. 3k_Posterior tooth gap treated with 3 Aadva implants; 4 years follow-up.

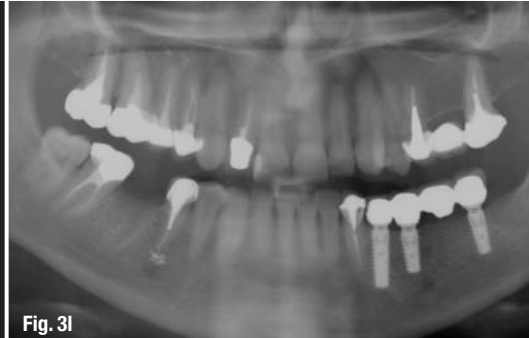
Fig. 3l

Fig. 3l_Posterior tooth gap treated with 3 Aadva implants; 5 years follow-up.
