# The atrophic crest

## Vestibular cortical stabilisation with bone graft

Authors: Dr Paolo Borelli & Dr Massimiliano Favetti, Italy

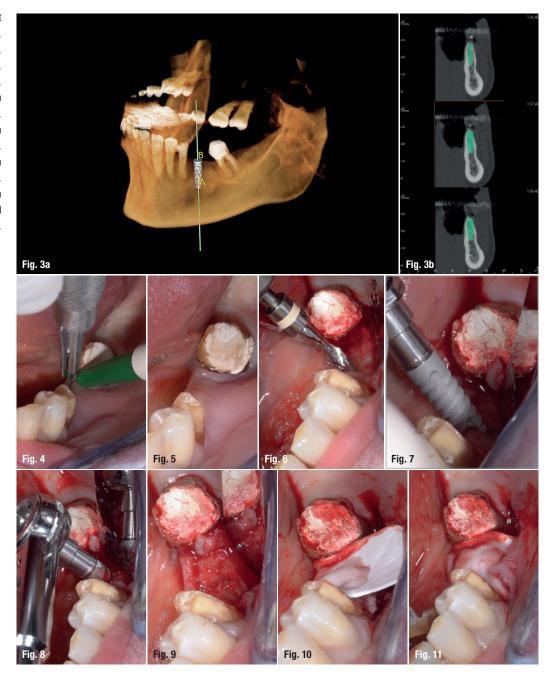
Figs. 10 & 11: Regeneration with resorbable membrane and heterologous bone.

Although no vestibular fenestration was observed at the time of surgery, it was decided to increase the vestibular cortical bone thickness, since some portion of this bone is usually resorbed after implant placement. First, the resorbable membrane was stabilised lingually and, after filling the relevant zone with heterologous bone, the membrane was folded down on the vestibular side to protect the graft (Figs. 10 & 11).

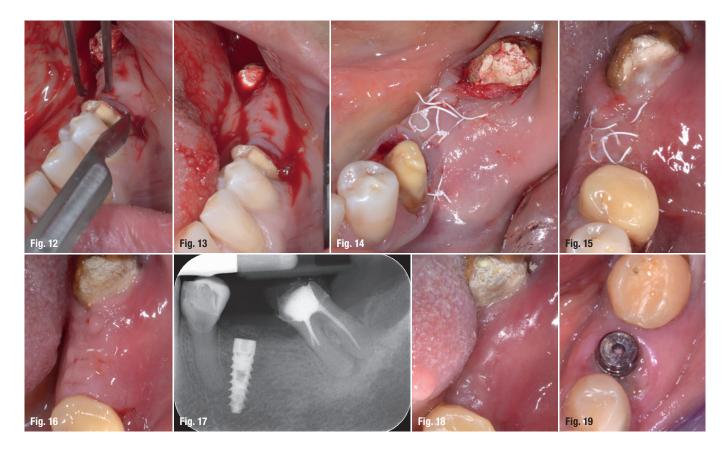
Figs. 12 & 13: Release of the flap and primary intention closure. Fig. 14: Suture. Fig. 15: Suture follow-up at 15 days. Fig. 16: Suture removal at 15 days. Figs. 17 & 18: X-ray and tissue healing after four months. Fig. 19: Healing abutment.

The surface of the membrane was then disinfected with a 0.2 % chlorhexidine solution, and the flap was closed passively in order to obtain a first degree closure without traction on the suture (Figs. 12 & 13).

Two lines of sutures were executed, the first with horizontal external mattresses, later stabilised by a second line of separate points more coronal to the first (Fig. 14). The patient was discharged with the following drug regimen: rinses with 0.12% chlorhexidine diclugonate for 60 seconds twice a day, antibiotic therapy with amoxicillin and clavulanic acid—one tablet of 875 mg twice a day, ice on the first day and a semiliquid diet for the first week. At 15 days after surgery, follow-up was performed to verify the healing of the tissues (Fig. 15).

After removal of the suture, the site did not show signs of dehiscence of the wound (Fig. 16). The successful osseointegration of the implant is visible on the four-month follow-up X-ray and all tissues ap-

pear to be well healed (Figs. 17 & 18). A healing abutment was then inserted (Fig. 19).
