Natural preservation of the emergence profile

Authors: Dr Umut Baysal & Dr Arzu Tuna, Germany

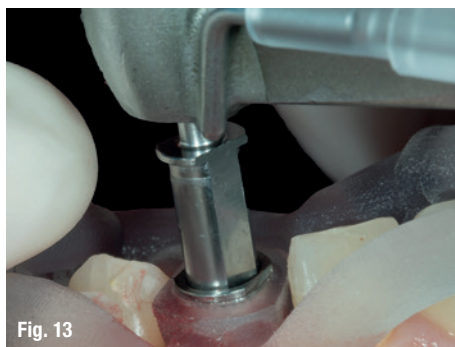
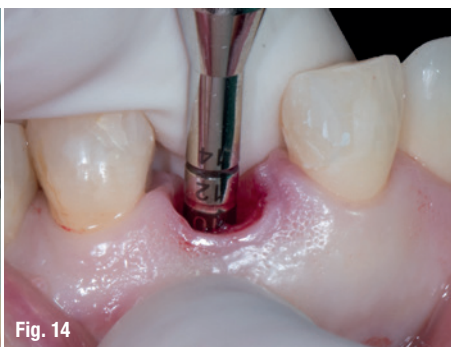
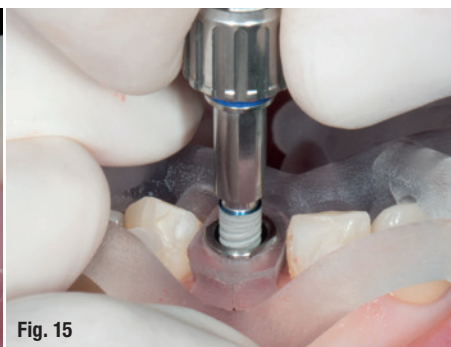
Fig. 13: Template-guided pilot hole (MIS Guide).

Fig. 14: After the pilot hole, the implant bed was further prepared, exclusively with osteotomes.

Fig. 15: A 3.3/11.5 mm implant in a special triangular design of the crest, which increases the bone deposit in the critical zone additionally used (V3, MIS Implants).

palatal direction with sufficient osseous volume of 2 mm on the buccal side. The replanted crown makes it possible to plan the implant position allowing for the prosthetic component in terms of backward planning. A template-guided implantation facilitates the incision-free technique and shorter treatment period, reduced patient morbidity, and better surface texture of the soft tissue. Figure 11 shows the situation after removal of the replanted crown and prior to the implantation. Using a micro scalpel blade, access to the bone was established (Fig. 12). Afterwards, the pilot hole was drilled using the template (MIS Guide, Fig. 13) and the further preparation performed with osteotomes (Fig. 14) after inspection of the buccal bone lamella. Despite the preventive measures, the purely subtractive preparation of the implant bed using drills was not indicated. We used a 3.3/11.5 mm implant in a special triangular design of the crest, which increases the bone deposit in the critical zone additionally (V3, MIS; Figs. 15 and 16).

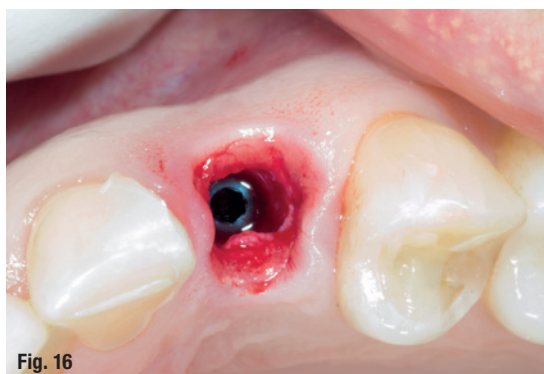
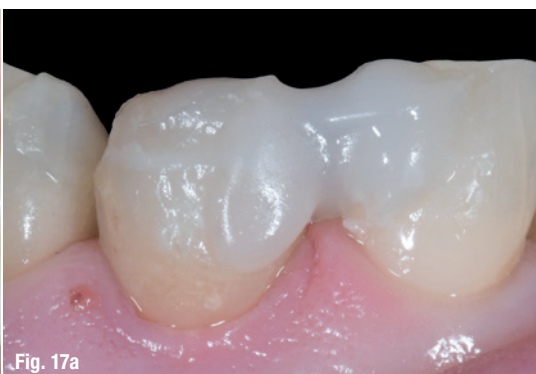
Fig. 16: Condition after implantation and prior to replantation of dental crown. The atraumatic status and the complete preservation of the emergence profile are remarkable.

Fig. 17a: Condition right after implantation.

Fig. 17b: Single-tooth radiograph after implantation.

After the implantation, the crown was replanted. Figures 16a und 17a show the status of the soft tissue right after the implantation. The atraumatic status and the complete preservation of the emergence profile are remarkable. A single-tooth radiograph was prepared to check the implantation (Fig. 17b).

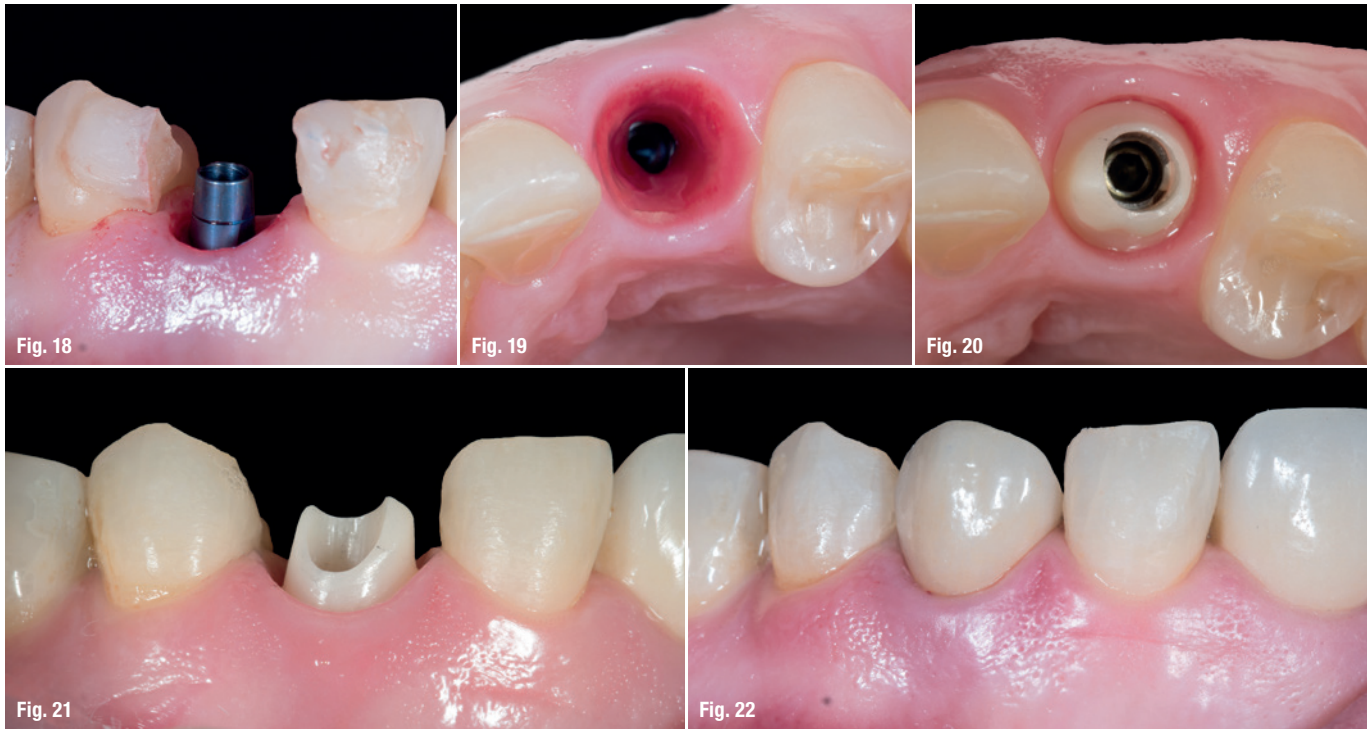
Fig. 18: Condition after exposure and prior to dental impression.

Fig. 19: To try the definite abutment on, the composite residues were removed from the adjacent teeth.

Fig. 20: The abutment was fixed tightly using a new screw according to the manufacturer's instructions.

A new silicone impression was made in filament technique. This impression serves to manufacture the crown with the newly defined contact points to the adjacent teeth.

Fig. 21: Buccal view.

Fig. 22: Condition right after placement of crown.

The dental impressions were taken in an analogue procedure using a closed tray via a transfer cap (Fig. 18). The next step was the manufacture of an individual hybrid abutment (titanium adhesive bonding, zircon abutment) at the laboratory. A digital dental impression would have the advantage that data scanned before the tooth extraction could be matched with the impression after exposure, thus enabling an exact copy of the natural tooth in line with the "biogeneric copy" concept.¹⁰ In the present case, we abstained from the digital workflow because the crown was individually manufactured in laminated ceramics. The dental crown was replanted again after the impression was taken.

In the next session, the definite abutment (Fig. 19) and a synthetic crown were tried on for aesthetic analysis. We removed the composite residues from the adjacent teeth and fixed the abutment tightly using a new screw according to the manufacturer's instructions (Fig. 20). A new silicone impression was made in filament technique. This impression serves to manufacture of the crown with the newly defined contact points to the adjacent teeth. Previously, the laboratory had manufactured an analogue to the abutment of super-hard plaster to ensure the exact preparation of the crown margin. Figure 21 shows the abutment after removal of the composite residues from the adjacent teeth. The synthetic crown was fixed using provisional cement (Telio CS Link, Ivoclar Vivadent). We were thus able to abstain from another replantation of the dental crown. The synthetic crown provides us with diagnostic value with regard to the

final appearance of the peri-implant soft tissue and the form of the crown.¹² Additional optimisation by applying and removing provisional masses to form the emergence is not necessary anymore in most cases. This shortens the treatment duration considerably. Figure 22 shows the definite crown right after its placement (Variolink Esthetic DC, Ivoclar Vivadent).
