# Natural preservation of the emergence profile

**Authors:** Dr Umut Baysal & Dr Arzu Tuna, Germany

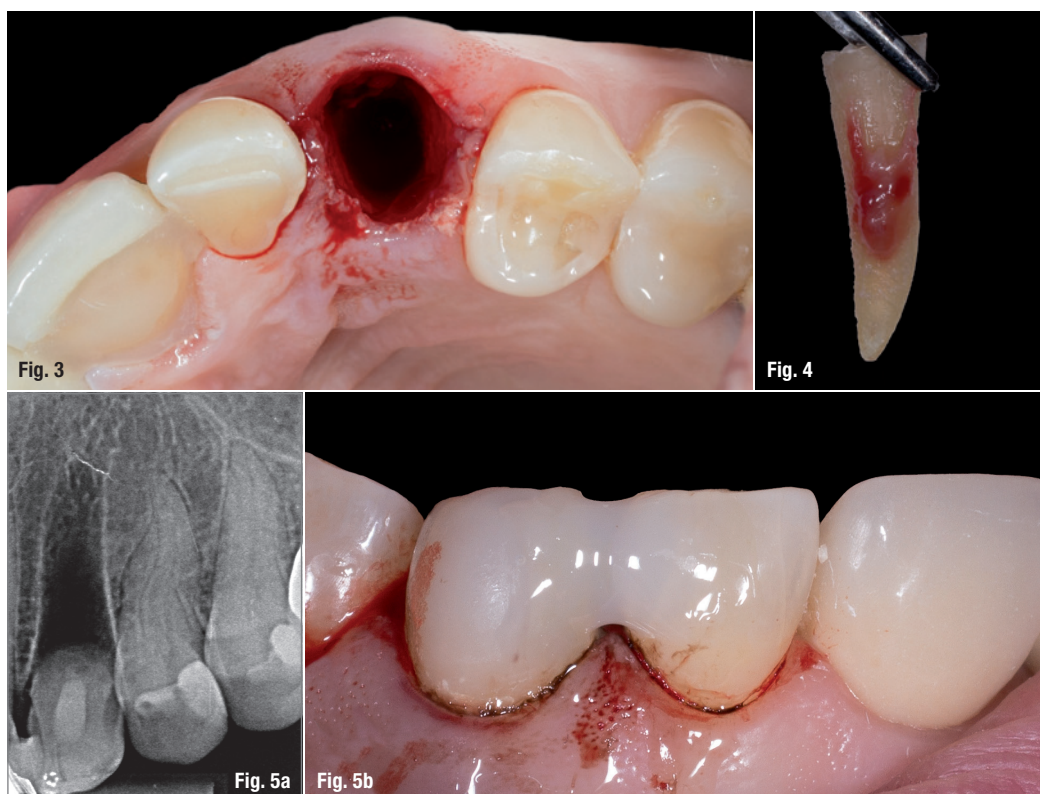
**Fig. 3:** Condition after extraction.

The inflammatory processes on the buccal side are clearly visible.

**Fig. 4:** Separated root and inflammatory process in medium third.

**Fig. 5a:** Single-tooth radiograph after replantation of dental crown.

**Fig. 5b:** Condition after replantation of dental crown (intraoral). Splinting with SDR® (Dentsply Sirona) to adjacent tooth.

Treating the alveolar bone and the surrounding tissue with care during the extraction may positively influence the formation of defects.<sup>11</sup> After cutting all periodontal fibres to be reached from the intrasulcular side using a micro scalpel blade, the tooth was removed from the alveolar bone axially using forceps. Figure 2 shows the situation before and figure 3 right after the extraction. The resorptive processes in the labial area are barely perceptible in figure 3, are confirmed though in figure 4, which shows the separated root and the internal resorption of the labial region. Crown and root were separated 2 mm below the enamel cement junction. If there was no root canal

filling available, the dental pulp areas were to be cleaned and filled with composite filler. For replantation, a pre-manufactured palatinal silicone key was used to attach the crown to adjacent tooth 22 by means of acid etching (phosphoric acid, Adhese® Universal, Ivoclar Vivadent) and composite filler (SDR®, Dentsply Sirona). Figures 5a and b show the situation right after replantation and fixing.

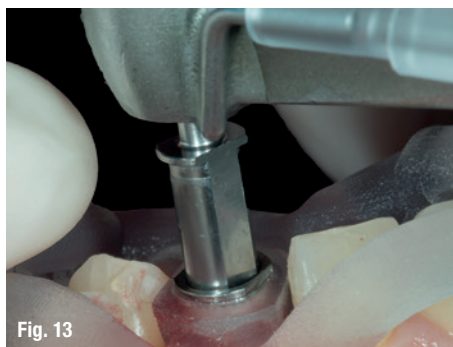
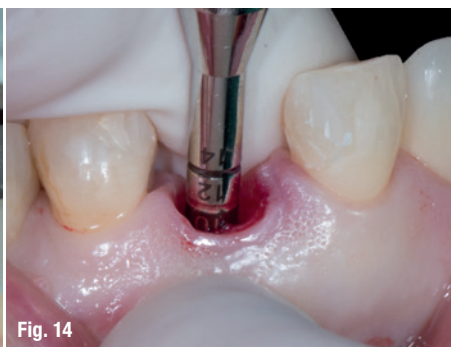
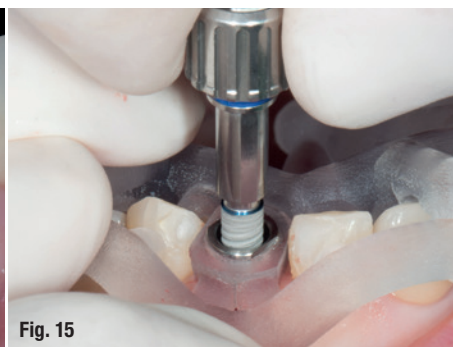
**Fig. 13:** Template-guided pilot hole (MIS Guide).

**Fig. 14:** After the pilot hole, the implant bed was further prepared, exclusively with osteotomes.

**Fig. 15:** A 3.3/11.5 mm implant in a special triangular design of the crest, which increases the bone deposit in the critical zone additionally used (V3, MIS Implants).

palatal direction with sufficient osseous volume of 2 mm on the buccal side. The replanted crown makes it possible to plan the implant position allowing for the prosthetic component in terms of backward planning. A template-guided implantation facilitates the incision-free technique and shorter treatment period, reduced patient morbidity, and better surface texture of the soft tissue. Figure 11 shows the situation after removal of the replanted crown and prior to the implantation. Using a micro scalpel blade, access to the bone was established (Fig. 12). Afterwards, the pilot hole was drilled using the template (MIS Guide, Fig. 13) and the further preparation performed with osteotomes (Fig. 14) after inspection of the buccal bone lamella. Despite the preventive measures, the purely subtractive preparation of the implant bed using drills was not indicated. We used a 3.3/11.5 mm implant in a special triangular design of the crest, which increases the bone deposit in the critical zone additionally (V3, MIS; Figs. 15 and 16).

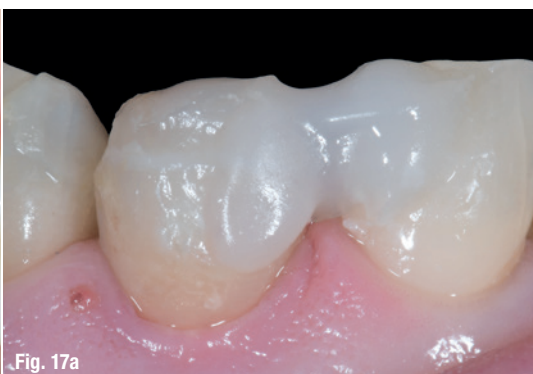
**Fig. 16:** Condition after implantation and prior to replantation of dental crown. The atraumatic status and the complete preservation of the emergence profile are remarkable.

**Fig. 17a:** Condition right after implantation.

**Fig. 17b:** Single-tooth radiograph after implantation.

After the implantation, the crown was replanted. Figures 16a und 17a show the status of the soft tissue right after the implantation. The atraumatic status and the complete preservation of the emergence profile are remarkable. A single-tooth radiograph was prepared to check the implantation (Fig. 17b).
