Aesthetic restoration in the incisal region

Michael Gahlert, Germany

Dr Michael Gahlert is a fellow of the International Team for Implantology (ITI) and has been specialising on the development and placement of ceramic implants. In this case report the aesthetic restoration of two maxillary incisors with ceramic implants is presented in detail. Dr Gahlert was supported by Otto Prandtner, dental technician at Dental Plattform and Dr Reza Saeidi Pour, prosthodontic specialist of the Dr Seehofer dental clinic, both from Munich, Germany.

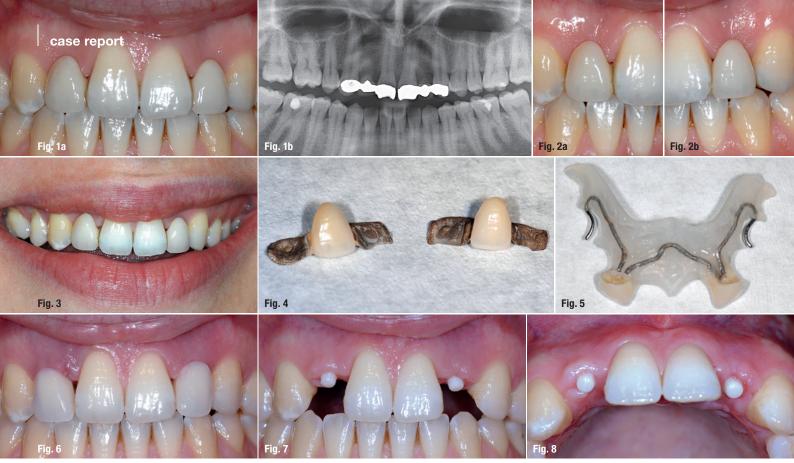
Figs. 1a & b: Initial clinical situation overview. Figs. 2a & b: Initial clinical situation of (a) tooth #12 and (b) tooth #22. Fig. 3: Lip-smile-line. Fig. 4: Former Maryland bridges. Fig. 5: Provisional aesthetic restoration with internal suspension clip. Fig. 6: Provisional restoration in situ. Fig. 7: One-piece ceramic implants prior to prosthetic placement. Fig. 8: Occlusal view.

A 28-year-old female patient attended the practice with the desire to have her incisors, which by nature did not exist, replaced with implants. The patient had until then been wearing Maryland bridges. However, in the past years they had repeatedly been falling out of posi-

tion and thus regularly had to be reglued. Consequently, the patient was not satisfied with this solution anymore (Figs. 1–4).

In a thorough consultation, the patient was extensively informed about available restoration options and she decided for one-piece ceramic implants (PURE Ceramic, Straumann Group). In a first step a provisional aesthetic restoration with an internal clip was produced and could be integrated immediately after the former bridges had been removed (Figs. 5 & 6).

In the following implantological procedure autologous bone material was simultaneously buccally accumulated. The teeth of the provisional restoration were hollowed in order to prevent them from touching the freshly inserted one-piece ceramic implants (Figs. 7 & 8).

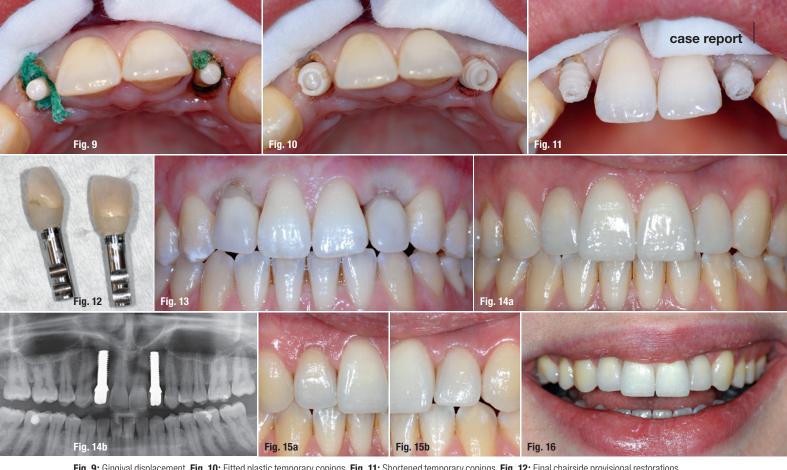
Fig. 9: Gingival displacement. **Fig. 10:** Fitted plastic temporary copings. **Fig. 11:** Shortened temporary copings. **Fig. 12:** Final chairside provisional restorations on laboratory implant analogues. **Fig. 13:** Chairside provisional restoration *in situ.* **Figs. 14a & b:** Definitive restorations. **Figs. 15a & b:** Final state of **(a)** tooth #12 and **(b)** tooth #22. **Fig. 16:** Lip-smile-line with final restoration. **Fig. 17:** Patient portrait with lip-smile-line.

After a healing period of three months the implants were prepared for the provisional crowns. In order to do so the peri-implant gingiva had to be displaced with retraction threads. Excess gingiva was removed with an electrotom on the palatinal side (Fig. 9).

Industrially produced temporary copings (Straumann Group) were then put on the implant fixture and shortened accordingly (Figs. 10 & 11). This so-called snap-on method facilitates the prosthetic handling and is also used for taking impressions with appropriately prefabricated impression caps.

The prosthetic teeth that had been removed from the provisional restoration were in a further step glued onto

the caps and transferred to the chairside provisional restoration. After forming the pink aesthetics, the definitive impressions were taken and the full-ceramic crowns were produced. Finally, the restorations were placed using glass ionomer cement (Ketac[™] Cem, 3M ESPE) as definitive mounting material (Figs. 12–14).
