# Peri-implantitis therapy

## Using resorbable bone replacement material

Dr Fernando Duarte, Portugal & Dr Gregor Thomas, Germany

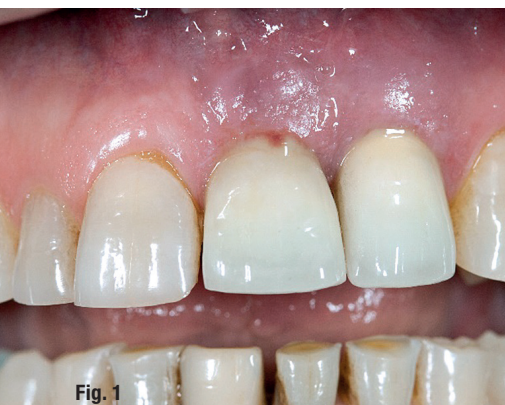
Fig. 1

A 59-year-old patient presented to the practice complaining about minor exudate at his dental implants in the anterior region (Fig. 1). Probing revealed a deep circular pocket around the implants during the initial examination. Mobility of the implants was, however, not detected. As suspected, the radiographic examination confirmed an advanced peri-implantitis at the recently placed implants (Fig. 2).

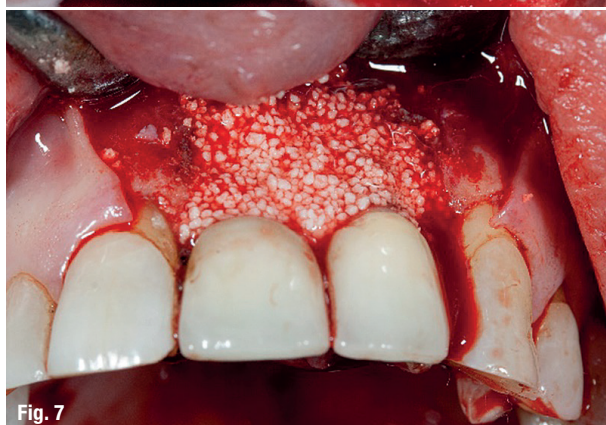
Fig. 7

After completion of the preparatory steps, the bone replacement material consisting of phase-free beta-tricalcium phosphate—which offers optimal conditions for osseous remodelling owing to its micro-, meso- and macropores—was inserted as previously described (Fig. 7).

8. Removal of the gauze.
9. The bone replacement material is blended with a sodium hyaluronate/piperacillin/tazobactam solution and autologous blood taken from the defect area or PRP in a sterile container and inserted into the affected area without pressure. The defect area is subsequently covered with a resorbable collagen membrane which was previously soaked in antibiotic solution.
