Peri-implantitis therapy

Using resorbable bone replacement material

Dr Fernando Duarte, Portugal & Dr Gregor Thomas, Germany

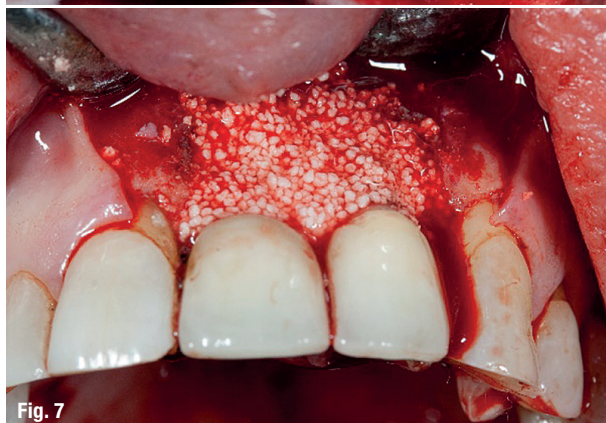
Fig. 7

After completion of the preparatory steps, the bone replacement material consisting of phase-free beta-tricalcium phosphate—which offers optimal conditions for osseous remodelling owing to its micro-, meso- and macropores—was inserted as previously described (Fig. 7).

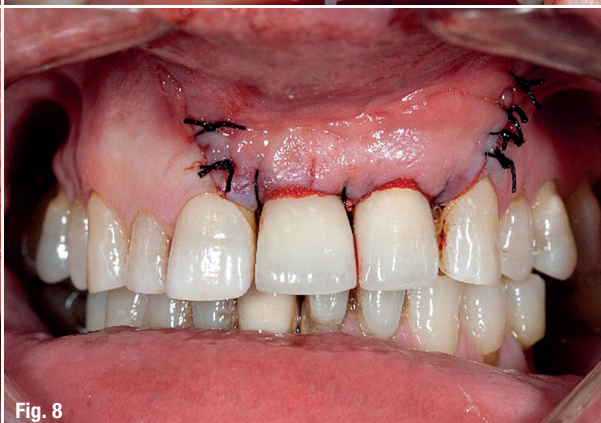
Fig. 8

Finally, the surgical area was covered with the bioresorbable membrane, and the flap was re-adapted with interrupted sutures in order to achieve a complete and impermeable wound closure (Fig. 8). The radiograph taken immediately after surgery showed the filled defect
