Buccal dehiscence and sinus lift cases

Predictable bone augmentation with synthetic bone material

Authors_ Dr Sérgio Alexandre Gehrke, Brazil & Dr. Giuseppe Maria Famà¹, Italy

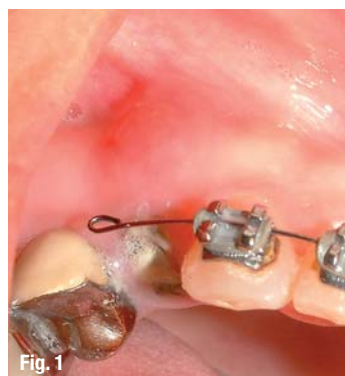
ograph as well as clinically (Fig. 1). The facts that the fracture was old and that a fistula developed around the root resulted in a large loss of the buccal bone wall. The treatment options were presented to the patient, who signed an informed consent form. The patient presented no contra-indications to the treatment.

markings (Figs. 2 & 8). The implants placed were in each case a Straumann RN SP (4.1 mm diameter, 14 mm length). The implants were installed at the level of the crestal bone of the adjacent teeth.

The injection of VitalOs must always be preceded by adequate control of the bleeding with the suction canula. The cement is placed within the defect without need for over-filling (Figs. 3 & 9), unlike what is often done with other types of bone substitutes like granules. Any material put in excess is always expelled or resorbed. With VitalOs, as the cement forms a block, a large quantity or even the whole material may be expelled. When the injected quantity is in large excess, the hardened block can easily break up and large pieces may be expelled out of the site. With granular materials it is only small granules that are expelled and this is less disturbing than pieces of cement. This is the reason why we never overfill sites with VitalOs.

A suture is then made with a 5-0 nylon suturing material. No attempt is made to achieve primary suture over the implant (Figs. 4 & 10) because we observed that even when the cement remains exposed to the oral environment, the bacteriae cannot adhere onto the surface of VitalOs and therefore no infection develops. The implants with a large platform help to maintain the volume and anatomy of the gums because they act as a shape keeper for the gingiva. A post-operative radiograph is taken for each case 7 days after implantation.

The sites were re-opened three months after implant installation to install the healing abutments. Measurement of the buccal bone level was measured again with the periodontal probe (Figs. 5 & 11).

After gingival conditioning, impressions were taken and the prosthetic restorations were made according to manufacturer's (Straumann) instructions. The two cases were followed up after one year and the esthetic result can be seen on Figures 6 and 12. The results show that there was neither loss of tissue nor gingival retraction in the grafted areas. Therefore, the anatomy obtained after implantation was maintained one year after restoration, ensuring a stable esthetic result.

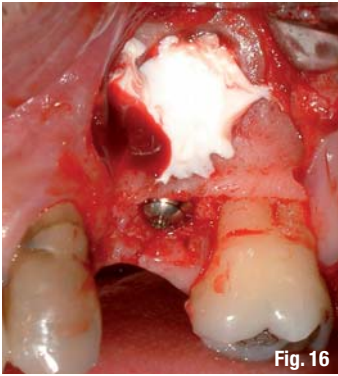
After local administration of anesthetics (Scandicaine 2%, Septodont) an intrasulcular incision was performed around the root and a lateral incision was made on the buccal side to gain access to the lateral wall of the maxillary sinus. After creation of the lateral window, the sinus membrane was carefully lifted and the site was prepared for implant installation. Then, the cement was injected against the inner (nasal) sinus cavity up to half of its width, and the implant Straumann RN SP (4.1 mm diameter, 12 mm length) was then installed (Fig. 13). Once the implant installed, the rest of the sinus cavity was filled with the cement (Figs. 14 & 16). The suture was made with 5-0 nylon simple

stitches. A post-operative radiograph was taken 7 days after surgery (Fig. 17). The distance between the sinus floor and the implant apex was measured on the radiograph. The results are shown in Table 2. The patients were recalled after one year to take a radiograph of the treated sites (Figs. 15 & 18).

Table 2 shows the values measured post-operatively and one year later.

We already observed that the process of resorption of the cement coupled with new bone growth can be conveniently followed up radiographically (Gehrke 2009). One year after functional restoration we could see that the level of newly formed bone was maintained, without loss around the apical portion of the implants. This is a very positive finding because the loss of bone at the apical level after loading the implants is a common phenomenon when this type of sinus grafting is performed.
