Buccal dehiscence and sinus lift cases

Predictable bone augmentation with synthetic bone material

Authors_ Dr Sérgio Alexandre Gehrke, Brazil & Dr. Giuseppe Maria Famà¹, Italy

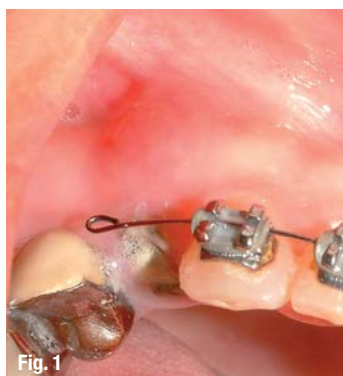
Case 1 was a 50-year old non-smoking female patient in good health who presented with a fractured root at the level of the maxillary first right premolar. This fracture was visible on the radi-

ograph as well as clinically (Fig. 1). The facts that the fracture was old and that a fistula developed around the root resulted in a large loss of the buccal bone wall. The treatment options were presented to the patient, who signed an informed consent form. The patient presented no contra-indications to the treatment.

After administration of the local anesthetics (Scandicaine 2%, Septodont), an intrasulcular incision was made around the root and a lateral one on the buccal side to provide access and allow visualization of the defect. The fractured roots were very carefully extracted to avoid increase of the bone loss. After curettage, the sites were prepared for the installation of the implant according to the manufacturer's instructions. The bone defects were measured with a periodontal probe with millimeter

markings (Figs. 2 & 8). The implants placed were in each case a Straumann RN SP (4.1 mm diameter, 14 mm length). The implants were installed at the level of the crestal bone of the adjacent teeth.

The injection of VitalOs must always be preceded by adequate control of the bleeding with the suction canula. The cement is placed within the defect without need for over-filling (Figs. 3 & 9), unlike what is often done with other types of bone substitutes like granules. Any material put in excess is always expelled or resorbed. With VitalOs, as the cement forms a block, a large quantity or even the whole material may be expelled. When the injected quantity is in large excess, the hardened block can easily break up and large pieces may be expelled out of the site. With granular materials it is only small granules that are expelled and this is less disturbing than pieces of cement. This is the reason why we never overfill sites with VitalOs.

A suture is then made with a 5-0 nylon suturing material. No attempt is made to achieve primary suture over the implant (Figs. 4 & 10) because we observed that even when the cement remains exposed to the oral environment, the bacteriae cannot adhere onto the surface of VitalOs and therefore no infection develops. The implants with a large platform help to maintain the volume and anatomy of the gums because they act as a shape keeper for the gingiva. A post-operative radiograph is taken for each case 7 days after implantation.

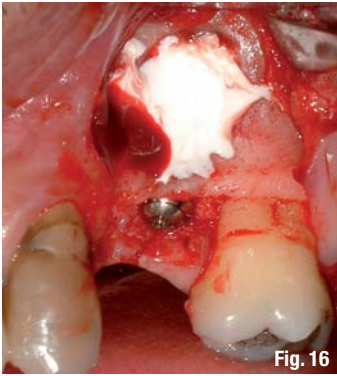
After local administration of anesthetics (Scandicaine 2%, Septodont) an intrasulcular incision was performed around the root and a lateral incision was made on the buccal side to gain access to the lateral wall of the maxillary sinus. After creation of the lateral window, the sinus membrane was carefully lifted and the site was prepared for implant installation. Then, the cement was injected against the inner (nasal) sinus cavity up to half of its width, and the implant Straumann RN SP (4.1 mm diameter, 12 mm length) was then installed (Fig. 13). Once the implant installed, the rest of the sinus cavity was filled with the cement (Figs. 14 & 16). The suture was made with 5-0 nylon simple

stitches. A post-operative radiograph was taken 7 days after surgery (Fig. 17). The distance between the sinus floor and the implant apex was measured on the radiograph. The results are shown in Table 2. The patients were recalled after one year to take a radiograph of the treated sites (Figs. 15 & 18).

Table 2 shows the values measured post-operatively and one year later.

We already observed that the process of resorption of the cement coupled with new bone growth can be conveniently followed up radiographically (Gehrke 2009). One year after functional restoration we could see that the level of newly formed bone was maintained, without loss around the apical portion of the implants. This is a very positive finding because the loss of bone at the apical level after loading the implants is a common phenomenon when this type of sinus grafting is performed.
