Buccal dehiscence and sinus lift cases

Predictable bone augmentation with synthetic bone material

Authors_ Dr Sérgio Alexandre Gehrke, Brazil & Dr. Giuseppe Maria Famà¹, Italy

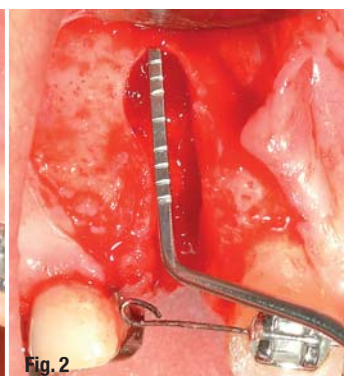
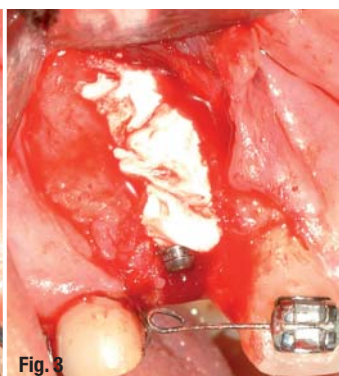
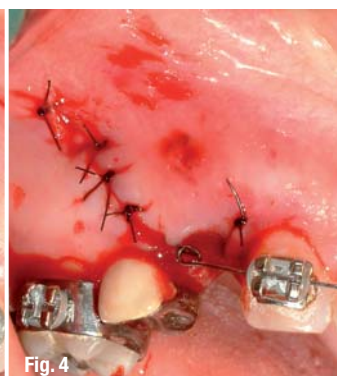
ograph as well as clinically (Fig. 1). The facts that the fracture was old and that a fistula developed around the root resulted in a large loss of the buccal bone wall. The treatment options were presented to the patient, who signed an informed consent form. The patient presented no contra-indications to the treatment.

markings (Figs. 2 & 8). The implants placed were in each case a Straumann RN SP (4.1 mm diameter, 14 mm length). The implants were installed at the level of the crestal bone of the adjacent teeth.

The injection of VitalOs must always be preceded by adequate control of the bleeding with the suction canula. The cement is placed within the defect without need for over-filling (Figs. 3 & 9), unlike what is often done with other types of bone substitutes like granules. Any material put in excess is always expelled or resorbed. With VitalOs, as the cement forms a block, a large quantity or even the whole material may be expelled. When the injected quantity is in large excess, the hardened block can easily break up and large pieces may be expelled out of the site. With granular materials it is only small granules that are expelled and this is less disturbing than pieces of cement. This is the reason why we never overfill sites with VitalOs.

A suture is then made with a 5-0 nylon suturing material. No attempt is made to achieve primary suture over the implant (Figs. 4 & 10) because we observed that even when the cement remains exposed to the oral environment, the bacteriae cannot adhere onto the surface of VitalOs and therefore no infection develops. The implants with a large platform help to maintain the volume and anatomy of the gums because they act as a shape keeper for the gingiva. A post-operative radiograph is taken for each case 7 days after implantation.

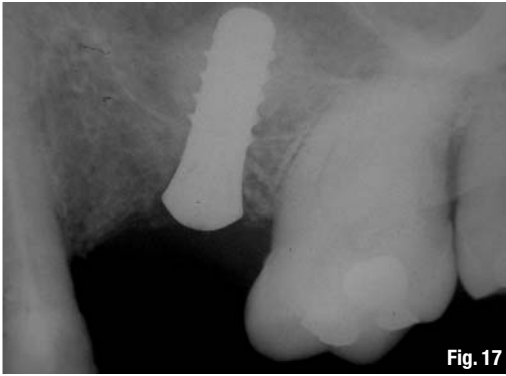
After local administration of anesthetics (Scandicaine 2%, Septodont) an intrasulcular incision was performed around the root and a lateral incision was made on the buccal side to gain access to the lateral wall of the maxillary sinus. After creation of the lateral window, the sinus membrane was carefully lifted and the site was prepared for implant installation. Then, the cement was injected against the inner (nasal) sinus cavity up to half of its width, and the implant Straumann RN SP (4.1 mm diameter, 12 mm length) was then installed (Fig. 13). Once the implant installed, the rest of the sinus cavity was filled with the cement (Figs. 14 & 16). The suture was made with 5-0 nylon simple

stitches. A post-operative radiograph was taken 7 days after surgery (Fig. 17). The distance between the sinus floor and the implant apex was measured on the radiograph. The results are shown in Table 2. The patients were recalled after one year to take a radiograph of the treated sites (Figs. 15 & 18).

Table 2 shows the values measured post-operatively and one year later.

We already observed that the process of resorption of the cement coupled with new bone growth can be conveniently followed up radiographically (Gehrke 2009). One year after functional restoration we could see that the level of newly formed bone was maintained, without loss around the apical portion of the implants. This is a very positive finding because the loss of bone at the apical level after loading the implants is a common phenomenon when this type of sinus grafting is performed.
