Comprehensive evaluation of previous root-canal therapy

Author_ Dr Richard E. Mounce, USA

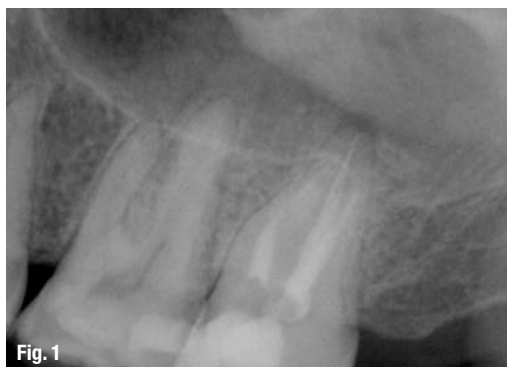
Fig. 1_Clinical case (tooth #15).

_I recently received an e-mail from a general dentist with the image of tooth #15 (Fig. 1). The e-mail read: "I have an X-ray of our son's #15 root-canal treatment done five years ago by an endodontist. He has pain. I would like your opinion on the re-treatment?" There was no additional information.

The above notwithstanding, the provided image yields significant information. The radiographic interpretation of this film demonstrates the following:

1. There is no coronal seal. In the endodontic literature, coronal leakage is highly correlated with failure of root-canal treatment. The tooth has not been crowned nor has the pulp chamber been restored. This radiographic appearance is diagnostic of coronal leakage. If accessed, the canals would almost certainly show overt evidence of such leakage, manifested as odour, discoloured gutta-percha, moisture and possible purulence, amongst other signs. Microbiologically, it is virtually certain that evidence of bacterial biofilm would be located alongside the existing gutta-percha in fins, cul de sacs and other inaccessible areas of the root-canal space.

2. There is a lack of continuity in the preparation and obturation in the taper from the crown to the apex of all three roots. The coronal halves of the disto-buccal (DB), mesio-buccal (MB) and palatal canals have greater taper than the apical halves do. It appears that the prepared shape in the coronal halves was made with Gates Glidden drills.

3. There is a radiographic lesion at the apex of the palatal root. It is unknown from this one radiographic view whether additional lesions are present at the apex of the MB and the DB roots.
4. There are obturation voids in the palatal and MB root. The root-canal spaces have not been filled three-dimensionally. Such voids in obturation (aside from a lack of coronal seal) would give rise to questions about the quality of the cleaning and shaping.
5. Although not based on an empirical radiographic observation, the working length of the cleaning, shaping and obturation appears to be appropriate as does the master apical diameter, but this may have little to do with the clinical reality, ideal true working length and/or master apical diameter.

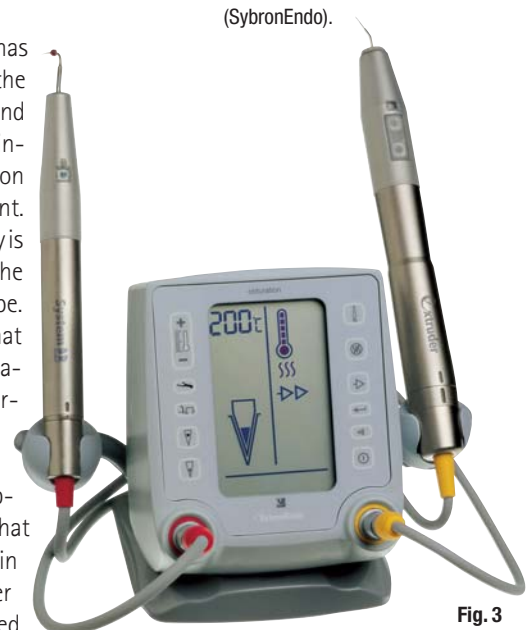
Fig. 3

Fig. 3_Elements Obturation Unit (SybronEndo).

a passive means to eliminate the obturation before solvents and/or mechanical means are used. While not directly related to re-treatment, this case is a strong argument for the use of bonded obturation. Relative to gutta-percha, in vitro and in vivo bonded obturation has been shown to either decrease the movement of bacteria in a coronal to apical direction and/or reduce apical inflammation and infection that results from a loss of coronal seal. In this clinical case, it could be argued that if the obturation had been bonded that it could have provided some additional defence against the evident loss of coronal seal. RealSeal (SybronEndo) master cones and/or RealSeal 1 Bonded Obturator (SybronEndo) would both have been excellent choices to provide this bonded obturation clinically.

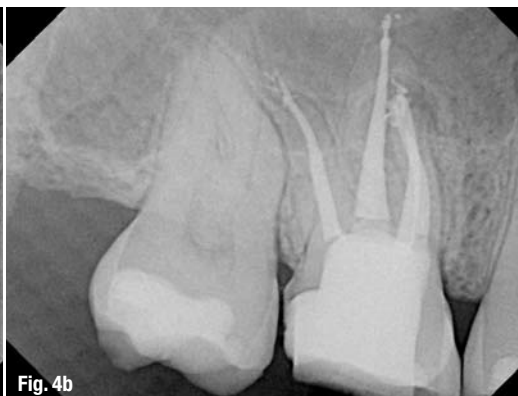
Figs. 4a & b Re-treatment of a failed root-canal treatment using the concepts and strategies discussed in the article.
