Comprehensive evaluation of previous root-canal therapy

Author_ Dr Richard E. Mounce, USA

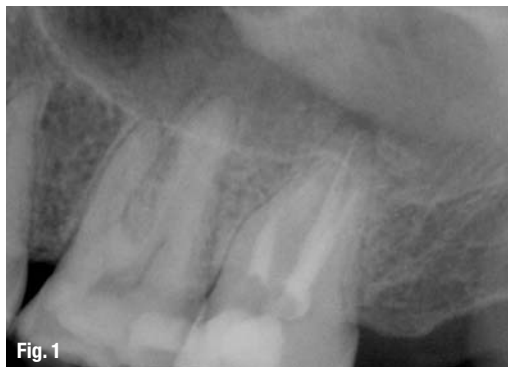
Fig. 1_Clinical case (tooth #15).

_I recently received an e-mail from a general dentist with the image of tooth #15 (Fig. 1). The e-mail read: "I have an X-ray of our son's #15 root-canal treatment done five years ago by an endodontist. He has pain. I would like your opinion on the re-treatment?" There was no additional information.

The above notwithstanding, the provided image yields significant information. The radiographic interpretation of this film demonstrates the following:

1. There is no coronal seal. In the endodontic literature, coronal leakage is highly correlated with failure of root-canal treatment. The tooth has not been crowned nor has the pulp chamber been restored. This radiographic appearance is diagnostic of coronal leakage. If accessed, the canals would almost certainly show overt evidence of such leakage, manifested as odour, discoloured gutta-percha, moisture and possible purulence, amongst other signs. Microbiologically, it is virtually certain that evidence of bacterial biofilm would be located alongside the existing gutta-percha in fins, cul de sacs and other inaccessible areas of the root-canal space.

2. There is a lack of continuity in the preparation and obturation in the taper from the crown to the apex of all three roots. The coronal halves of the disto-buccal (DB), mesio-buccal (MB) and palatal canals have greater taper than the apical halves do. It appears that the prepared shape in the coronal halves was made with Gates Glidden drills.

3. There is a radiographic lesion at the apex of the palatal root. It is unknown from this one radiographic view whether additional lesions are present at the apex of the MB and the DB roots.
4. There are obturation voids in the palatal and MB root. The root-canal spaces have not been filled three-dimensionally. Such voids in obturation (aside from a lack of coronal seal) would give rise to questions about the quality of the cleaning and shaping.
5. Although not based on an empirical radiographic observation, the working length of the cleaning, shaping and obturation appears to be appropriate as does the master apical diameter, but this may have little to do with the clinical reality, ideal true working length and/or master apical diameter.

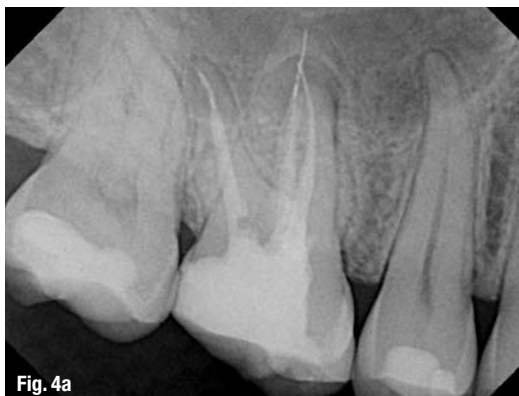
Figs. 4a & b Re-treatment of a failed root-canal treatment using the concepts and strategies discussed in the article.
