Opalescent composite resin

Author_ Ulf Krueger-Janson, Germany

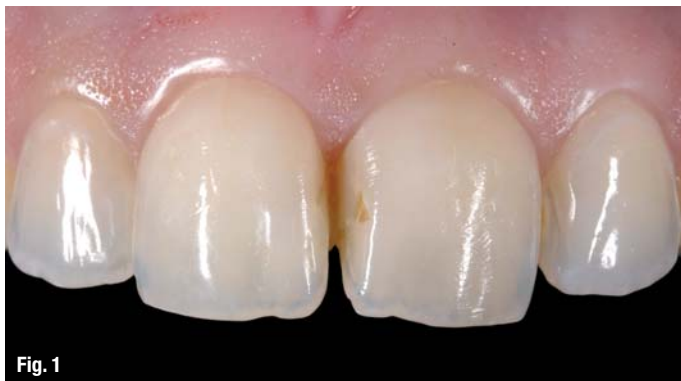
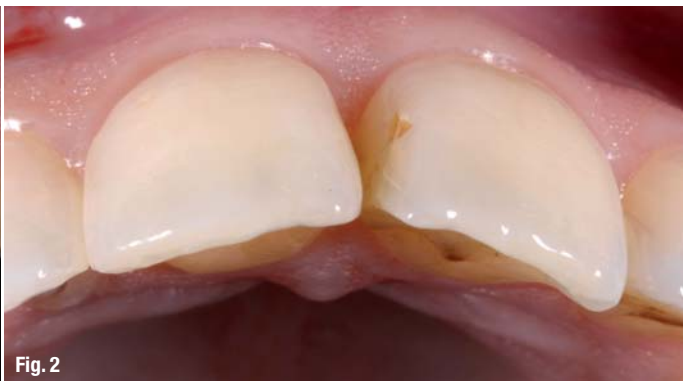
Fig. 1 Initial findings: defective restorations in teeth 11 and 21.

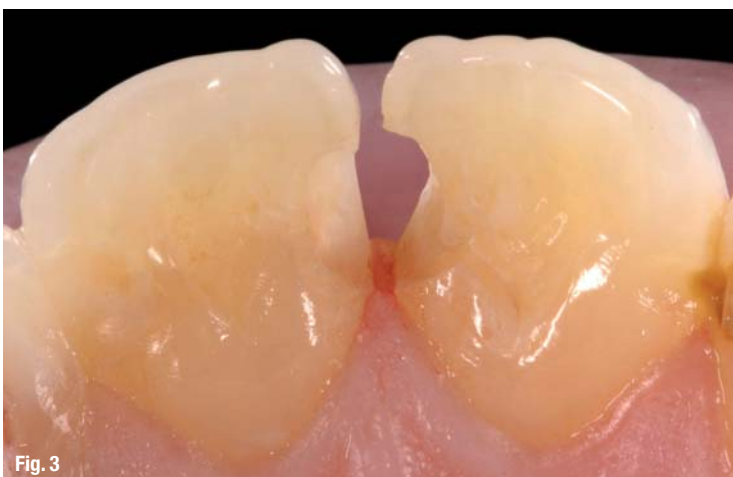
Fig. 3 View after removal of the old fillings.

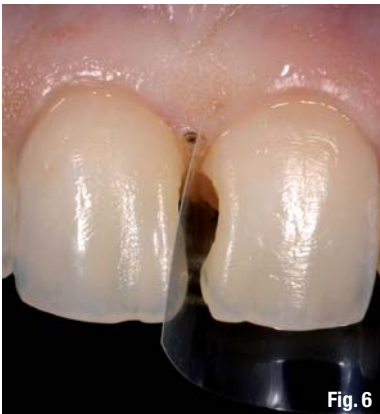
Fig. 4 Defects viewed from the vestibular aspect.
Fig. 5 Beveling of the preparation margin using diamond abrasive strips.
Fig. 6 Placement of the matrix band.
Fig. 7 Palatal view.
Fig. 8 Application of the first composite increment.
Fig. 9 Further IPS Empress Direct Dentin Shade A3 increment.
Fig. 10 Completion of the dentine core using IPS Empress Direct Dentin Shade A2.
Fig. 11 Coverage with IPS Empress Direct Enamel Shade A2.
Fig. 12 Contouring of the final tooth shape using IPS Empress Direct Trans Opal.
