Opalescent composite resin

Author_ Ulf Krueger-Janson, Germany

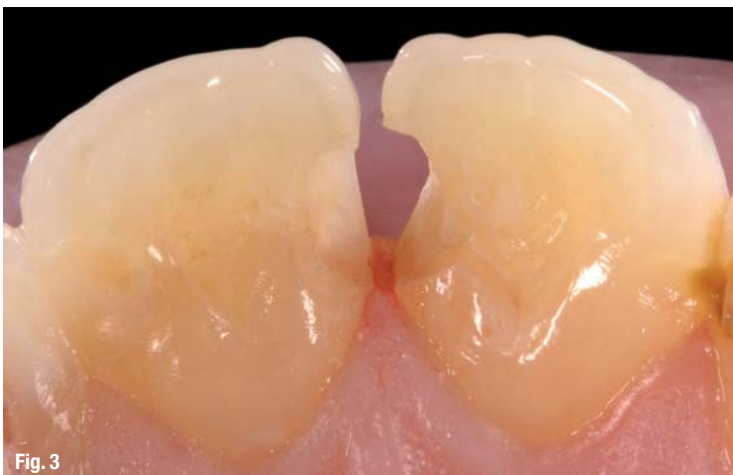
Fig. 3 View after removal of the old fillings.

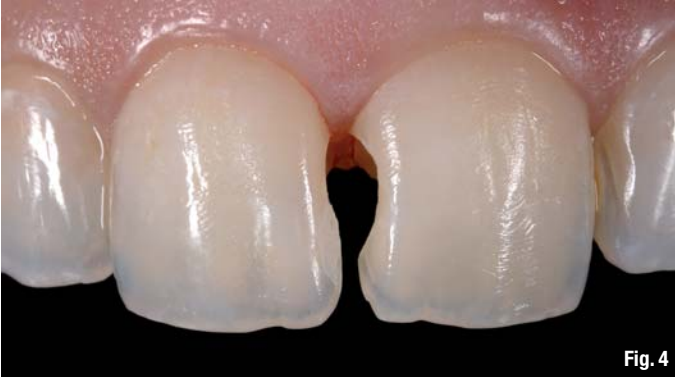
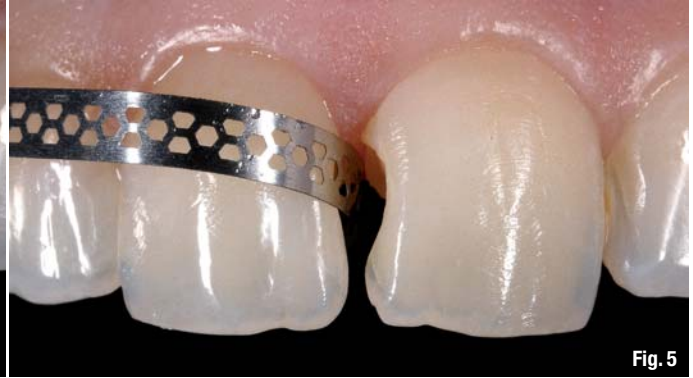
composed demonstrated that the optical incisal edge effects described above were particularly eye-catching in this case. Moreover, the bluish-whitish line extended far into the interproximal area. The challenge was to create a highly aesthetic restoration. We strove to achieve this by means of a slight reduction of the diastema and the application of opalescent effects. Following, I describe the way improved restorative results can be achieved if an opalescent material is also available (IPS Empress Direct Trans Opal, Ivoclar Vivadent).

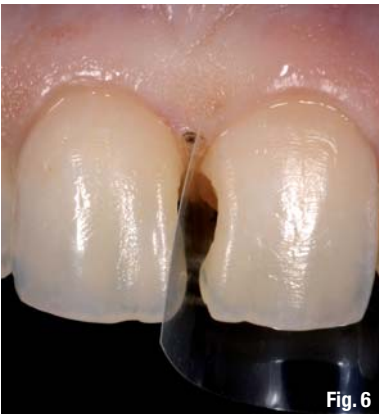
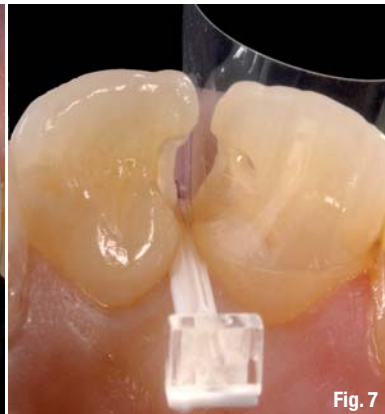
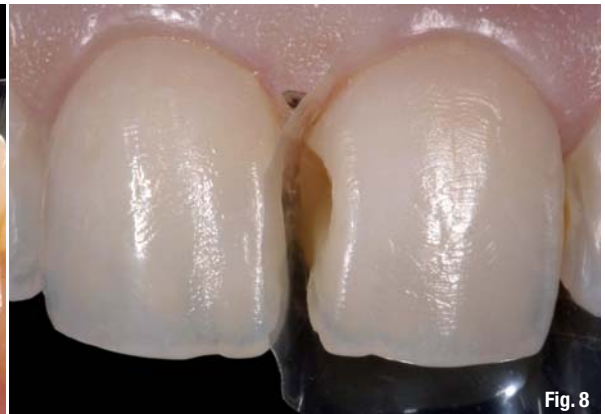
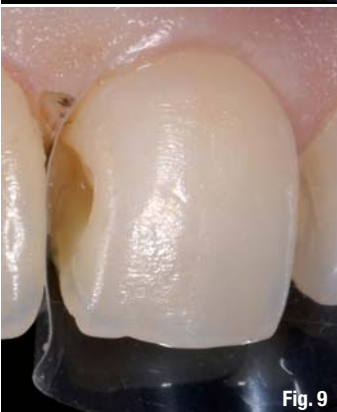
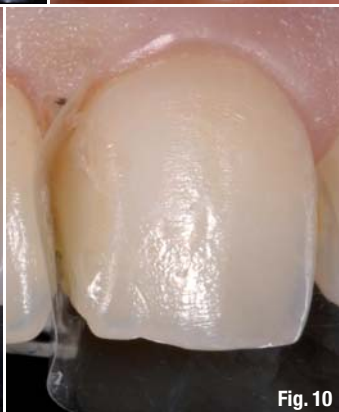
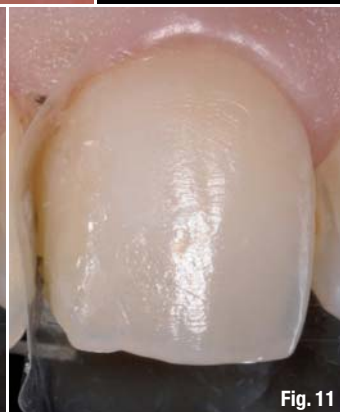
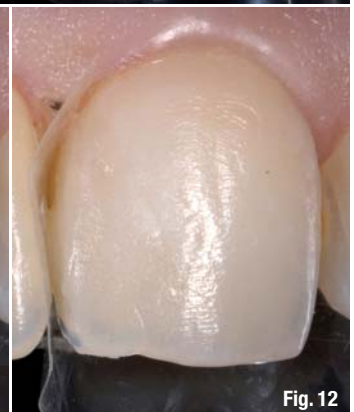
Fig. 4 Defects viewed from the vestibular aspect.
Fig. 5 Beveling of the preparation margin using diamond abrasive strips.
Fig. 6 Placement of the matrix band.
Fig. 7 Palatal view.
Fig. 8 Application of the first composite increment.
Fig. 9 Further IPS Empress Direct Dentin Shade A3 increment.
Fig. 10 Completion of the dentine core using IPS Empress Direct Dentin Shade A2.
Fig. 11 Coverage with IPS Empress Direct Enamel Shade A2.
Fig. 12 Contouring of the final tooth shape using IPS Empress Direct Trans Opal.
