Opalescent composite resin

Author_ Ulf Krueger-Janson, Germany

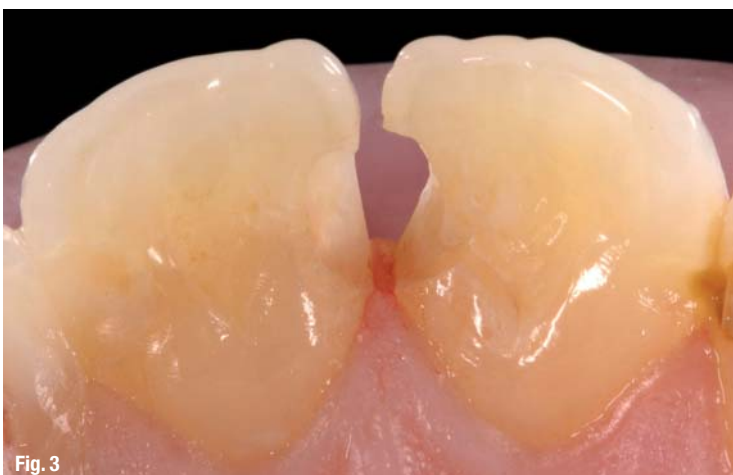
Fig. 3 View after removal of the old fillings.
