Immediate implant placement and temporisation in the aesthetic zone

Author_ Dr Philip J. Friel, Great Britain

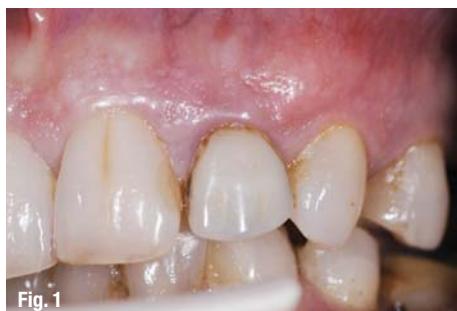
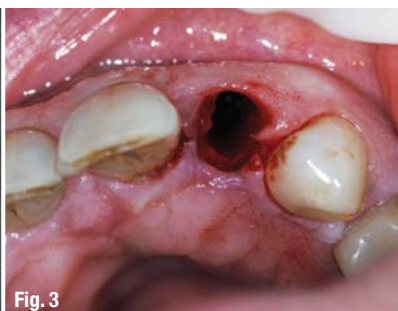
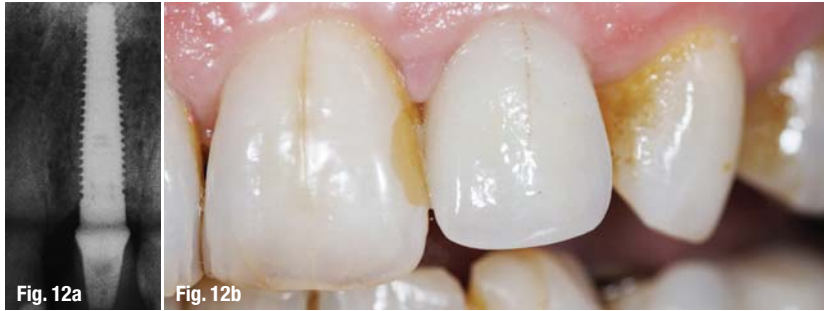
Following atraumatic tooth removal, the socket was thoroughly irrigated, debrided and fully assessed (Fig. 3). The socket was found to be intact, stable and formed from solid bone. The

temporary crown is luted to the temporary abutment using a temporary cement. The post operative radiograph (Fig. 7) shows this situation and highlights a small excess of temporary cement which can be easily removed with floss. The temporary restoration is kept clear of the occlusion. Given the implant is placed directly into the extraction socket, and that the adequately supportive temporary crown provides an excellent crestal gingival seal, no flap is required and consequently, no sutures are used in this procedure. Standard post operative protocols are followed. As a result of this flapless approach, the trauma of surgery is lessened, and review one week post surgery shows an excellent recovery (Fig. 8), with very little sign of any trauma, swelling or alteration of the surrounding gingival tissue, which largely remains unchanged. After a five to six month healing period, during which regular review is undertaken, the temporary crown is removed using a crown remover. The temporary abutment is removed and the socket irrigated. A standard open tray impression technique is used to record the position of the implant, and the temporary abutment and crown replaced. The subsequently produced model is used to construct an abutment and crown, replicating the exact support given by the temporary set up. The case is completed by final abutment placement and torque to 35 Ncm. Following trial fit, and approval of the definitive restoration, the occlusion is checked and adjusted as required. The Zirconia crown is cemented using a resin cement, with care being taken to minimally load the cement and remove any excess prior to and after cure. Occlusion is again assessed and adjusted as required. The success of the restoration is evident immediately after cementation (Fig. 9), at 3 month (Fig. 10), six month (Fig. 11) and 18 month review (Fig. 12a & b). In order to successfully perform the procedure outlined above, timing is essential, particularly in the case of the root fractured tooth. In these cases, if such treatment is not initiated in good time, the area can become infected with corresponding sinus formation and inevitable loss of the buccal plate of bone. This would entail reassessment and treatment using a multi-staged, delayed placement regime. In order to perform
