Rehabilitation of an edentulous mandible

Restoration with one-piece zirconia implants

Prof. Ziv Mazor, Israel

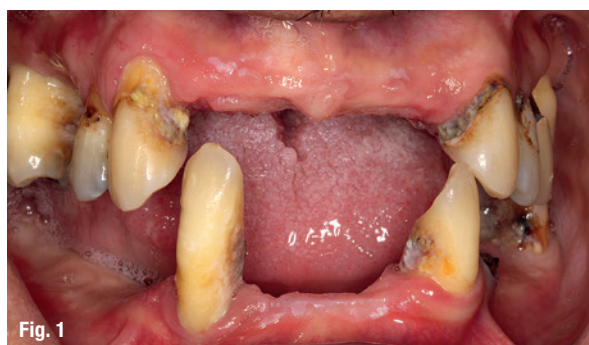
Fig. 1

Fig. 1: Frontal view of the patient's mandible. **Figs. 2 & 3:** Implant positioning using the planning software Simplant.

A 37-year-old patient presented suffering from aggressive periodontitis which resulted in almost total edentulism in the lower jaw (Fig. 1). For that reason, the patient asked for fixed restorations. The treatment plan involved
