Implant treatment of heavy smokers with critical bone situations

Drs Branislav Fatori & Inge Schmitz, Germany

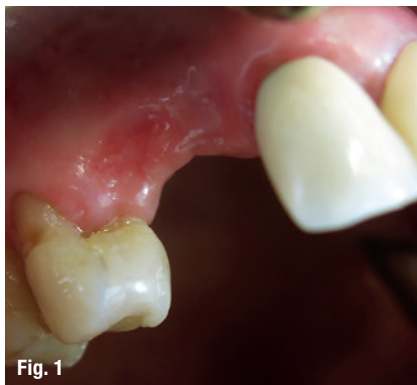
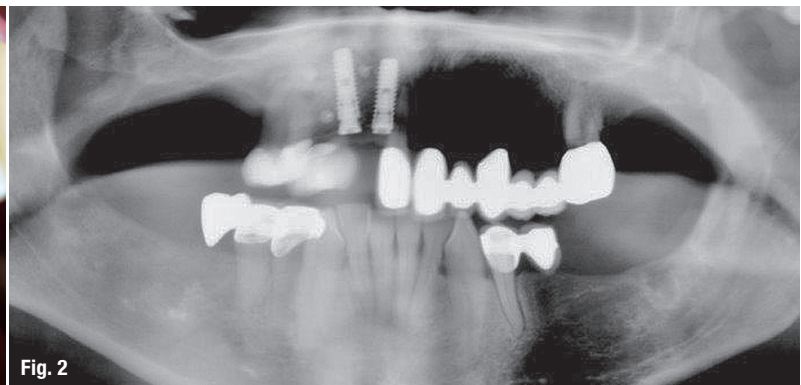
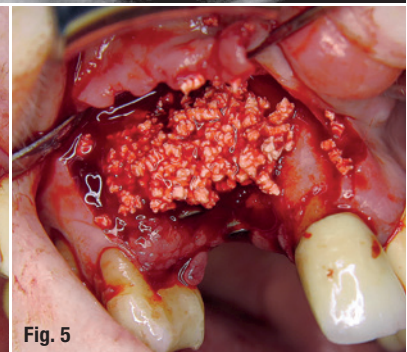
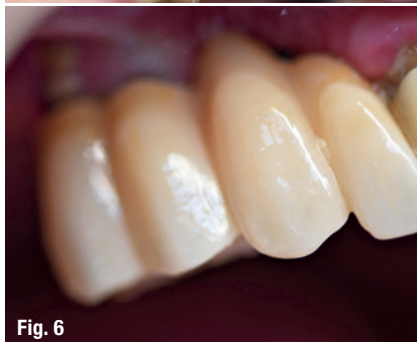
Case 1—Fig. 1: The intra-oral examination revealed extreme atrophy. **Fig. 2:** Pre-op radiograph with view of the implants and pins. **Fig. 3:** View of the completely exposed implant with visibly missing bone material. **Fig. 4:** A membrane was used for augmentation purposes. **Fig. 5:** View of the bone graft material. **Fig. 6:** View of the highly aesthetic final result. **Fig. 7:** Final post-op radiograph.

The first patient, a 65-year-old woman, was a heavy smoker, smoking about 45 cigarettes per day. Upon examination, prominent atrophy in regions #12 and 13 was observed, with complete loss of the buccal bone lamella. Augmentation was necessary in the lateral and vertical regions. NanoBone granulate (Artoss) was used. A membrane (imperiOs) was fixed with titanium pins. Two DENTAL RATIO implants (DRS International), 10 and 12mm in length and with a diameter of 3.75mm, were simultaneously inserted.
