Implant treatment of heavy smokers with critical bone situations

Drs Branislav Fatori & Inge Schmitz, Germany

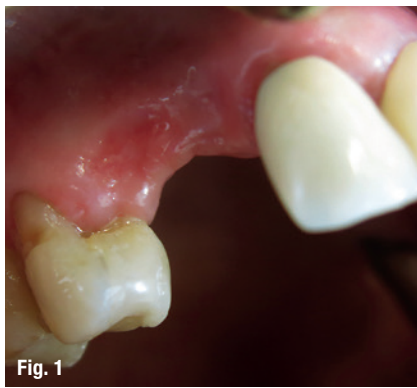
Case 1—Fig. 1: The intra-oral examination revealed extreme atrophy. **Fig. 2:** Pre-op radiograph with view of the implants and pins. **Fig. 3:** View of the completely exposed implant with visibly missing bone material. **Fig. 4:** A membrane was used for augmentation purposes. **Fig. 5:** View of the bone graft material. **Fig. 6:** View of the highly aesthetic final result. **Fig. 7:** Final post-op radiograph.

The first patient, a 65-year-old woman, was a heavy smoker, smoking about 45 cigarettes per day. Upon examination, prominent atrophy in regions #12 and 13 was observed, with complete loss of the buccal bone lamella. Augmentation was necessary in the lateral and vertical regions. NanoBone granulate (Artoss) was used. A membrane (imperiOs) was fixed with titanium pins. Two DENTAL RATIO implants (DRS International), 10 and 12mm in length and with a diameter of 3.75mm, were simultaneously inserted.
