# Restoration after augmentation in the maxillary anterior region

Dr Falk Nagel, Germany

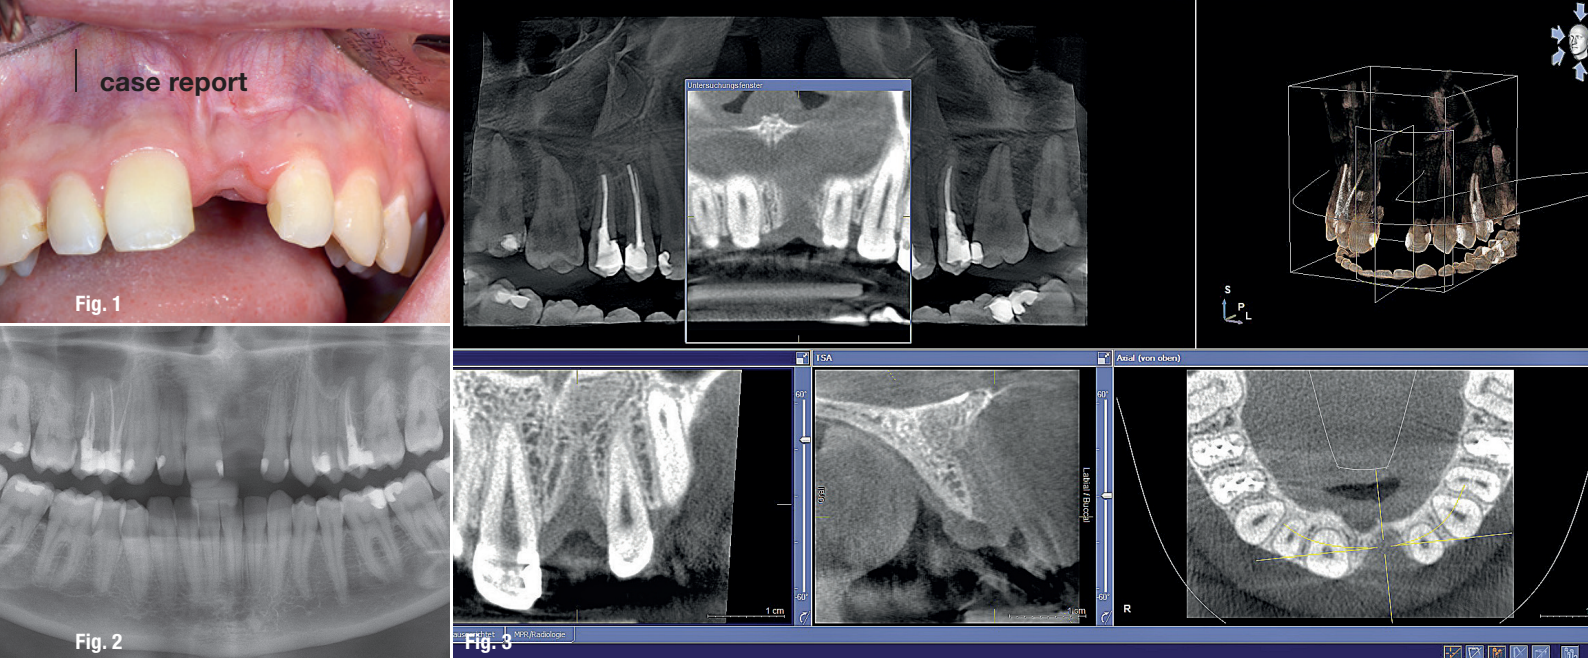
Fig. 1: Pre-op clinical situation. Figs. 2 & 3: Radiograph and CBCT evaluation of the initial clinical situation.

The patient explicitly requested restoration of the single tooth gap with an implant only. She rejected grinding of the adjacent teeth for a bridge restoration or an adhesive prosthesis. Her aesthetic demand for a harmonious overall situation was not superficial. Oral hygiene was still in need of improvement (Fig. 1). After the extraction socket had healed without volume maintenance,

a pronounced hard- and soft-tissue deficit appeared in the area of the missing anterior tooth. The 3D resorption of the alveolar bone was exactly depicted in the CBCT scan, which made it possible to calculate the vertical and horizontal volume to be built up in order to achieve a stable implant bed (Figs. 2 & 3). The patient and the referring colleague were informed that the implantation had to be performed in two stages owing to the complex restorative needs.

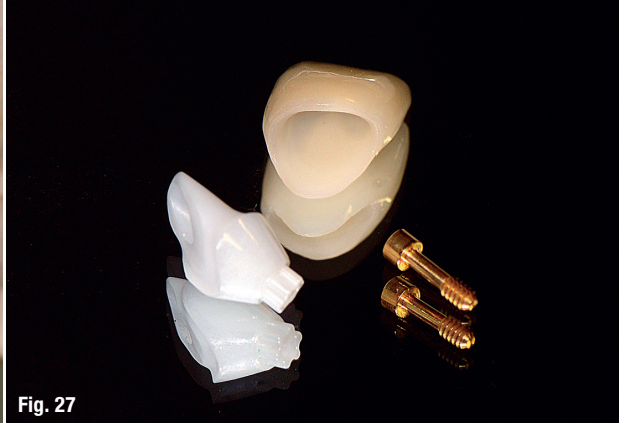
**Figs. 26 & 27:** A zirconium dioxide abutment was made by DEDICAM. **Figs. 28–30:** The all-ceramic crown was cemented onto the screw access hole.

In an interview with the patient, the interdisciplinary team agreed on aesthetic details to determine the shade of the final restoration. An all-ceramic crown was to be cemented onto an individualised CAD/CAM-fabricated full zirconium dioxide abutment. In order to transfer the crown emergence profile exactly to the master cast, the dental technician fixed the shape by screwing the temporary crown to a laboratory implant and taking a silicone impression. He removed the crown, screwed on an impression post for the open impression and filled the crown profile in the silicone key with acrylic. The customised impression post was placed in the mouth and an impression of the entire jaw was taken (Figs. 22–25). The dental technician fabricated the model and quickly waxed the temporary crown using the silicone key. He scanned the model, the implant position and the wax-up, and sent the abutment design data to DEDICAM, CAMLOG’s CAD/CAM fabrication service provider.

The milling and sintering of the internal implant geometry are extremely technically sensitive and can only be optimally fabricated by the manufacturer. Special attention was paid to the position of the crown–abutment transition. It was placed circularly about 1 mm below the gingival margin to ensure that the cement could be removed exactly from the sulcus. A zirconium dioxide framework was fabricated on the abutment in the laboratory and individually veneered with appropriate ceramic materials (Figs. 26 & 27). On the day of placement, the temporary implant crown was unscrewed and the abutment placed and fixed with a gold screw at a torque of 15 Ncm. The screw access hole was closed with a clip and the all-ceramic crown was cemented onto it after a functional and aesthetic check (Figs. 28–30). Both the treating team and the patient were satisfied with the final result of the complex case. It was desirable to increase the patient’s commitment to oral hygiene.
