Restoration after augmentation in the maxillary anterior region

Dr Falk Nagel, Germany

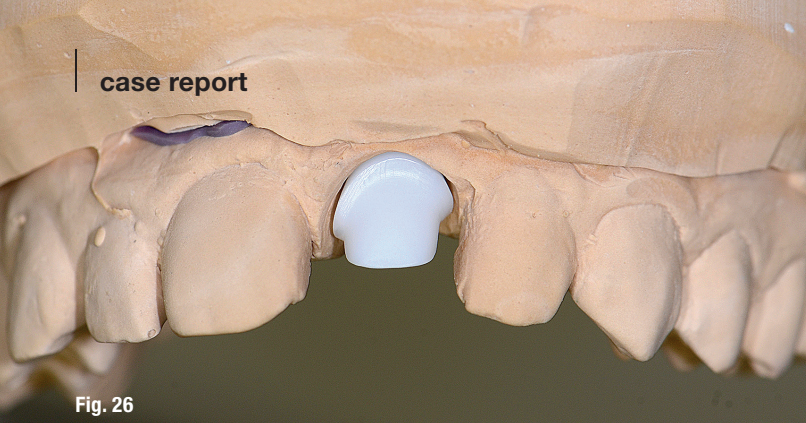
Figs. 26 & 27: A zirconium dioxide abutment was made by DEDICAM. **Figs. 28–30:** The all-ceramic crown was cemented onto the screw access hole.

In an interview with the patient, the interdisciplinary team agreed on aesthetic details to determine the shade of the final restoration. An all-ceramic crown was to be cemented onto an individualised CAD/CAM-fabricated full zirconium dioxide abutment. In order to transfer the crown emergence profile exactly to the master cast, the dental technician fixed the shape by screwing the temporary crown to a laboratory implant and taking a silicone impression. He removed the crown, screwed on an impression post for the open impression and filled the crown profile in the silicone key with acrylic. The customised impression post was placed in the mouth and an impression of the entire jaw was taken (Figs. 22–25). The dental technician fabricated the model and quickly waxed the temporary crown using the silicone key. He scanned the model, the implant position and the wax-up, and sent the abutment design data to DEDICAM, CAMLOG’s CAD/CAM fabrication service provider.

The milling and sintering of the internal implant geometry are extremely technically sensitive and can only be optimally fabricated by the manufacturer. Special attention was paid to the position of the crown–abutment transition. It was placed circularly about 1 mm below the gingival margin to ensure that the cement could be removed exactly from the sulcus. A zirconium dioxide framework was fabricated on the abutment in the laboratory and individually veneered with appropriate ceramic materials (Figs. 26 & 27). On the day of placement, the temporary implant crown was unscrewed and the abutment placed and fixed with a gold screw at a torque of 15 Ncm. The screw access hole was closed with a clip and the all-ceramic crown was cemented onto it after a functional and aesthetic check (Figs. 28–30). Both the treating team and the patient were satisfied with the final result of the complex case. It was desirable to increase the patient’s commitment to oral hygiene.
