# Surgical aspects of two-piece ceramic implants

# A solution in compromised bone sites

Dr Bernard Dahan, DCD, Israel

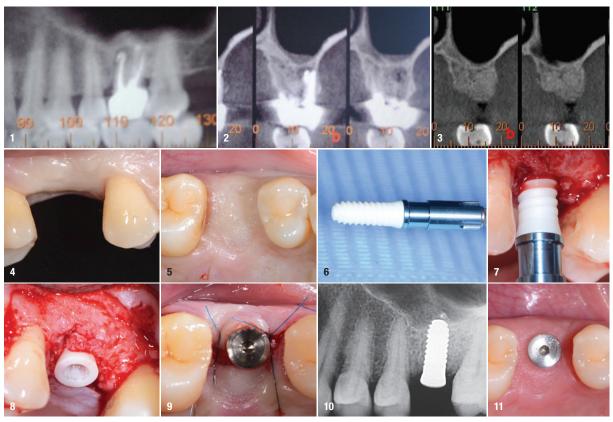
Case 1—Figs. 1 & 2: Radiographs before the extraction (first stage). Figs. 3–5: Healing of the socket preservation. Figs. 6 & 7: Implant insertion. Figs. 8–10: End of surgery. Two-piece ceramic implant at tissue level. Fig. 11: Successful tissue integration at two months.

# Case 1: Implant placement in regenerated bone (two-stage approach)

The implant insertion was preceded by endodontic treatment, which had failed. The first stage of implant treatment involved tooth extraction and socket preservation by means of an allograft and a collagen membrane. Six months after the initial treatment, a two-piece ceramic implant was inserted into the bone, which had regenerated at that point, as part of the second treatment stage (Figs. 1–11).

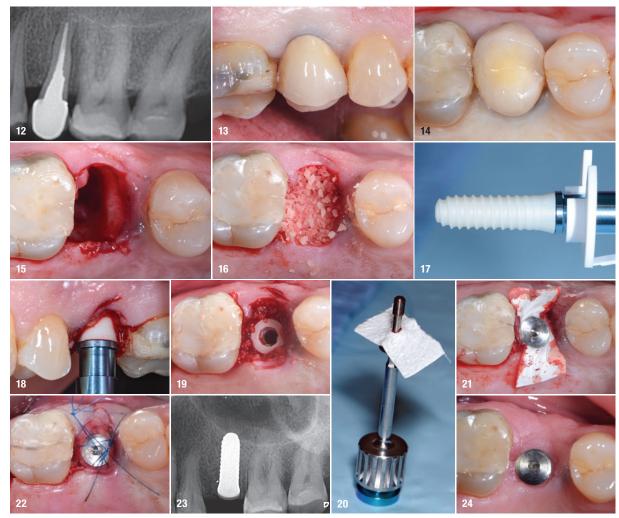
Case 2—Figs. 12–14: Hopeless tooth. Fig. 15: Atraumatic extraction. Fig. 16: Bone allograft for socket preservation. Figs. 17–19: Two-piece ceramic implant placement at tissue level. Figs. 20–22: Collagen membrane placement and suture. Fig. 23: Radiograph showing successful tissue integration at two months. Fig. 24: Successful tissue integration at two months.

#### Case 2: Immediate implant placement

The clinical diagnosis revealed a cracked premolar. As a consequence, atraumatic extraction was carried out.

Immediate placement of a two-piece ceramic implant at tissue level was done along with socket preservation (allograft bone substitute and a resorbable collagen membrane). No loading was done at that point (Figs. 12–24).

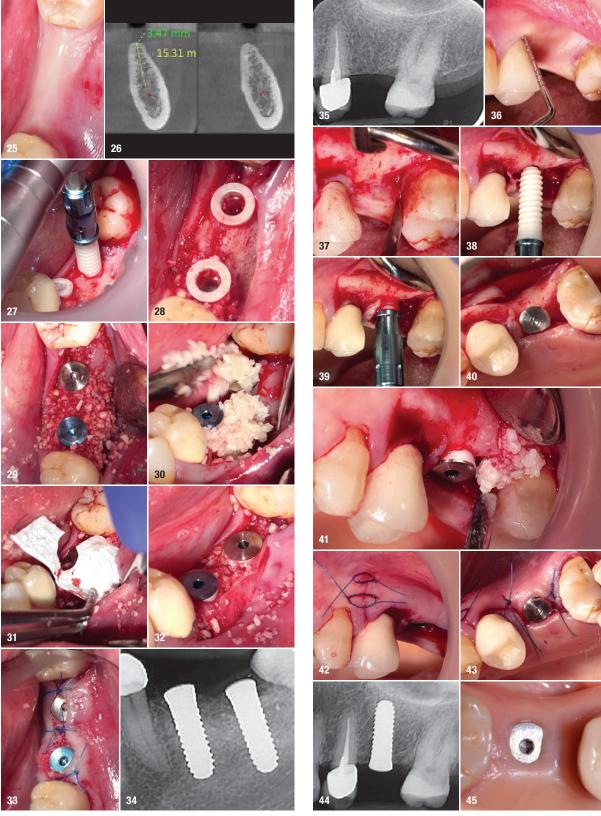
Case 3—Figs. 25 & 26: Narrow edentulous area compromised for implant placement. Figs. 27 & 28: Two-piece ceramic implant placement at tissue level. Figs. 29 & 30: Lateral bone augmentation (guided bone regeneration) with allograft bone substitute at the time of the implant placement. Figs. 31–33: Placement of a collagen membrane as a barrier and sutures. Fig. 34: Control radiograph at two months.

Case 4—Figs. 35 & 36: Edentulous molar area before implantation. Fig. 37: Exposure of the periodontal defect (the mesial aspect of the second molar). Figs. 38–40: Two-piece ceramic implant placement at tissue level. Fig. 41: Bone grafting and guided tissue regeneration at the mesial aspect of the second molar. Figs. 42 & 43: Micro-sutures. Figs. 44 & 45: Control radiograph and good integration of the ceramic implant in the environment.

# Case 3: Implant placement combined with lateral bone augmentation (guided bone regeneration) via a simultaneous approach

The site in the mandibular molar area presented with an alveolar crest too narrow for predictable implant placement without augmentation. Two-piece zirconia implants were placed simultaneously with lateral bone augmentation using an allograft and a resorbable collagen membrane (Figs. 25–34).

# Case 4: Implant placement in molar area with guided tissue regeneration

A patient with an infrabony defect came to the practice explicitly demanding a zirconia implant in the molar area. Thus, a two-piece zirconia implant was inserted, and at

the same time, the infrabony defect was treated by means of a bone allograft and Emdogain (Straumann). No loading was done at this stage (Figs. 35–45).

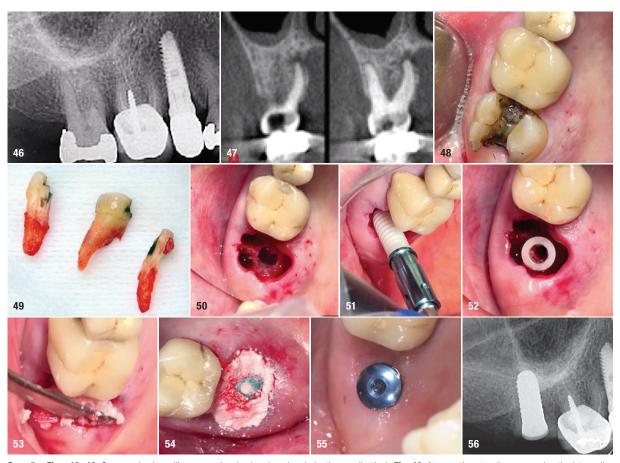
Case 5—Figs. 46–48: Compromised maxillary second molar (crack and endodontic complication). Fig. 49: Atraumatic extraction, preserving the interradicular septum. Figs. 50: Osseodensification technique with Densah burs using the interradicular septum. Figs. 51 & 52: Two-piece ceramic implant placement. Figs. 53 & 54: Allograft bone substitute and biphasic calcium sulphate protection. Figs. 55 & 56: Tissue integration and control radiograph at two months.

# Case 5: Immediate implant placement with the osseodensification technique

Diagnostics found a furcation, and a compromised prognosis for the maxillary second molar involved was made because of an interradicular crack. The tooth was gently removed, keeping in place the interradicular septum into which the implant was planned to be inserted. The osseodensification technique was performed by means of Densah burs (Versah), allowing successful stabilisation of the implant at tissue level. Allograft bone substitute and biphasic calcium sulphate were used for socket preservation. After eight weeks, we could observe and appreciate the successful integration of the ceramic implant into the surrounding tissue (Figs. 46–56).
