Replacement of two incisors with zirconia implants

Prof. Curd Bollen & Dr Ilian Dargel, UK & Netherlands

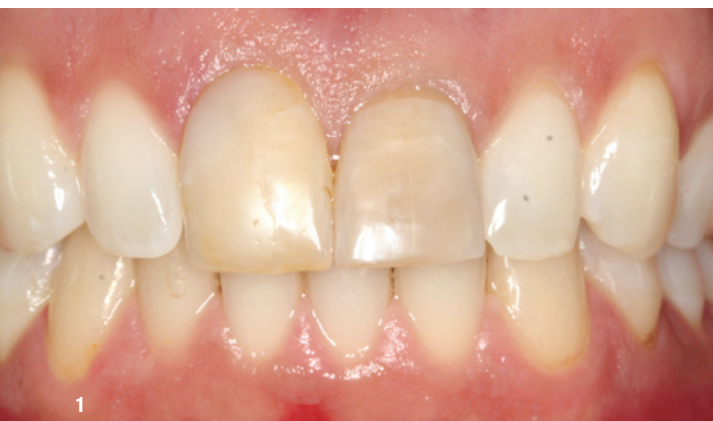
Fig. 1: General intra-oral situation at baseline in 2016. Fig. 2: The panoramic radiograph.

This 37-year-old female patient presented to our clinic at the end of 2016. Her ASA score was I and she claimed to have never smoked. Her alcohol consumption was moderate. In 2013, this patient was involved in a minor car accident, causing damage to her maxillary anterior teeth. In particular, teeth #11 and 21 sustained significant trauma. An endodontic treatment was only performed on tooth #21 at that time. On tooth #11, no endodontic treatment was indicated by her former dentist. This tooth showed severe untreated root caries in combination with an inadequate distal composite filling on our initial radiograph. Both central incisors had buccal composite restorations (Fig. 1). On both apices, cystic inflammation was

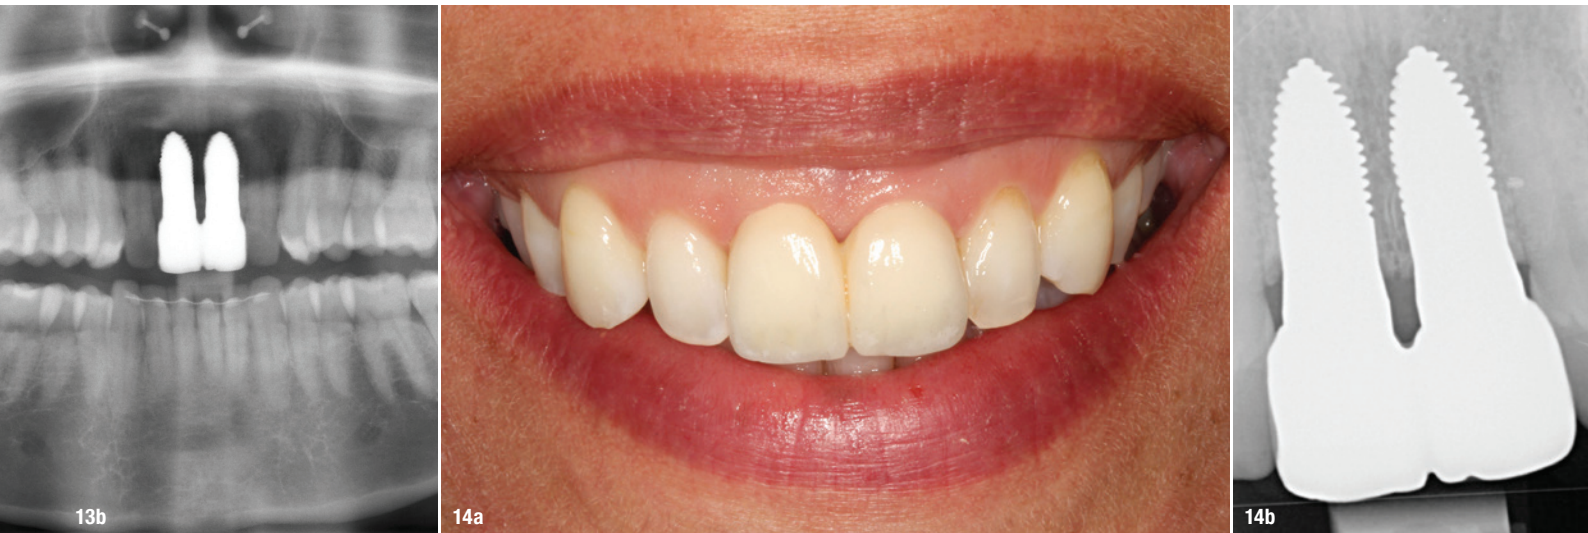
Fig. 13b: Panoramic radiograph after six months. **Fig. 14a:** Clinical situation two years after initial surgery. **Fig. 14b:** Periapical radiograph after two years.

covered with an IPS e.max layer (Ivoclar Vivadent). For stability reasons, it was decided to fuse both crowns centrally (Fig. 11). The definitive crowns were cemented with a glass ionomer cement (Ketac Cem, 3M ESPE). The radiograph showed an excellent fit at the crown-implant connection (Fig. 12). After six months, the patient was invited to a recall. The soft tissue was extremely healthy, and there was complete papillary regrowth between tooth #12 and tooth #11, tooth #11 and tooth #21, and tooth #21 and tooth #22 (Fig. 13a). The radiograph showed no signs of inflammation or marginal bone loss (Fig. 13b). Two years postoperatively, the patient was seen at another recall. The soft tissue was still very healthy. The radiograph taken at this appointment again showed no signs of inflammation or bone loss (Figs. 14a & b).
