# Successful immediate implant loading—According to the **Socket Shield** Technique

Dr Ramón Gómez Meda, Spain

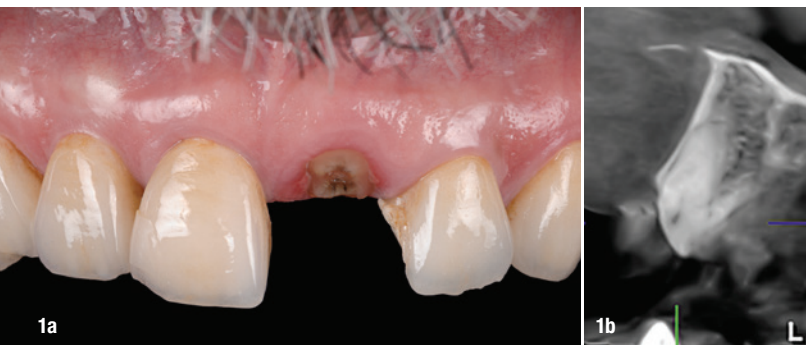
**Figs. 1a & b:** Initial situation before partial extraction of the fractured tooth and immediate implant placement. The epigingival fracture made a horizontal reduction of the root unnecessary.

splinted but even so the crown of the tooth broke horizontally at gingival level. The pulp sensitivity test of the fractured tooth with CO<sub>2</sub> snow was negative, the peri-coronal tissue was irritated, but showed absence of active purulent infections. Hard and soft tissue showed no signs of bone loss or recession, in comparison of the soft tissue and bone support of the two maxillary quadrants there was no difference from one quadrant to the other. Radiologically the root remnant showed no alterations or signs of fracture (Figs. 1a & b). Oral hygiene was good. Tooth conservation was assessed to be feasible but seemed rather unpredictable due to the

lack of enough dentine to predictably support a crown in the long term. Another alternative was to extract the root and to retreat the adjacent teeth with a fixed bridge. After a discussion of the treatment options and the respective risks and benefits, the patient agreed to substitute the tooth by an implant. The crown of the fractured tooth was temporarily positioned in place with the help of flowable composite.

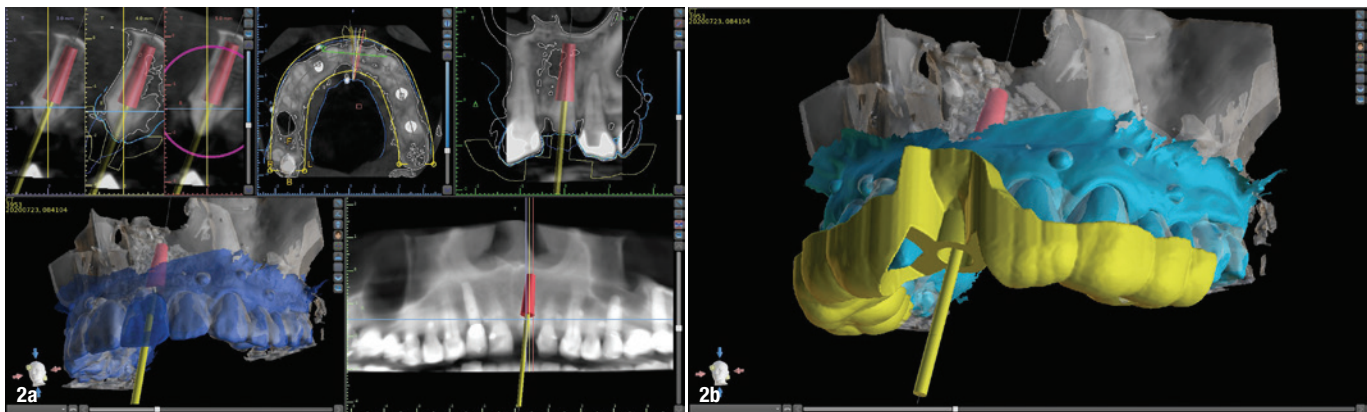
**Figs. 2a & b:** The DICOM files as well as the intra-oral STL files were imported into a software (Blue Sky Bio) to plan the ideal implant position. Finally, a surgical guide was printed.

(Planmeca Promax 3D Plus) paying special attention to the integrity of the cortical plate and the quantity of bone present in the apical area to be able to properly stabilise the implant. The DICOM files as well as the intra-oral STL files were imported into a software (Blue Sky Bio). These files were superimposed and a virtual wax-up helped to create the exact virtual position of the implant with an ideal prosthodontic emergence profile. Finally, a surgical guide was designed and immediately printed at the office with the help of a high-quality 3D printer (Nextdent 5100, 3D Systems; Figs. 2a & b). An alginate impression was taken to elaborate a thermoplastic vacuum formed provisional and the patient was released with a crown integrated into the removable template to temporarily solve the aesthetic problem. Antibiotics and AINES were prescribed for the day of the surgery. Also, the patient was advised to rinse his teeth with an antiseptic solution (0.2% chlorhexidine, DENTAID) the day before the surgery to reduce the bacteria load in the mouth. The crown of the fractured tooth (Fig. 3) was handed to the dental technician for orientation to build the screw-fixed temporary restoration on the implant for day of surgery.

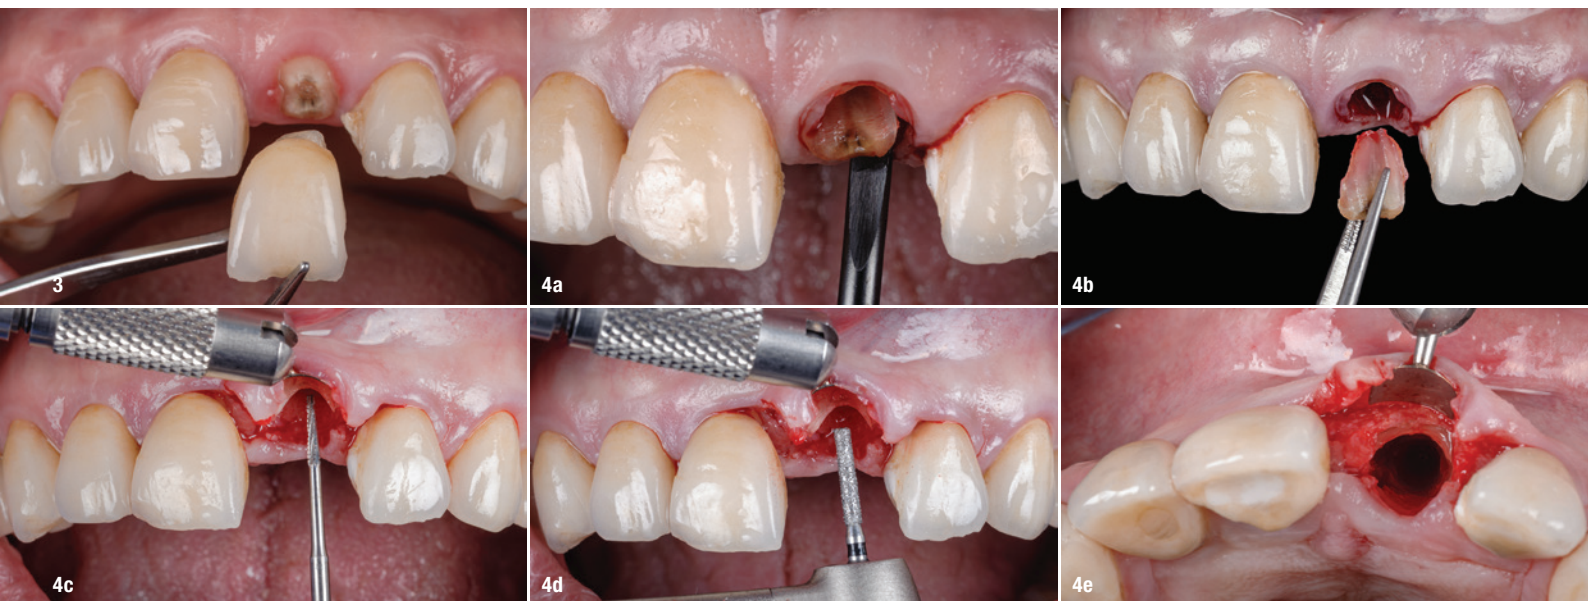
**Fig. 3:** After impression taking, the fractured crown was sent to the laboratory technician to copy the shape and colour. **Figs. 4a–e:** Partial tooth extraction with Socket Shield approach: bisection of the root, extraction of the palatal parts and contouring of the buccal shield.

was mobilised in order to better control later tooth fragment preparation and the surrounding tissue. Before implant bed preparation, the root was bisected vertically and the palatal aspect of the root was removed (Figs. 4a–e). Further dentine parts were removed in individual pieces, focusing to extract the entire root tip. The guide template was seated to prepare the implant bed through the root remnants. Sterile saline coolant was used during the entire drilling procedure. Only a small part of the root in the crestal area on the buccal side was intentionally left in place preserving the facial part of the periodontal ligament and as a consequence the bundle bone (Fig. 4e). As accurate tooth fragment preparation and implant placement is the key to successful treatment with the Socket Shield Technique,<sup>6</sup> the buccal root piece needed a little reshape with a lancet drill to thin it and such to guarantee that the dentine would not be in direct contact with the implant for proper bone formation.

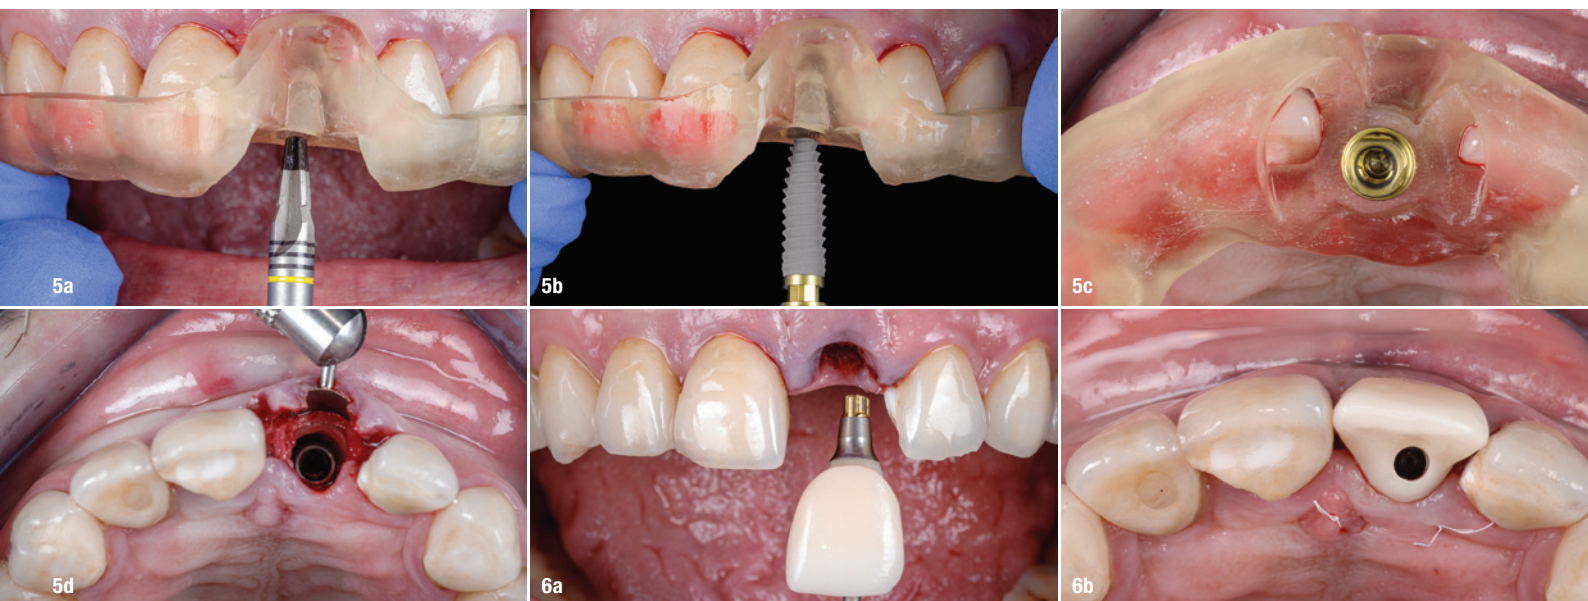
**Figs. 5a–d:** Fully guided placement of the implant into the exact 3D prosthodontic position, in distance to the root shield. Care was given to not change the position of the buccal root shield. **Figs. 6a & b:** The interim restoration had been designed based on the intra-oral scan. It could be screwed onto the implant immediately after the surgery to close the extraction wound and preserve the soft tissue.

A PROGRESSIVE-LINE (CONOLOG 3.8x13mm) implant was placed fully guided in the palatal part of the extraction socket in the correct 3D prosthodontic position (Figs. 5a–d). As being an apically tapered implant and threads down to the apex, this implant was chosen for the surgery as it enables to anchorage well within the basal bone but still not endangering the buccal lamella in the apical area. Also, the pronounced thread design makes it easy to reach very good primary stability even in situations with poor quality bone. Reaching an insertion torque of more than 35Ncm, the implant qualified to be restored immediately with a screw-

retained one-piece provisional crown (Figs. 6a & b). Therefore, a scan body had been screwed in immediately after implant placement to register the 3D position of the implant and scanned digitally (Figs. 7a & b). The interim restoration was designed in the office after importing the STL file into a professional software (Exocad dentalCAD) and after half an hour the provisional was manufactured with a milling machine (Ceramill Motion 2 5X, Amann Girschbach). Afterwards the wound was microsurgically sutured (Cytoplast 6/0 PTFE) to fix the flap in position. The interim restoration was cemented onto a Ti-base (CONELOG Titanium base CAD/CAM crown, CAMLOG) with a resin cement (SpeedCEM plus, Ivoclar Vivadent). This customised healing abutment placed immediately after the implant placement covered exactly the extraction wound and helped in maintaining the soft-tissue contours. A control radiograph confirmed the right position of the implant, the position stability of the shield and the correct distance from the tooth shield to the implant (Figs. 8a & b). After 2.5 months of healing, an optimal soft-tissue emergence profile was obtained (Fig. 9) and final restoration was delivered after 10 weeks (Figs. 10–12). Six months after insertion of the final restoration the crown is perfectly integrated (Fig. 13).

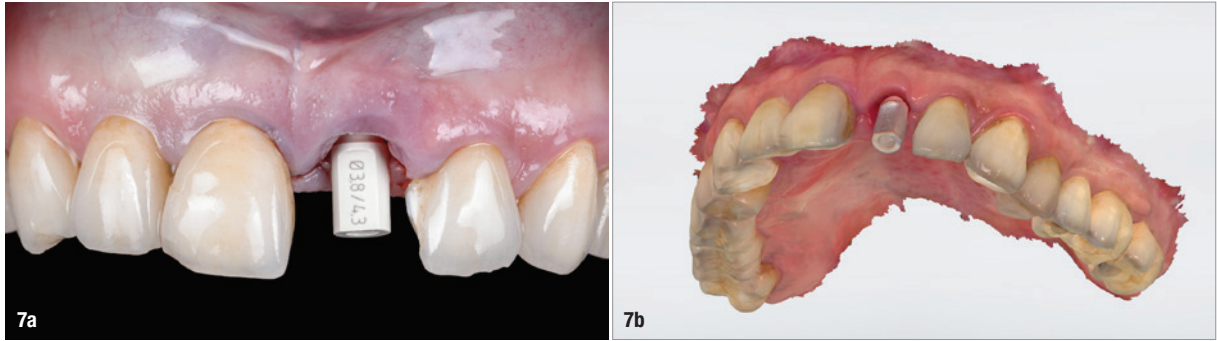
**Figs. 7a & b:** A scan body is used to immediately register the 3D position of the implant.

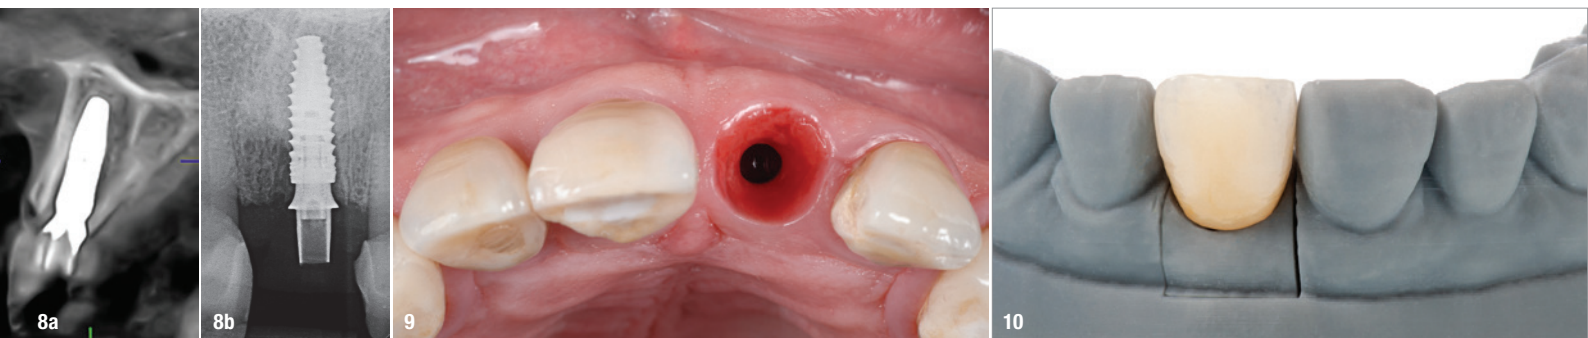
**Figs. 8a & b:** Radiological control of the position of the buccal root remnant and the implant. **Fig. 9:** After 8 weeks and removal of the provisional restoration the peri-implant region impresses by a voluminous and healthy soft tissue. **Fig. 10:** The final zirconia crown was produced following a fully digital workflow.

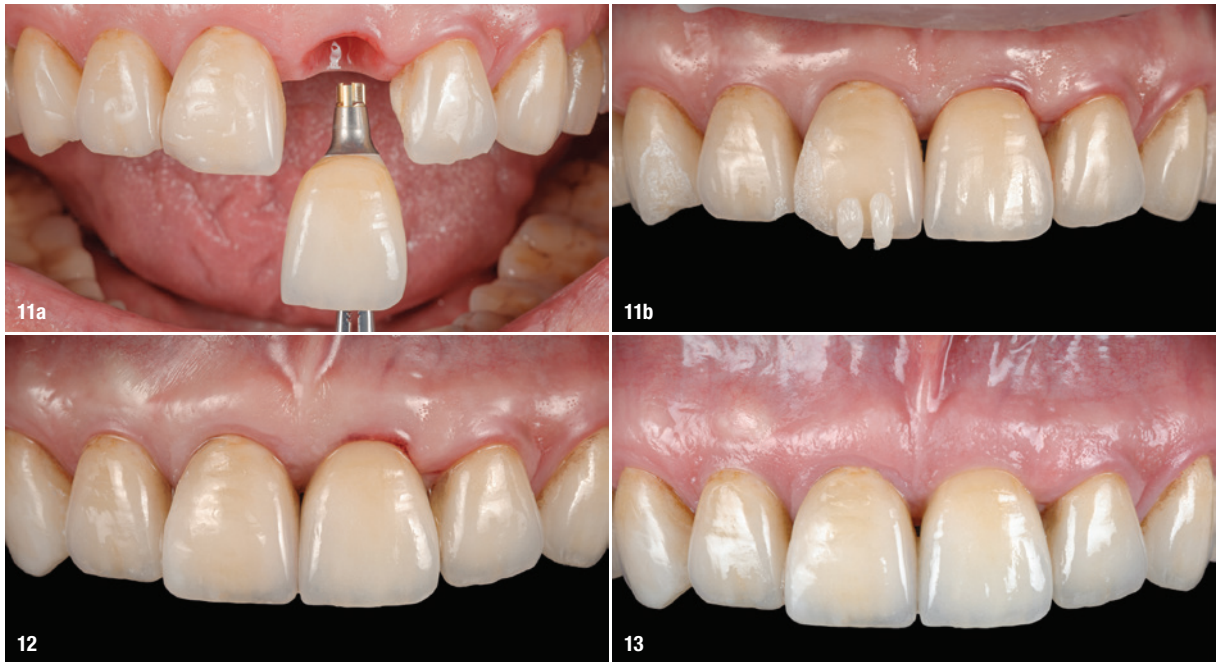
**Figs. 11a & b:** After seating the final prosthesis, slightly chipped adjacent crowns were repaired with composite. **Fig. 12:** Final situation the day the crown was delivered. **Fig. 13:** Follow-up 6 months later.
