# Successful immediate implant loading—According to the **Socket Shield** Technique

Dr Ramón Gómez Meda, Spain

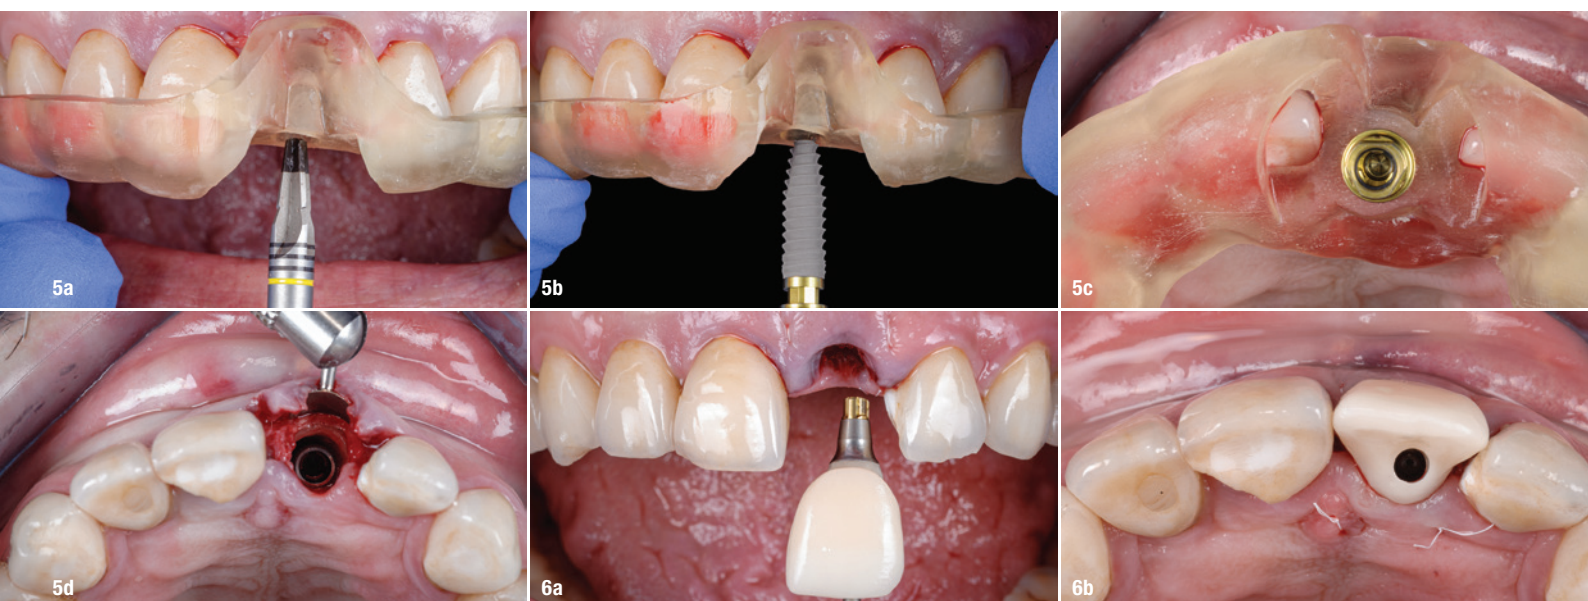
**Figs. 5a–d:** Fully guided placement of the implant into the exact 3D prosthodontic position, in distance to the root shield. Care was given to not change the position of the buccal root shield. **Figs. 6a & b:** The interim restoration had been designed based on the intra-oral scan. It could be screwed onto the implant immediately after the surgery to close the extraction wound and preserve the soft tissue.

A PROGRESSIVE-LINE (CONELOG 3.8x13mm) implant was placed fully guided in the palatal part of the extraction socket in the correct 3D prosthodontic position (Figs. 5a–d). As being an apically tapered implant and threads down to the apex, this implant was chosen for the surgery as it enables to anchorage well within the basal bone but still not endangering the buccal lamella in the apical area. Also, the pronounced thread design makes it easy to reach very good primary stability even in situations with poor quality bone. Reaching an insertion torque of more than 35Ncm, the implant qualified to be restored immediately with a screw-

retained one-piece provisional crown (Figs. 6a & b). Therefore, a scan body had been screwed in immediately after implant placement to register the 3D position of the implant and scanned digitally (Figs. 7a & b). The interim restoration was designed in the office after importing the STL file into a professional software (Exocad dentalCAD) and after half an hour the provisional was manufactured with a milling machine (Ceramill Motion 2 5X, Amann Girschbach). Afterwards the wound was microsurgically sutured (Cytoplast 6/0 PTFE) to fix the flap in position. The interim restoration was cemented onto a Ti-base (CONELOG Titanium base CAD/CAM crown, CAMLOG) with a resin cement (SpeedCEM plus, Ivoclar Vivadent). This customised healing abutment placed immediately after the implant placement covered exactly the extraction wound and helped in maintaining the soft-tissue contours. A control radiograph confirmed the right position of the implant, the position stability of the shield and the correct distance from the tooth shield to the implant (Figs. 8a & b). After 2.5 months of healing, an optimal soft-tissue emergence profile was obtained (Fig. 9) and final restoration was delivered after 10 weeks (Figs. 10–12). Six months after insertion of the final restoration the crown is perfectly integrated (Fig. 13).
