The Stable Tissue Concept

Dr Kai Zwanzig, Germany

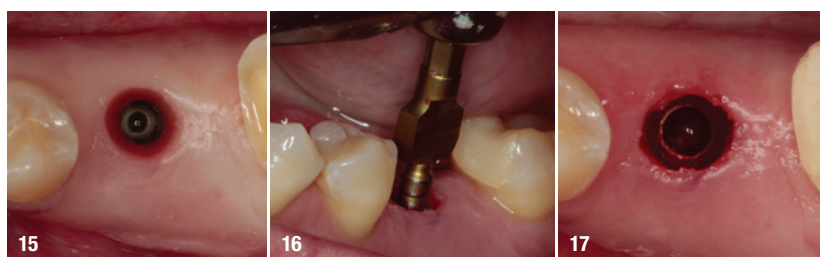
Five months after insertion, it was found that the band of keratinised gingiva was too narrow and that movements from the cheek were transmitted to the alveolar ridge (Fig. 9). This underpins the importance of the presence of sufficiently keratinised gingiva.⁸ Implant exposure was carried out by means of elevation of an apical flap (Fig. 10). If locating the membrane support screw is easy, as it was in this case, in almost all cases no further removal of bone is necessary (Fig. 11). Upon removal of the screw, the effect produced by this procedure became visible. Figure 12 clearly shows the cylindrical chimney that extended the entire length of the membrane support screw to the transition into the inner cone. This tissue was quite stiff and immobile. The histological composition would be interesting to know, since macroscopic evaluation is rather difficult. The author suspects that this was a complex connective tissue structure with slight mineralisation. For this treatment case, the author had a customised anatomical healing abutment milled, which was to accommodate the slim design in the apical part so that the augmented bone did not have to be removed again (Fig. 13). Owing to the still insufficient amount of keratinised tissue and lack of soft-tissue thickness, an

autologous soft-tissue graft was taken from the palate and fixated vestibularly to ensure that there was no movement whatsoever (Fig. 14). The thickness of the tissue above the implant shoulder also plays an important role; it should not be less than 3mm, otherwise bone resorption will occur.⁹
