# Rehabilitation of the maxilla with implant-supported zirconia bars

Dr Witalij Kolbe, Germany

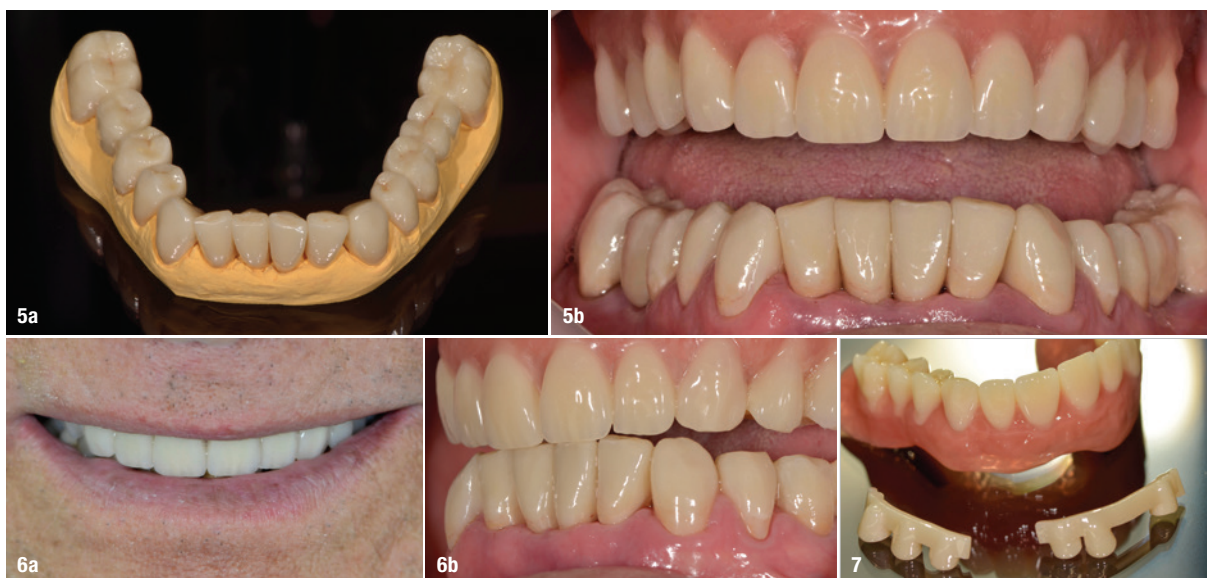
**Figs. 5a & b:** The prosthesis for the mandible was fabricated with IPS e.max pressed ceramics. **Figs. 6a & b:** Eighteen months after placement, the restoration was considered satisfactory. **Fig. 7:** The prosthesis produced in the WITAR laboratory.

Eighteen months after placement, the treating clinician and the patient were still satisfied not only with the overall aesthetic result of the restoration (Figs. 6a & b) but also with a stable implant-supported superstructure, which was installed without complications and which offers significant advantages from both a biological and technical point of view (Fig. 7).

The superstructure, a sliding construction over the bars, was fabricated from solid PEEK material. The finishing was done with autopolymerising PMMA denture acrylic (Palapress vario, Kulzer) and fabricated denture teeth (Genios, Dentsply Sirona). During the fabrication of the combination prosthesis, aesthetic, phonetic and functional aspects were taken into consideration with a particular view to the acrylic material used. The try-in of the completed bars went smoothly and without complications. The definitive bars were placed on the abutments and cemented with glass ionomer cement (CX-Plus, SHOFU Dental) in a tension-free way (Fig. 4). The prosthetic restoration in the mandible was fabricated in a second step with lithium disilicate pressed ceramics (IPS e.max Press, Ivoclar Vivadent; Fig. 5).
