Radiant, beautiful anterior teeth

Authors | Dr Stefen Koubi & Gérald Ubassy, France

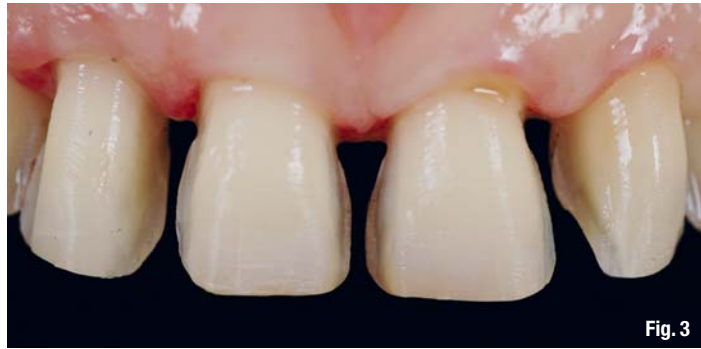
Fig. 3 Preparations with sub-gingival margins in the proximal region.

In order to keep the depth in check and observe the biological concept, the drill was placed directly on the mock-up. With this procedure, a uniform thickness of approximately 0.5 mm is achieved on the basis of the volume of the final restoration.¹ After removing the preparation key (mock-up), the presence of larger, non-prepared enamel areas is observed. In the present case, the treatment protocol was slightly varied in view of the cervical preparation margins: usually, the preparation margins are located above the gum line for veneer preparations; in this case, however, the margins had to be designed sub-gingivally (Fig. 3).

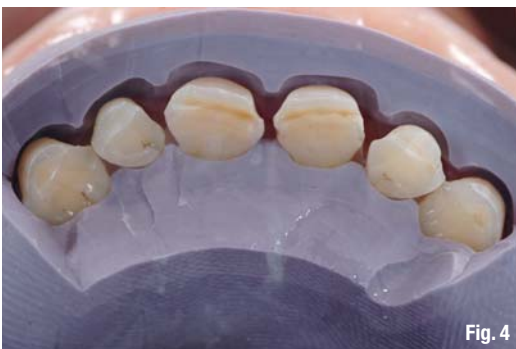
Fig. 4 Checking the relation between the preparations and the volume of the final restoration with the help of a silicone matrix.
Fig. 5 Isolating individual teeth in order to achieve optimum bonding.
Figs. 6 & 7 Lateral view of the IPS e.max Press veneers from right (Fig. 6) and left (Fig. 7).

contact surface with a soft transition from the edge of the root to the margins of the contact surface could be designed to mask the missing papillae (Fig. 4).

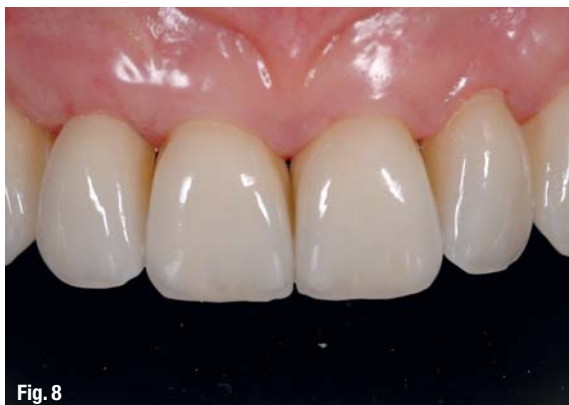
Fig. 8 Frontal view of the restorations; an expansion of the interdental papillae can be observed.

sors (Fig. 5), followed by the lateral incisors and canines and so on, thus allowing the clinician to carry out corrections on the proximal areas of the less prominent teeth (distal surfaces of canines or premolars). The restorations were conventionally placed with Variolink Veneer (Ivoclar Vivadent). In a last step, the composite joints were carefully finished with a scalpel in order to maintain the surface gloss of the ceramic and the excellent fit in the periodontal tissue (Figs. 6-8).

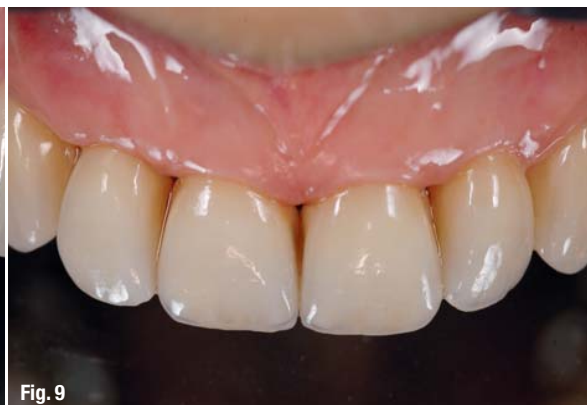
Fig. 9 View of the maxillary teeth; the optical properties of IPS e.max Press material are particularly highlighted in this image.

the distance between the contact point and the tip of the papilla had to be less than 5 mm in order to allow the papilla to grow back.² After some months, the papilla will have grown and filled the small spaces that were reserved for it. This is also a confirmation of the bio-compatibility of the lithium-disilicate glass-ceramic IPS e.max Press (Figs. 9 & 10).

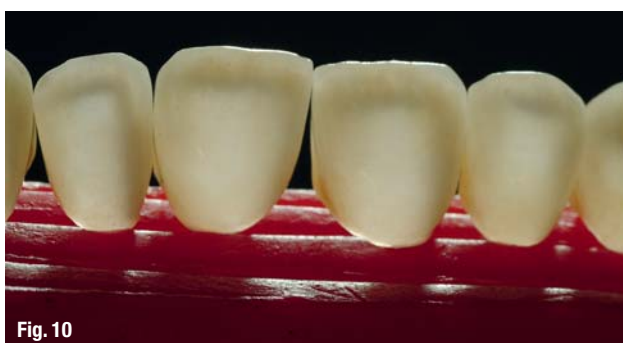
Fig. 10 Light transmission through IPS e.max Press veneers.
