A periodontal and restorative success formula

Rehabilitation of a failing central incisor

Dr Rita Singh, Nepal

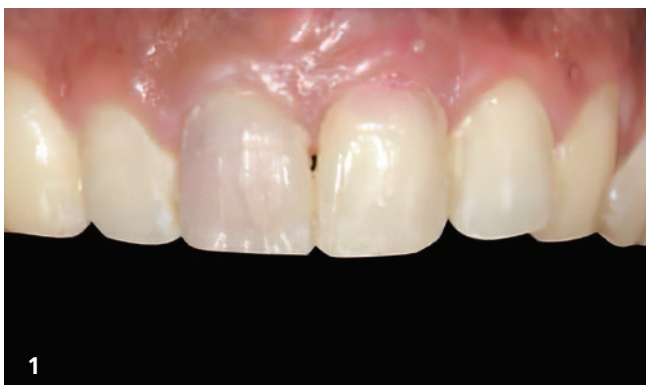
Fig. 1: Pre-op clinical image showing the affected teeth #11 and 21. **Fig. 2:** CBCT evaluation showing fenestration at tooth #21.

The patient presented with the chief complaint of discomfort and mild mobility of the maxillary left central incisor and gave a history of trauma to the same jaw region about ten to twelve years before that had led to avulsion of the same tooth, following which the tooth was replanted. The right central incisor showed purple discoloration and required endodontic re-treatment (Fig. 1)

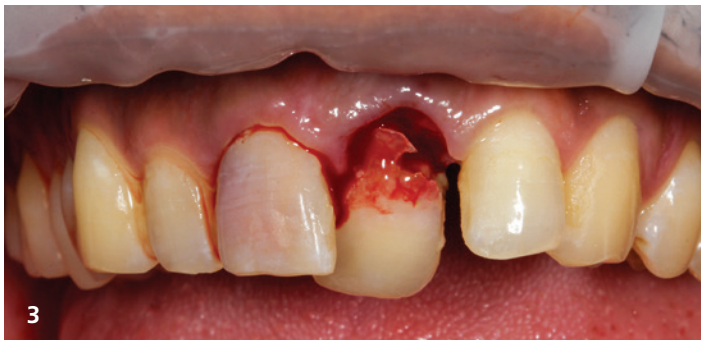
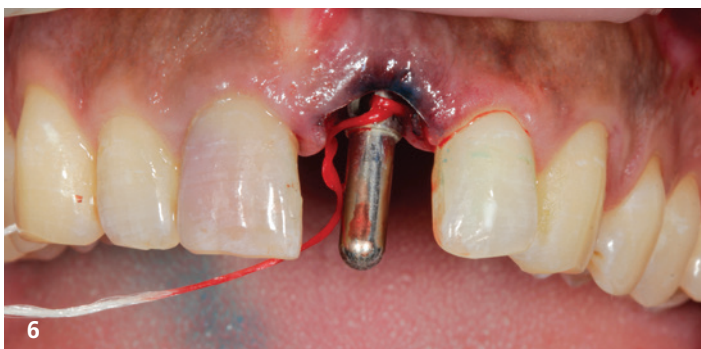
Fig. 3: Fractured cervical portion of tooth #21. **Fig. 4a:** Granulation tissue after extraction. **Fig. 4b:** Extraction socket after mechanical debridement. **Fig. 5:** HELBO antimicrobial photodynamic therapy. **Fig. 6:** Verifying implant position and angulation. **Fig. 7:** Implant placement 4 mm below the gingival margin, respecting biologic width.

The procedure was flapless in order to minimise hard- and soft-tissue trauma. The fractured portion of the tooth was gently removed with a tweezer and the remaining root was atraumatically luxated (Fig. 3). Thorough curettage was done to ensure the total removal of the granulation tissue (Figs. 4a & b). To ensure complete disinfection of the site, antimicrobial photodynamic therapy was done using the HELBO laser (bredent medical). Blue photosensitiser (methylene blue) was applied inside the socket and left *in situ* for 60 seconds to stain the bac-

teria. After the dye had been rinsed off, the socket was then exposed to the HELBO TheraLite diode laser for 1 minute (Fig. 5). This ensures focused antibacterial action by singlet oxygen molecules, destroying bacteria in the biofilm.

The implant osteotomy site was prepared with sequential drills, and 3D position verified with paralleling tools (Fig. 6). The implant (copaSKY, 4 × 12 mm; bredent medical) was placed with sufficient primary stability (torque of 45 Ncm), facilitating predictable immediate loading of the implant. The implant was placed 4 mm below the gingival margin to accommodate biologic width (Fig. 7).
